MLP GARAGE EXISTING CONDITIONS EVALUATION**EXECUTIVE SUMMARY**

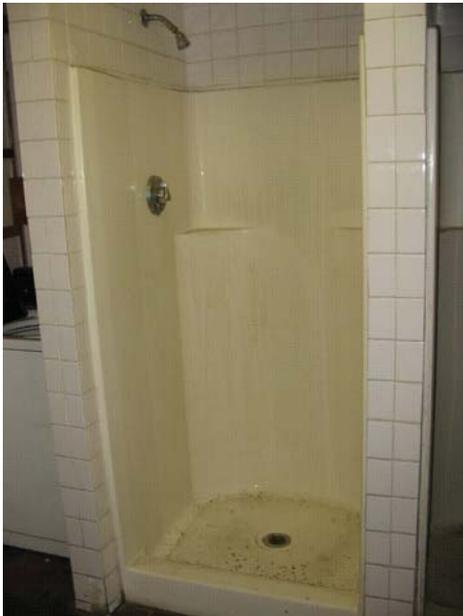
Picture P-1

The existing plumbing systems are antiquated and in poor condition. Within the shower and toilet facilities, the shower valves leak, the floor drains are slow to drain, and the toilet facilities are not ADA compliant.

A slow drain was also detected for the kitchen sink drain, indicating a clog in the system. Accordingly we would recommend removing existing fixtures, installing new fixtures in accordance with current building codes, and power cleaning the sanitary piping.

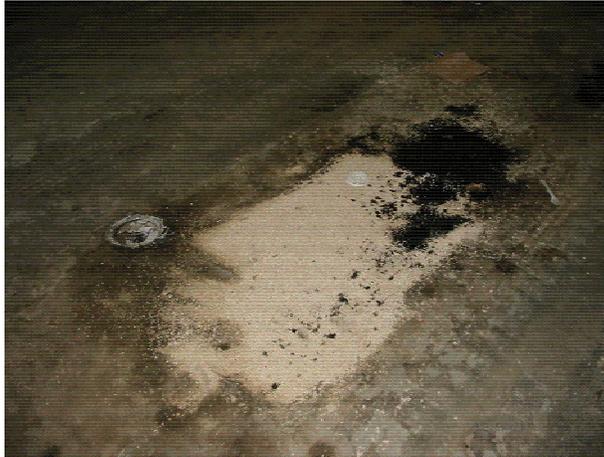
Picture P-3

There are several garage areas throughout the facility; within each garage area there are floor drains to capture any snowmelt or miscellaneous vehicle fluids (e.g., oil, gas, antifreeze). Upon evaluation of the site and facility an oil/gasoline interceptor was not found. Therefore all vehicle

fluids are entering the sanitary system without any pretreatment. This is a code violation in accordance with 248 CMR Massachusetts Plumbing Code, MWRA regulations and EPA regulations. During the site investigation fresh oil was seen around a floor drain (see picture P-3). In addition, the floor drains do not contain trap primers, which can lead to floor drains drying out and allowing sewer gases to infiltrate the facility. The current plumbing code 248 CMR Paragraph 10.10 (10.5) requires all floor drains to have trap primers.

Accordingly we would recommend removing all under slab sanitary piping leading to floor drains including the sanitary piping which connects the facility to the sewer main. Removing this piping eliminates any oil or gas that may be embedded in the piping. A new floor drain system could then be installed and connected to an oil/gasoline interceptor located outside the facility. All new floor drains shall have trap primers in accordance with 248 CMR Chapter 10. This work will involve extensive slab cutting, trenching and patching.

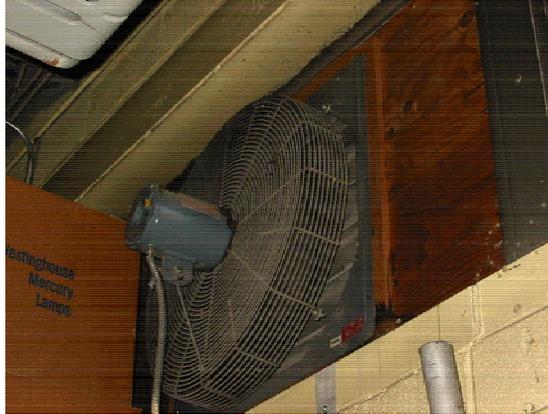
Picture P-4

Ventilation. Ventilation pertains to the clean fresh air that is required for a building in accordance with 780 CMR Massachusetts Building Code, which in turn refers to the 1993 BOCA Mechanical Code Chapter 16. The existing facility does not contain a working fresh air ventilation system and its windows are inoperable due to the age and condition of the window mechanisms. This is evident in the excessive amount of exhaust odors within the building. The air quality of the building is poor; and strong exhaust and oil odors are prevalent in the office areas, garage areas, and storage areas, which pose a health hazard to the personnel working in the facility. In accordance with current building codes, an exhaust system is required in all bathrooms, locker rooms, and garage areas. The garage areas are required to run continuously unless operating in conjunction with a carbon monoxide detection system. In addition, the locker room and bathroom exhaust should operate during working hours. There were three exhaust fans observed within the facility (see picture P-4). The exhaust fans were manually controlled by a switch and only one

of the three was operational. The operational exhaust fan removed air from a storage area and exhausted the air into a garage area, hence the fan acted as a transfer fan, instead of an exhaust fan. Accordingly we would recommend installation of a complete ventilation system including a CO detection and exhaust system.

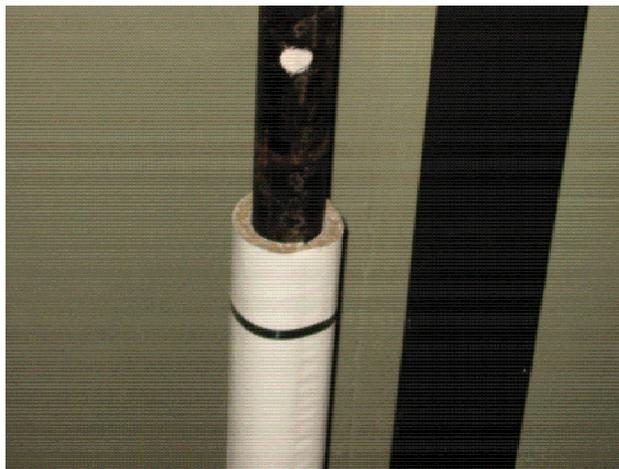
Picture P-5

Heating. Originally the building had a steam heating system, which has been replaced by a combination of indirect gas fired and electric unit heaters. The steam system appears to have been abandoned in place; therefore there are steam unit heaters, piping, radiators and a boiler still located within the facility. The piping and boiler are insulated with a material that is suspected to contain asbestos. This material is exposed and may create a dangerous condition if inadvertently disturbed. (see picture P-5). Note that a separate investigation of potential hazardous materials within the existing building is currently being conducted. Based on the results of that survey and testing, we would recommend all identified materials be abated or removed in accordance with proper procedures.

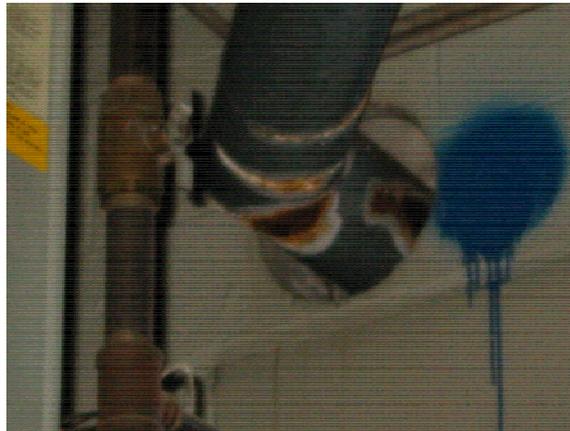
Picture P-6

The building windows are single pane and drafty. Drafty windows are prevalent in the office areas, where heating is accomplished by undersized, recessed electric wall unit heaters. The gas fired unit heater flue penetrations are not insulated and cold air can be felt infiltrating the penetrations (see picture P-6).

Drafty windows, cycling of unit heaters, lack of nighttime setback controls, and un-insulated penetrations contribute to preventable heat loss within the facility, which is translated to energy costs. Correcting these problems will significantly lower energy costs. Accordingly, we would recommend removal of all unit heaters and replacement with makeup air units working in conjunction with the CO detection system, an air handling unit for the office areas, and replacement of all windows with energy efficient windows. The roof is not constructed to handle the weight of makeup air units and air handling units; therefore structural analysis and supplementary steel should be anticipated to support the units if they are to be roof-mounted. *Cooling.* Cooling within the facility is limited to 3 thru-wall residential type air conditioners. Two of the three air conditioners reject their heat into an adjoining room or storage area (see pictures P-7 and P-8).

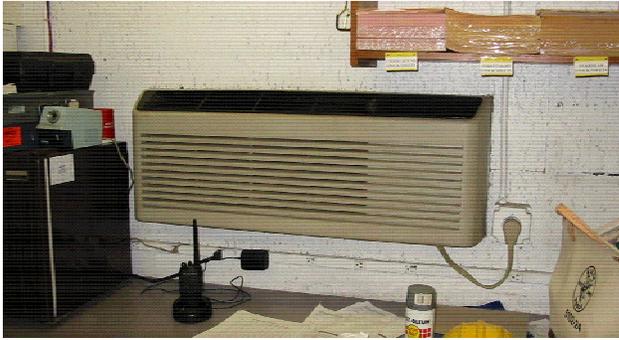
Picture P-7

Since the two air conditioners are located in walls that adjoin the storage/garage area, the fresh air intake transfers air containing vehicle exhaust fumes into the office area and poses a potential health hazard to the occupants of the office. Accordingly we would recommend removing all three air conditioners and installing an air handling system with cooling and heating coils.

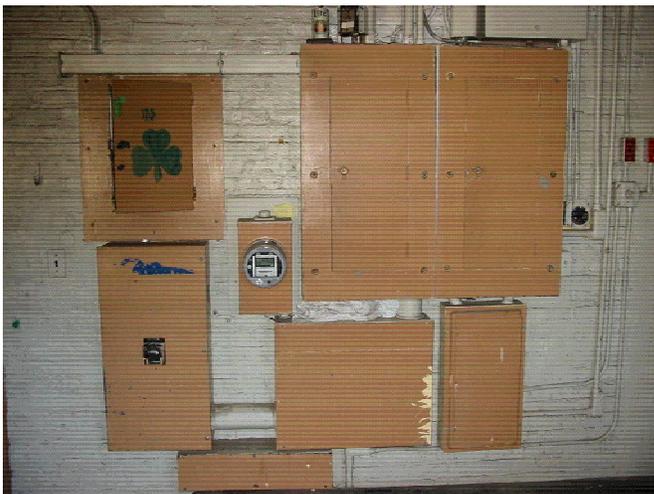
Existing Conditions. The building's main electrical service is a 400A, 3-phase, 208/120V service. The service is protected by a 400A molded case self-enclosed circuit breaker and enters the building to a junction box via (2) underground 2" conduits with 1/0 conductors. Within the junction box the (2) sets of incoming conductors are spliced into one set of 250 MCM conductors and continues on to the line side of the 400A breaker. The breaker's load side conductors feed through metering current transformers within a junction box and then into a 400A double tub MLO Main Distribution Panel (MDP). The above noted conduit and conductor sizes are based on an observational estimate and further investigation would be required to confirm the actual sizes.

Picture E-1: 400A Main Electrical Service, MDP, Meter & Sub-Distribution Panel

- The equipment and their installation described above are in fair condition, are of several vintages based on their installation periods, and appear to be in working condition.
- The metallic raceway throughout the facility is in fair to poor condition. In numerous places the raceway is not supported properly, it does not run along ceiling surfaces, nor is it run straight and perpendicular to walls and ceilings as a proper installation would require. *This is a violation of NEC articles 110.12 & 300.11.*

Accordingly we would recommend addressing code violations and consideration of a consolidation/replacement of existing equipment to support the anticipated uses and meet contemporary standards.

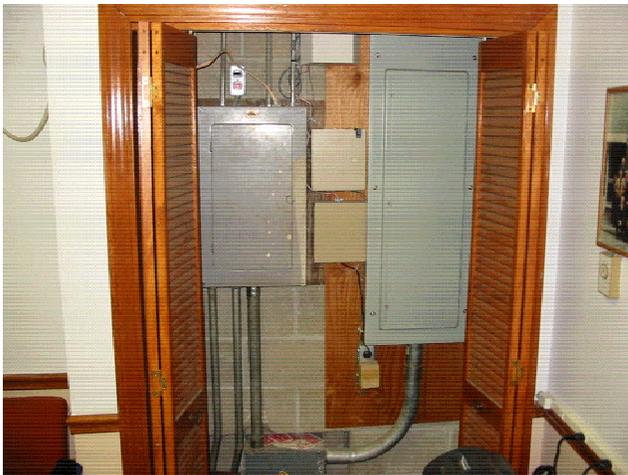
The (2) sub-distribution panels located in the lunchroom closet has branch circuits in mainly NM type cable that seem to service the lunchroom, locker room, kitchen, and bathroom.

Picture E-2: (2) Sub-Distribution Panels in Lunch Room

- Plate covers to both switches and receptacles are missing at various locations throughout the facility. *This is a violation of NEC article 110.27.*
- One of the panel boards in the lunchroom closet is not fully accessible with the closet doors open. *This is a violation of NEC article 110.26.*
- A disconnect switch and contactor for the air compressor are located behind the air compressor and is not accessible without leaning over or squeezing in behind the compressor. *This is a violation of NEC article 110.26.*

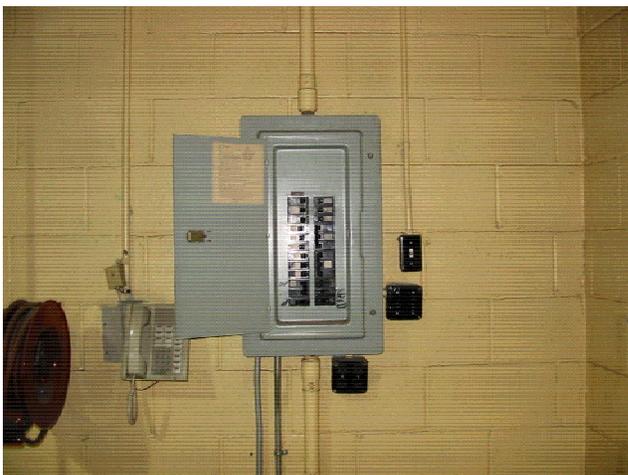
The sub-distribution panel located in the MLP shop has branch circuits in metallic raceway that most likely services equipment in the adjacent area.

Picture E-3: Sub-Distribution Panel in MLP Shop

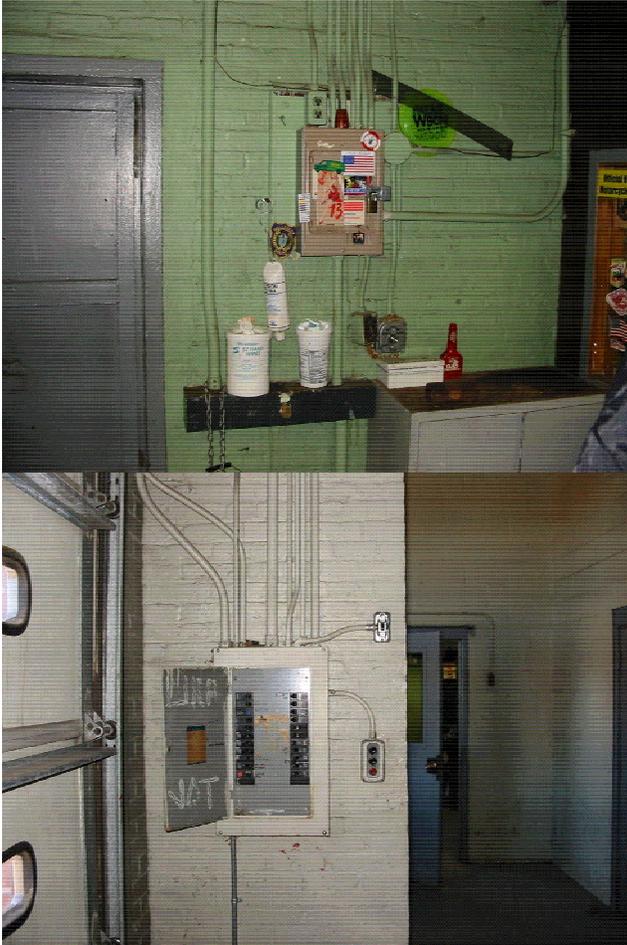
In the Water Department portion of the building there is another Distribution Panel that feeds a sub-distribution panel. It was unclear from observation if this Distribution Panel was fed from a separate incoming building service or was from the 400A MDP. The distribution and sub-distribution panels have branch circuits in metallic raceway that most likely services equipment in the adjacent area.

Picture E-4: Water Department Distribution Panel and Water Department Sub-Distribution Panel

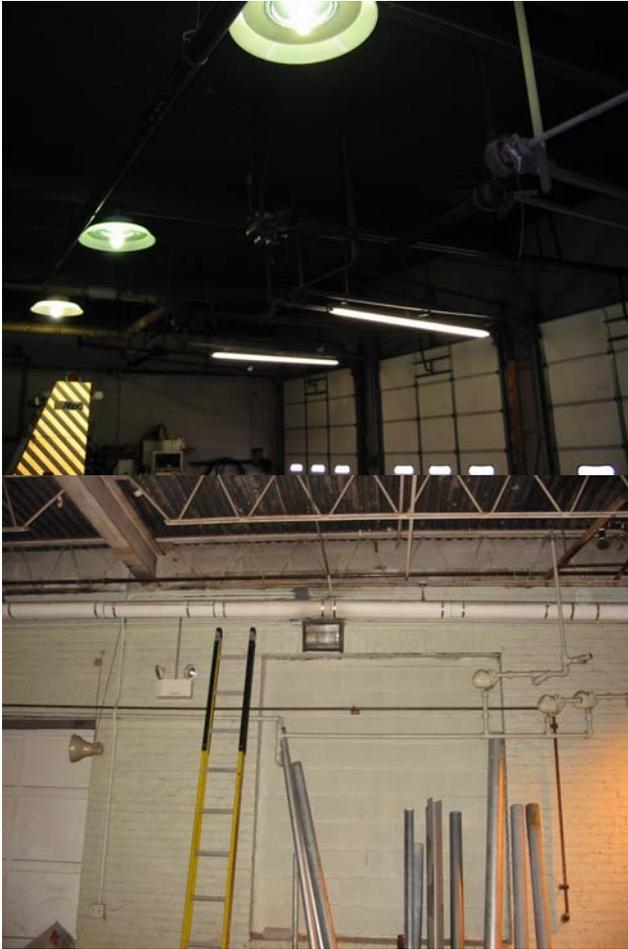
Existing Conditions. The existing lighting consists of both older 8ft. strip fluorescent fixtures, HID low bay fixtures, and wall pack fixtures. A combination of switches and circuit breakers appear to provide control of the lighting but the particular control was not immediately evident as you entered an area. In various locations the light fixtures were not working either due to blown bulbs or bad fluorescent ballasts. Many of the HID fixtures did not have lens covers.

**Picture E-5: HID & 8'ft Strip Fluorescent Fixtures
Wall Pack & Emergency Lighting Unit**

- The lighting level in general throughout the area is very poor and inadequate for the usage. There are many areas of shadows and of hot spots making a non-uniform and low level of lighting. In (1) garage bay and (1) small hallway there was no lighting at all.
- In general there are not enough emergency lighting units in the facility for egress lighting. *This is a violation of The Massachusetts State Building Code 780 CMR 1024.*
- There were no illuminated exit signs throughout the building. *This is a violation of The Massachusetts State Building Code 780 CMR 1023.*

Accordingly we would recommend that lighting fixtures and switches be replaced, that emergency lighting be upgraded, and exit signs be provided.

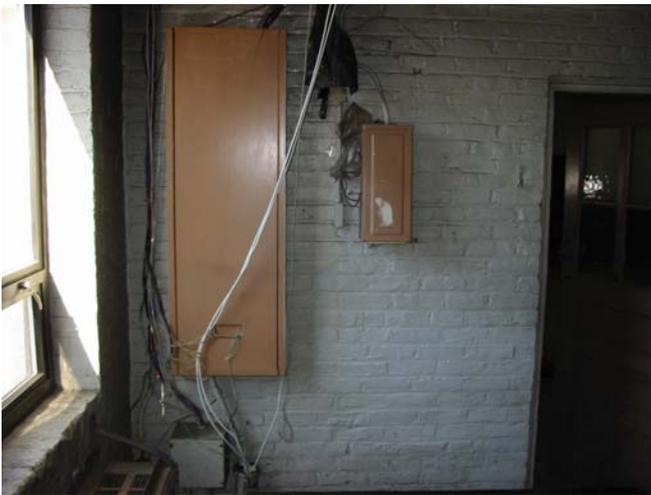
Existing Conditions. Telephone lines are provided by a multi-conductor cable entering the building underground via a 4" conduit. The cable enters a telephone termination cabinet and terminates. Several multi conductor cables feed out of the cabinet and service various parts of the building. The cables are strung in free air from ceiling frame supports and electrical raceway.

Picture E-6: Telephone Cabinet and Data Entrance

In general the cable installation throughout the building is in poor condition. In many places the cable hangs and does not run in a neat and orderly fashion along its supports. *This could be considered a violation of NEC article 110.12*

Accordingly we would recommend that the cabling installation be improved as part of any building reuse.
