Roofing and Envelope Feasibility Study

Wellesley Police Station
Wellesley, MA
2 October 2015

SGH Project 150841

Project 150841 – Roofing and Envelope Feasibility Study (#WFMD-RFP-FY16-001),
Wellesley Police Station, 485 Washington St., Wellesley, MA

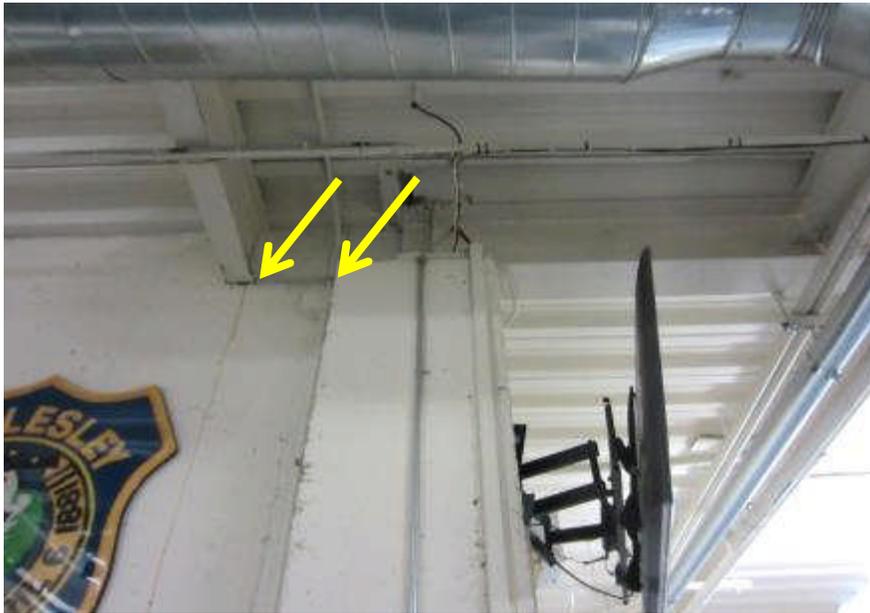
Fitness room

- Brown water streaks and/or injection grout on the white painted concrete foundation walls in the fitness room and storage room (Photos 1 and 2), at the inside corners between the sally port and main building. Based on the streak stains and description from WPD staff, these leaks appear to originate from the top of the foundation wall. WPD staff told us that the top of both walls were previously injected with grout to mitigate the leakage, with limited success. We observed yellow/orange foam-like material remnants suggesting that the walls were injected with urethane material.

Brown water streaks and/or injection grout on the white painted concrete foundation walls in the fitness room. The arrow identifies the general location where we were told water leaks from the top of the wall.

- The below-grade dampproofing is performing satisfactorily and does not require replacement. Localized wall and below-grade dampproofing repair is required where water leaks into the Fitness and Storage Rooms.

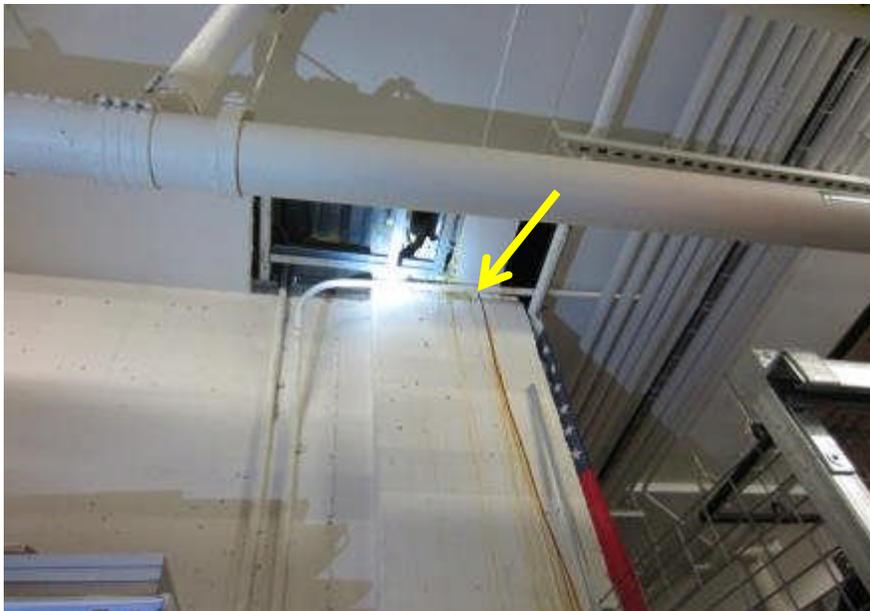
Storage room

Brown water streaks and/or injection grout on the white painted concrete foundation walls in the storage room.

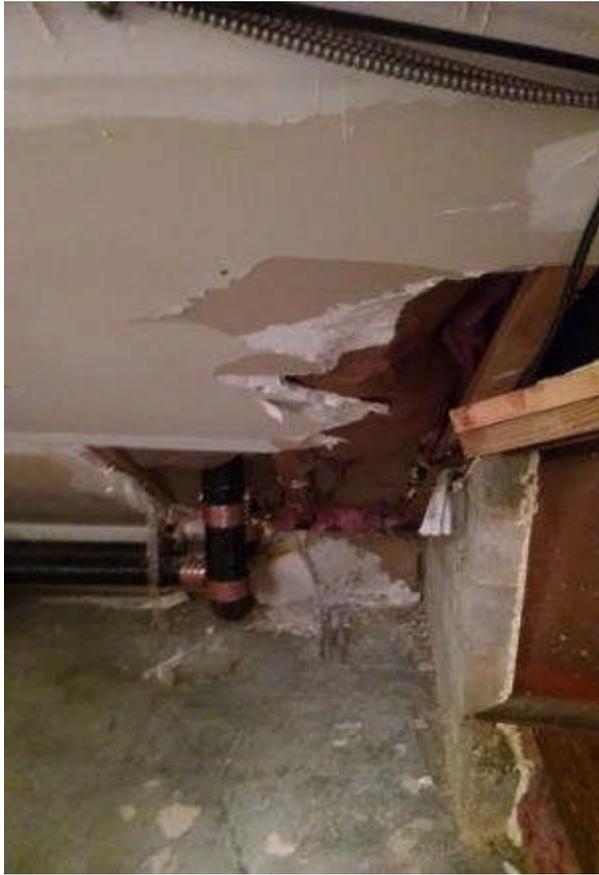
Interior water damage in the crawl space over the garage (sally port west wing).

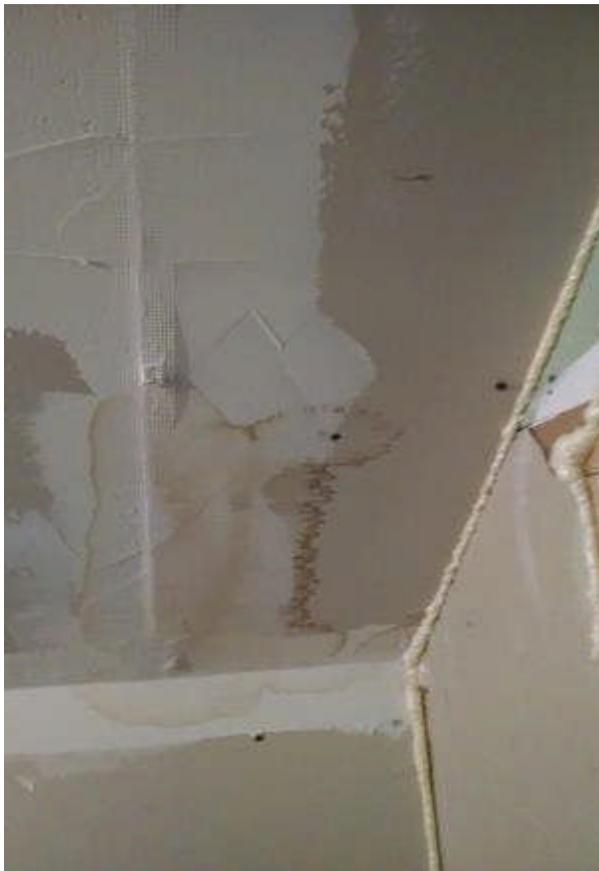
Interior water damage in a crawl space.

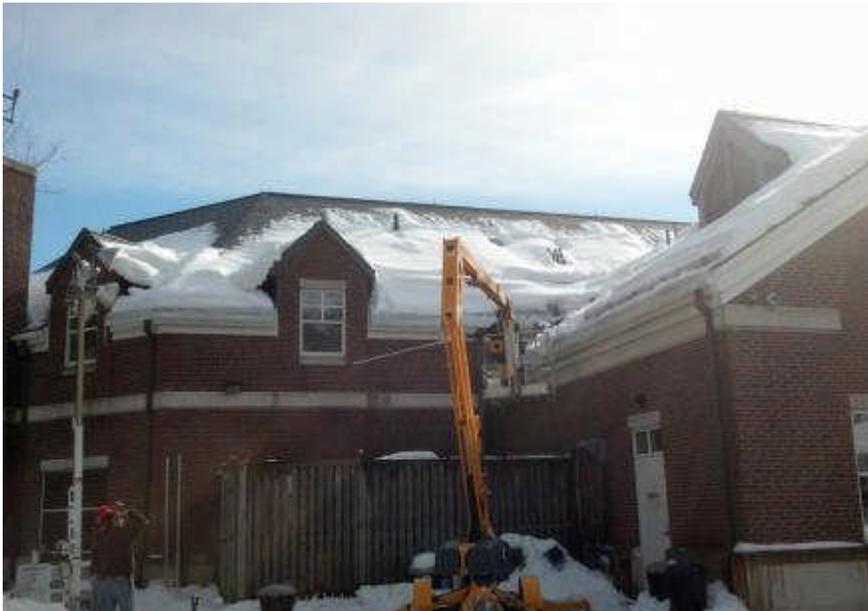
Ice and snow accumulation (ice dam) at the valley/eave/sidewall above the sally port during the winter of 2014-2015.

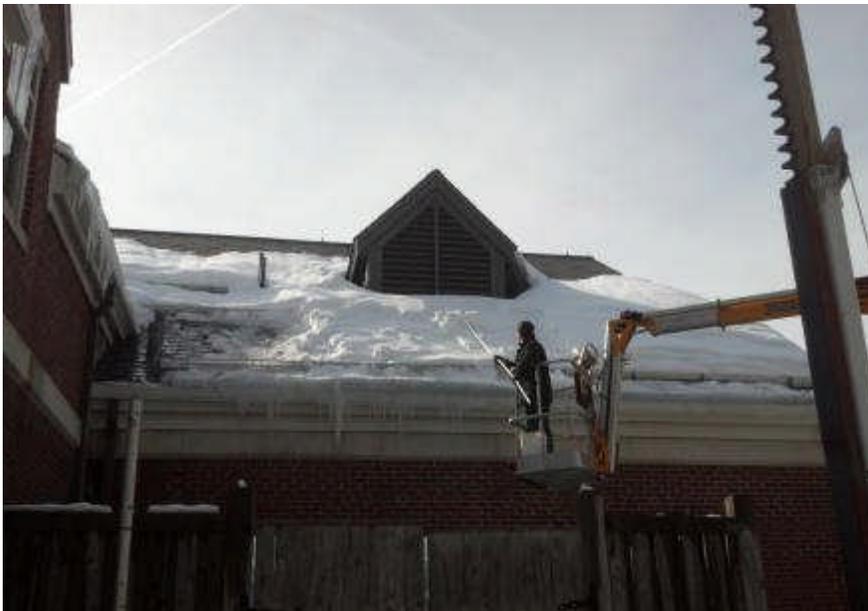
Ice and snow accumulation (ice dam) at the HVAC intake louver above the sally port during winter of 2014-2015.

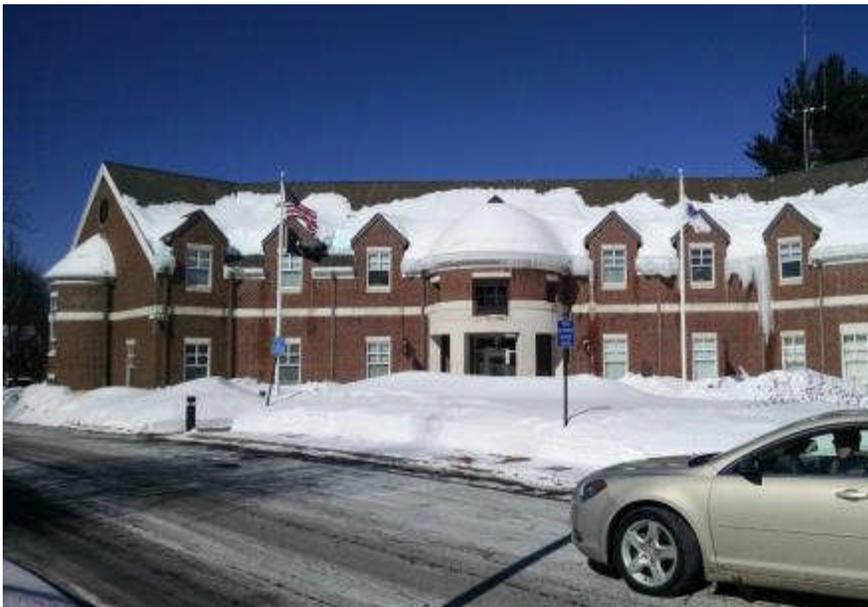
Snow and ice on the front roof during the winter of 2014-2015.

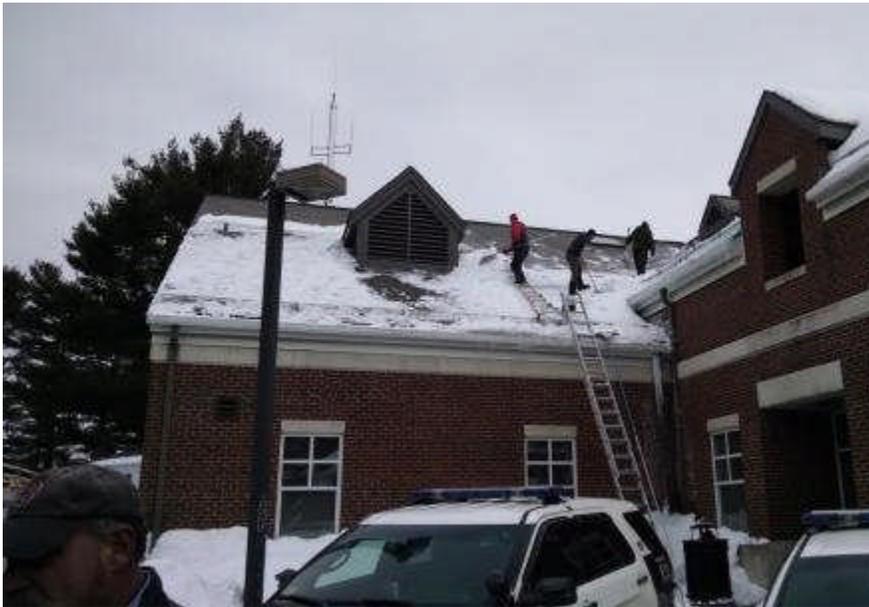
Workers removing snow and ice from the valley/eave/sidewall above the sally port during the winter of 2014-2015.

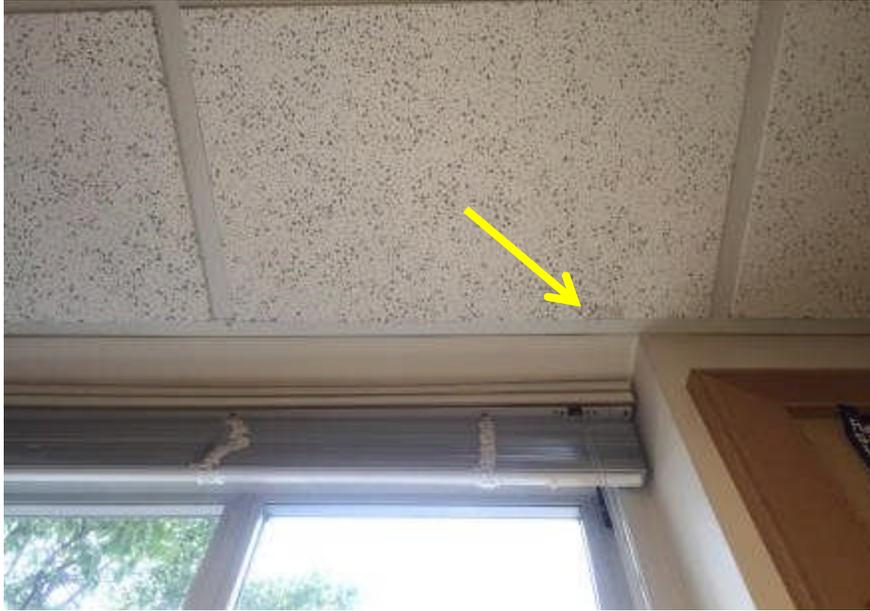
Room 107

- Stained sealing tile that may be from exterior water leakage; we did not inspect above the ceiling tile (Photo 17). WPD staff told us that several ceiling tiles were damaged from ice dam-related roof leaks during the 2014-2015 winter, and the damaged/stained ceiling tiles were replaced in spring 2015.

Stains on ceiling tile that may be caused by exterior water leakage.

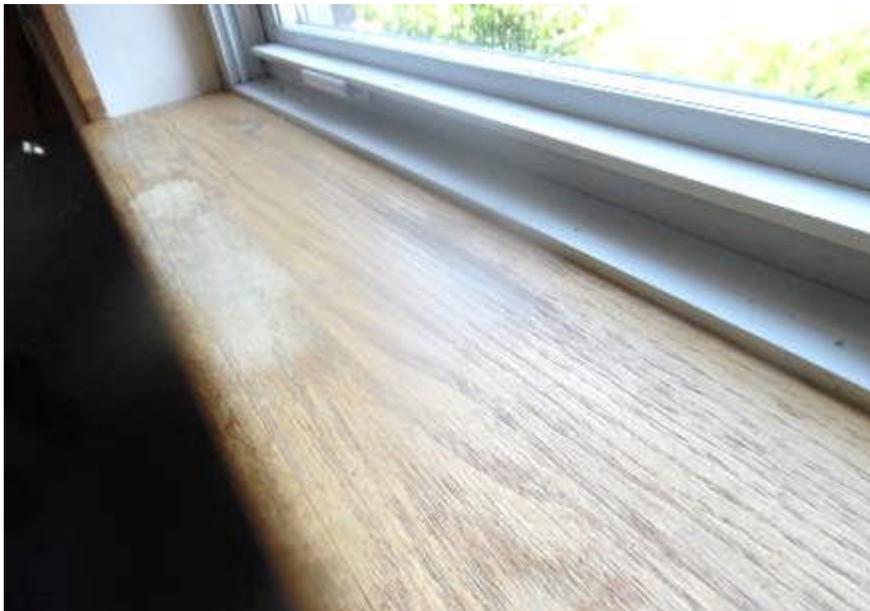
Room 138

- Water stains and/or deteriorated finish on the laminated wood stools (Photo 18). Most of the water stains appear to be from cups, plants, leaving the windows open, etc. At two locations, we observed stains on the sill that could be from water leakage through the sill/jamb frame corner (Photo 19) based on the water leakage observed during our testing (see Report Section 4.2)

Water stains and/or deteriorated finish on the laminated wood stool.

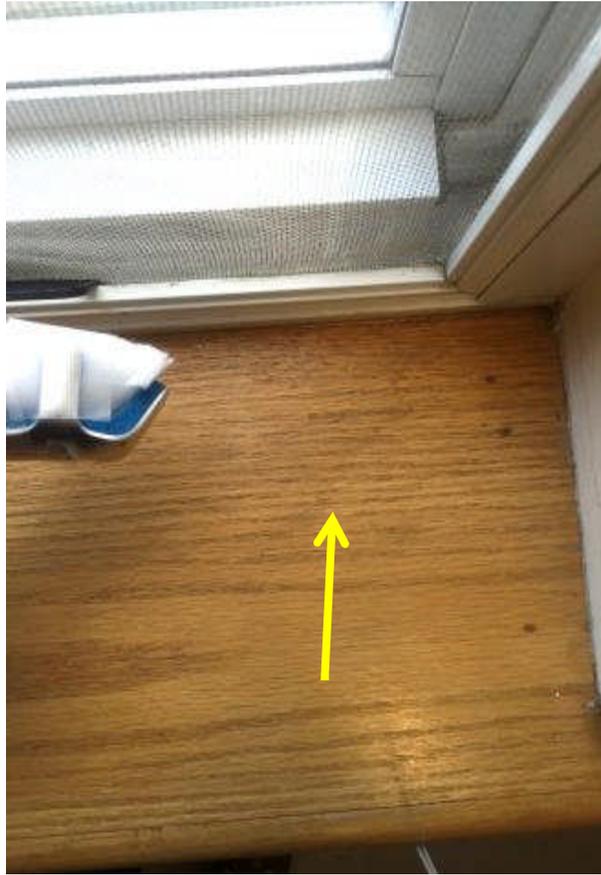
Room 110

Water stains on the stool below the jamb that could be from water leakage through the sill/jamb frame corner.

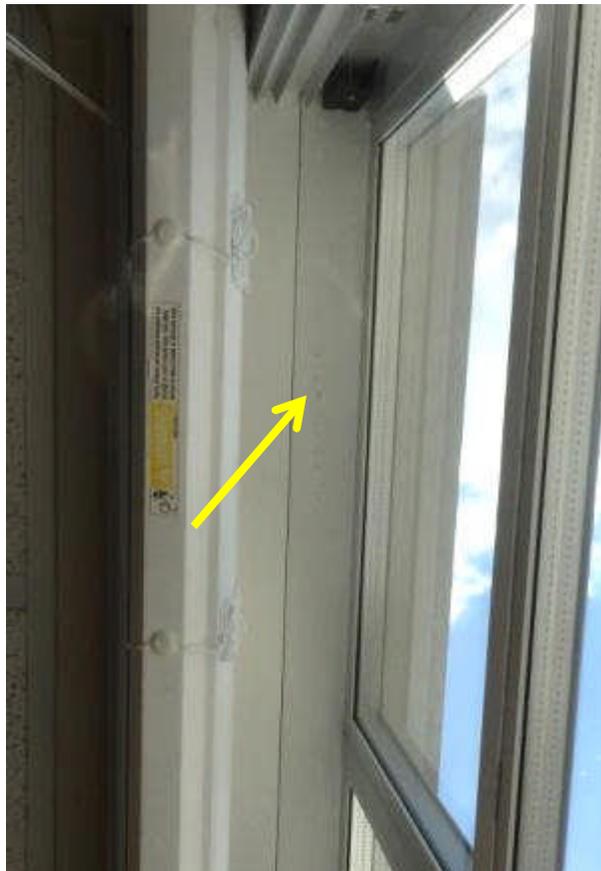
Room 108

- Water stains/streaks on window frame head and/or jambs (Photos 20 and 21). These stains/streaks could be from exterior water leakage or condensed water.

Water stains/streaks on window frame head. Note: photo is oriented with window head on the left and the window jamb at the top.

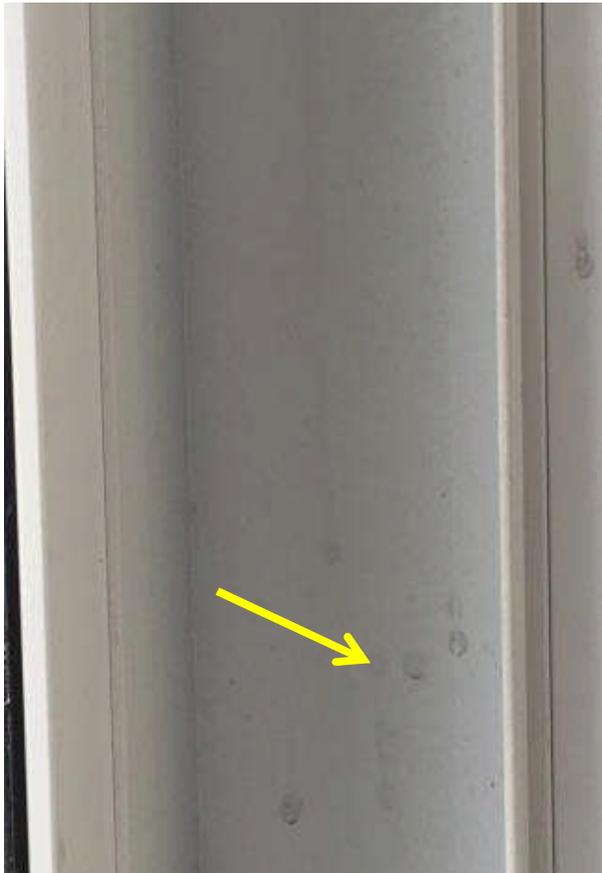
Room 139

Water stains/streaks on window frame at jamb.

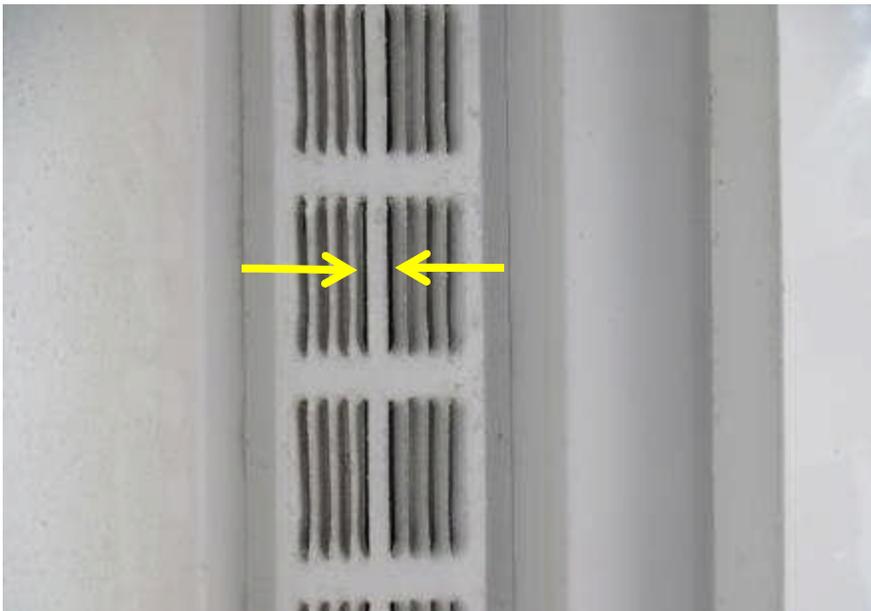
The soffit vent is 2 in. wide, but mostly blocked by metal frieze and fascia trim cladding. The yellow arrows identify the cladding metal edges behind the soffit vent. The space between the arrows is the available vent opening.

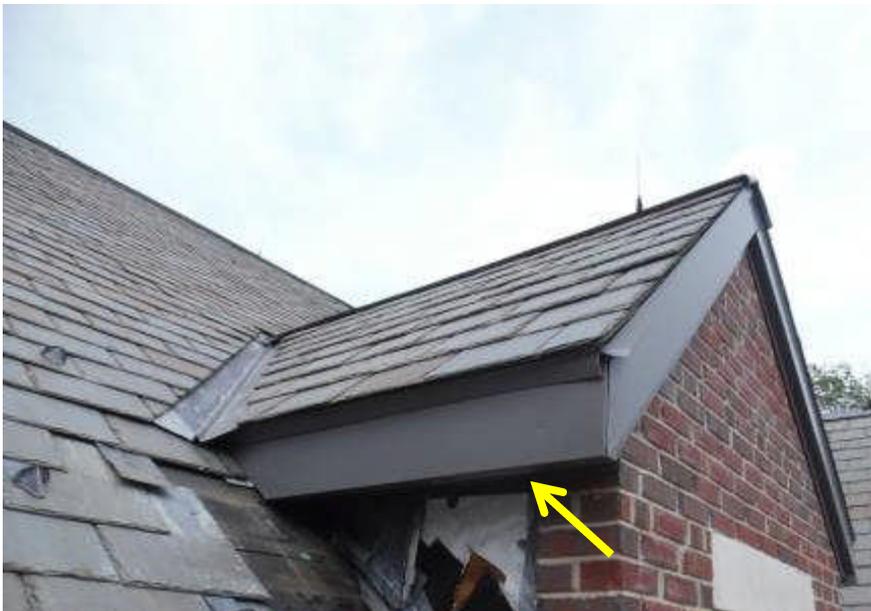
The dormers have perforated soffit vents, but do not have ridge vents.

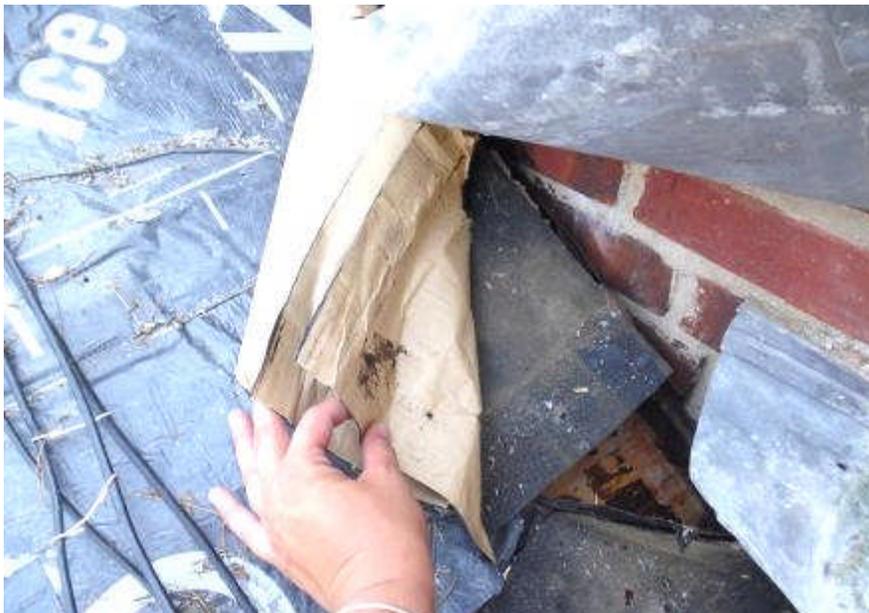
Roof Opening 1

Multiple layers of self-adhering ice barrier membrane (at eaves where we made openings) and asphalt-saturated felt roofing underlayment. W.R. Grace Ice & Water Shield installed at this location (sally port), which we understand was part of repair work to mitigate roof leakage (release paper not removed).

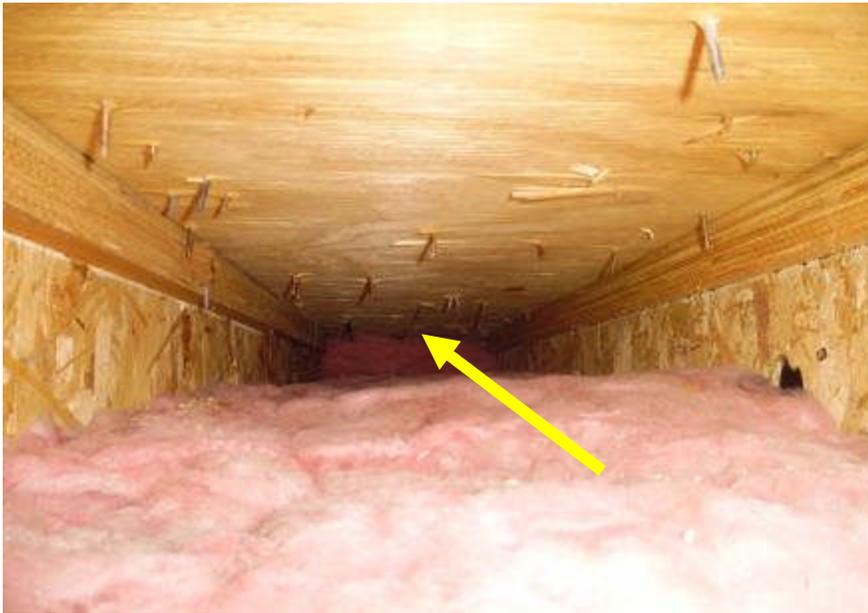
In various locations the batt insulation is in contact with the underside of the plywood sheathing (arrow).

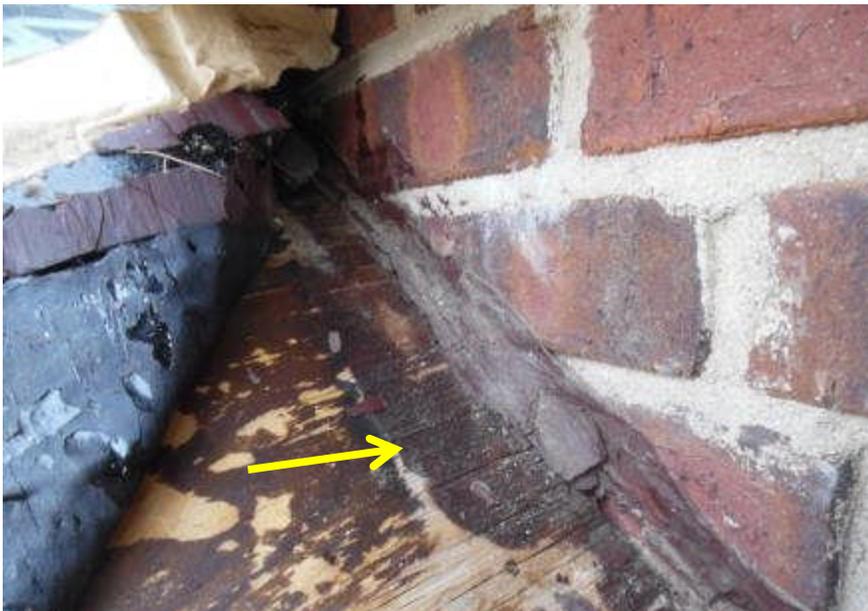
Roof Opening 1

- The self-adhering ice barrier membrane and asphalt-saturated felt underlayment terminate at the edge of the plywood sheathing at the brick masonry. A fluid-applied liquid mastic/sealant covers the gap between the plywood sheathing and brick masonry (Photo 34). The plywood sheathing has apparent water staining.

A fluid-applied liquid mastic/sealant covers the gap between plywood sheathing and brick masonry. We observed an apparent water stain on the sheathing (arrow).

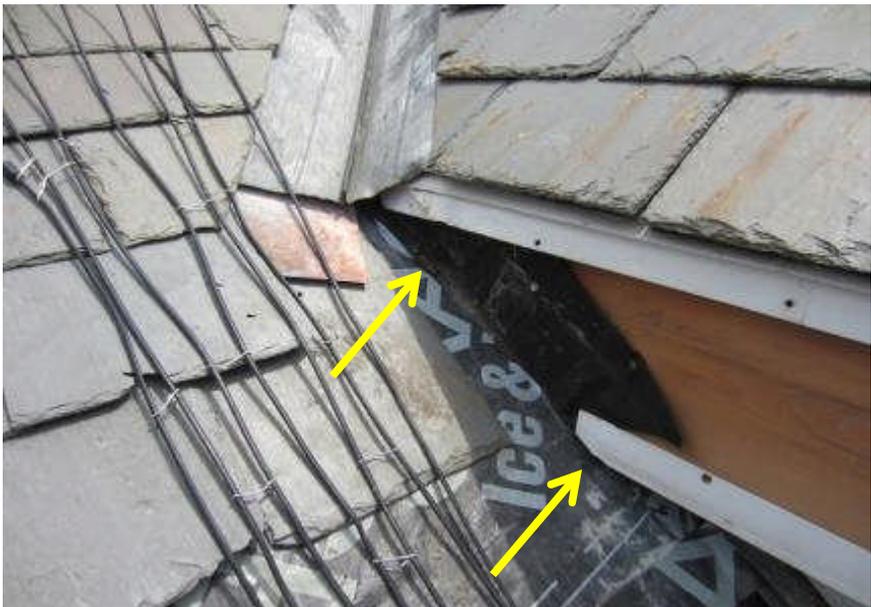
Roof Opening 1

- The roofing underlayments (felt and membrane) terminate at the fascia and under the soffit where the eave is terminated against the roof at the base of the valley (Photos 37 and 38). We observed holes in the underlayment, through which water can leak, at several locations along the base of the sidewall. A large volume of sealant filled the void between the end of the gutter and roofing at this location (Photo 39); we assume this was an attempt to mitigate water leakage.

The roofing underlayment (felt and membrane) terminates at the fascia and under the soffit where the eave terminates against the roof at the base of the valley. The upper arrow identifies the hole shown in Photo 38, and the lower arrow points to the membrane termination.

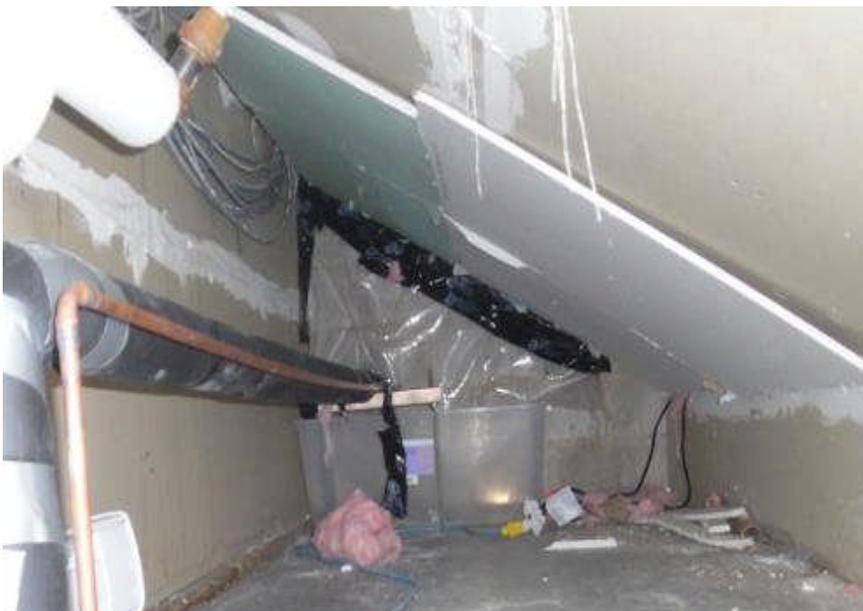
Crawl space along the sally port west eave.

- We observed evidence of water leakage (water stained and damaged plywood sheathing and gypsum wallboard) in the crawl spaces below this opening and the corresponding location on the other side of the sally port (Photos 40 and 41).

Damaged gypsum board in the crawl space below the valley/eave/sidewall intersection at the main building.

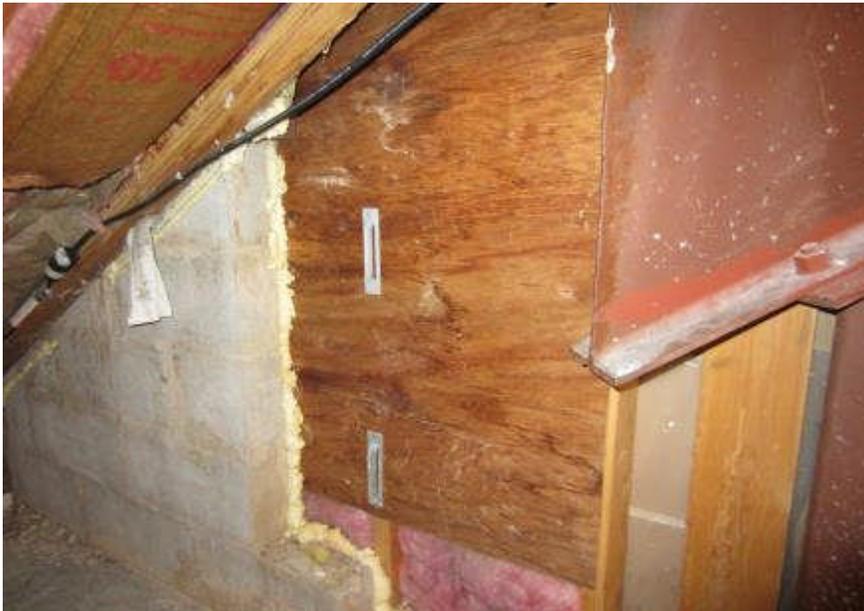
Crawl space along the sally port east eave.

Water stains on plywood sheathing in the crawl space below the valley/eave/sidwall at the main building.

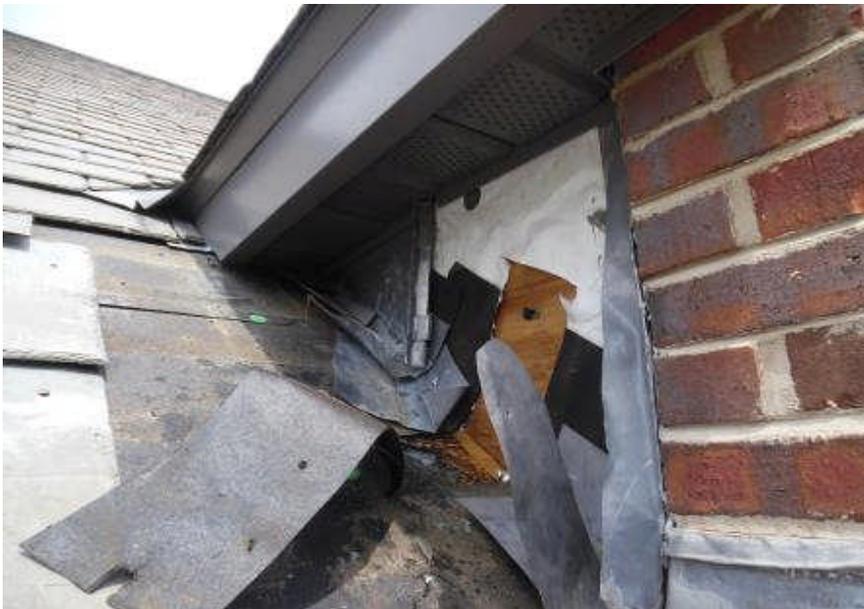
Roof Opening 2

The roofing underlayment turns up the dormer sidewall and is adhered to DuPont Tyvek water-resistant barrier installed on the sidewall, forming a reverse lap.

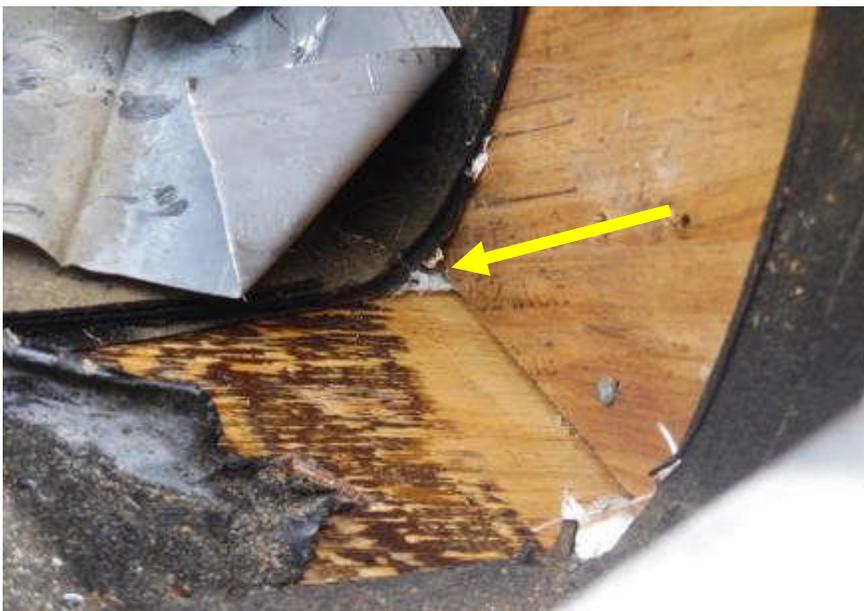
Roof Opening 2

The roofing underlayment turns up the dormer sidewall and is adhered to DuPont Tyvek installed on the sidewall. Note tunnels through laps at base of sidewall (arrow).

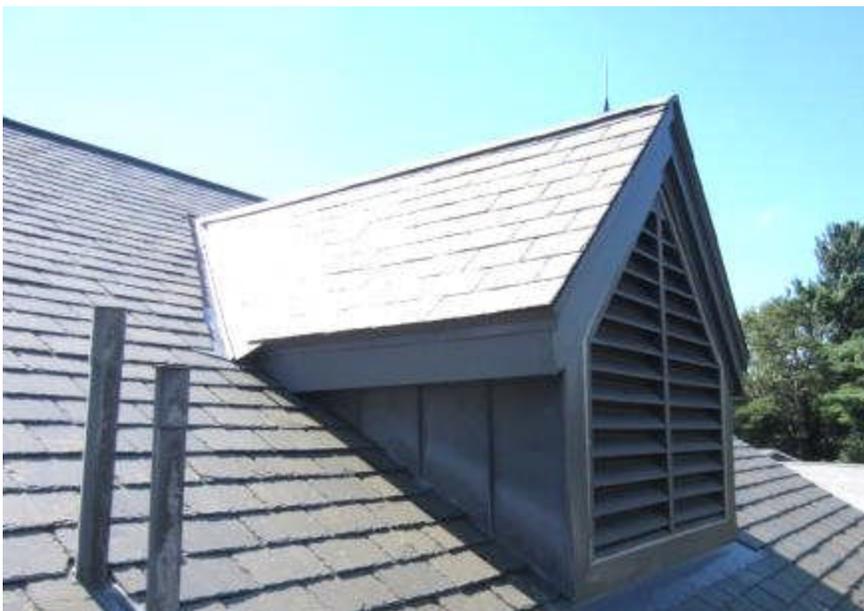
Roof Opening 3

- The louver perimeter joint is filled with sealant. We observed no flashing at the head, jamb or sill of the louver (Photo 46). The sealant is deteriorated and has holes. The wood dormer framing at the louver perimeter is covered with sheet metal cladding that terminates behind the sealant joint. The roof sheet metal base flashing terminates behind the louver sill sealant joint with no end or back dams (Photo 47).

The joint around the louver perimeter is filled with sealant. We observed no flashing at the louver head, jamb, or sill.

- The louver perimeter must be flashed and the plenum must be modified to be watertight and drained to stop water leakage; other modifications may also be appropriate.

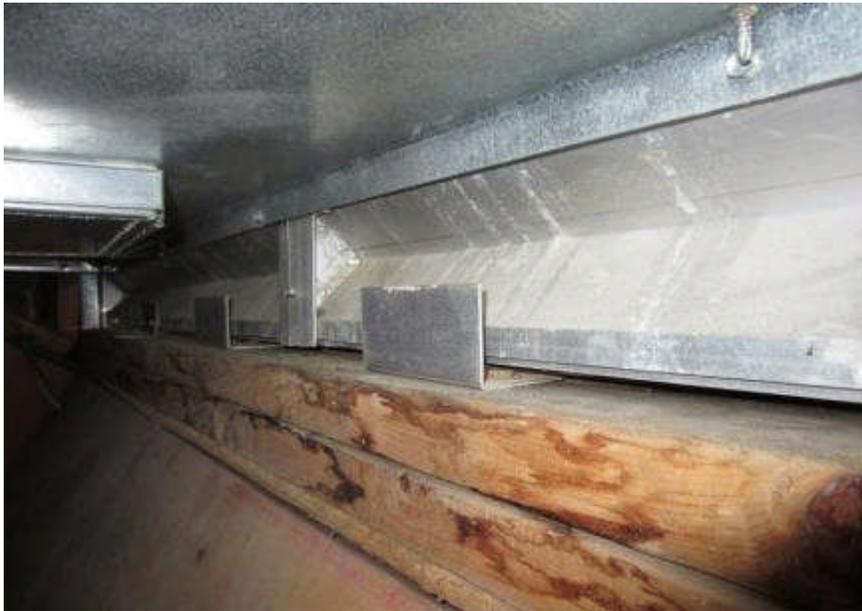
Roof Opening 3

Interior view of the louver sill. The wood framing is stained from apparent water leakage.

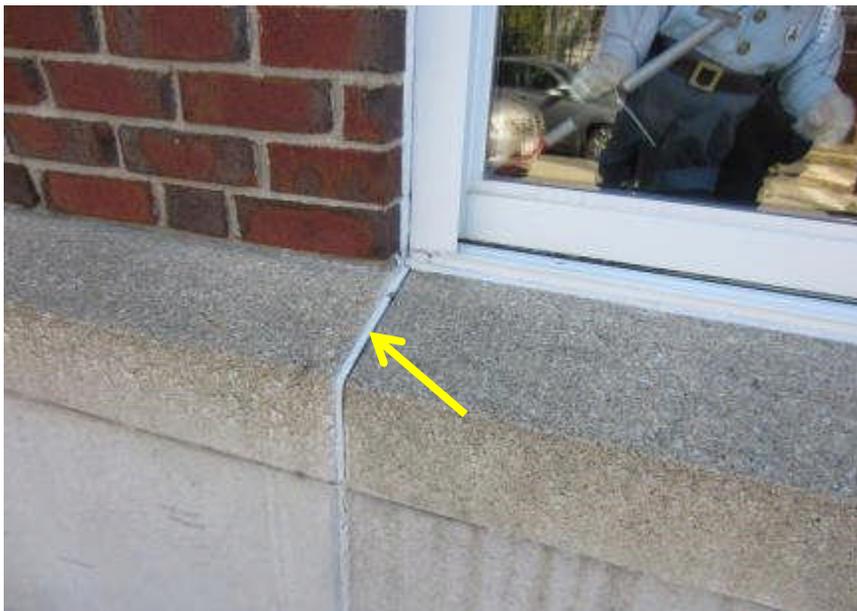
Continuous sealant joint at precast concrete joints. The sealant is failed.

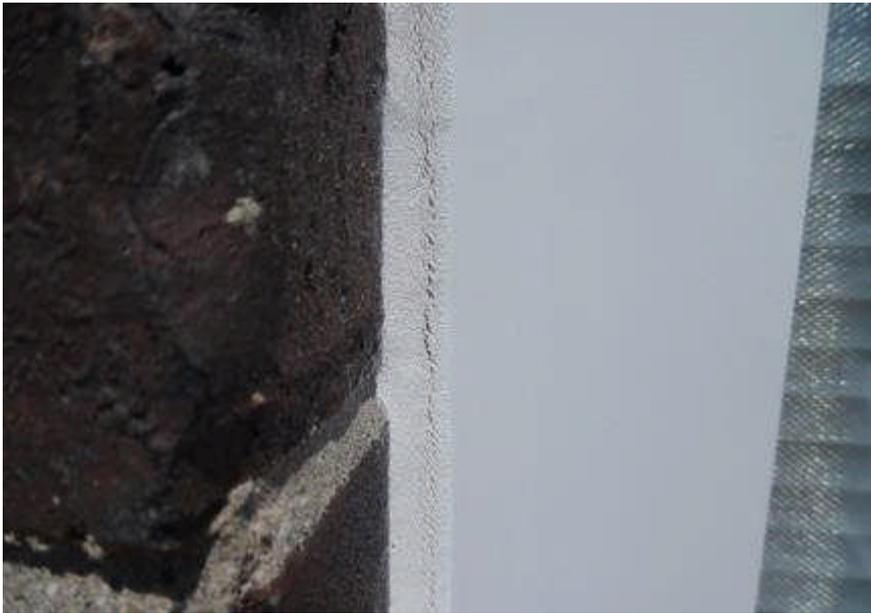
Window perimeter sealant joint. The sealant is generally chalky, cracked, crazed, and debonded.

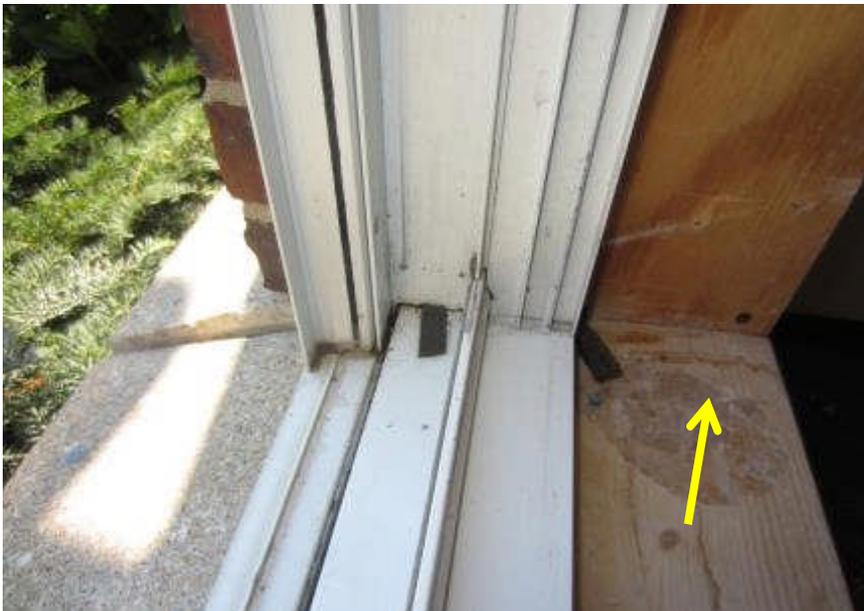
Test Location 1

Apparent water stains on the wood blocking in the window rough opening.
