Tell Me Mortar

"An exploration into latent conditions on an iconic structure"

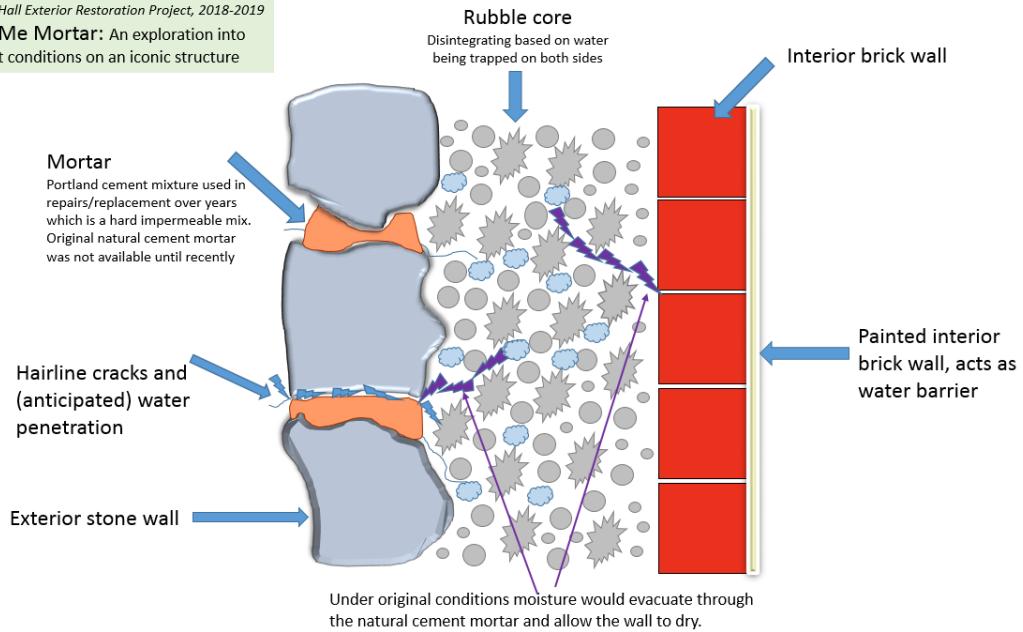
Better understanding the complex latent conditions of the entire exterior requires us to take a deeper dive into specific topics, one being the mortar which binds together the stone walls and keeps water out of the building. Town Hall was originally constructed with natural cement mortar which was discontinued and replaced by Portland cement mortars which were stronger, more workable, readily available, but also less permeable. In the past, the repointing (cleaning out and replacing) campaigns utilizing Portland cement mortar only went 1 ½ inches deep and invariably created a unique condition where water could enter through inevitable hairline cracks but not evacuate due to its less permeable nature. In addition the interior brick wall surface was painted creating an equally impermeable barrier on the inside of the building. The combined conditions of water entering and not evacuating inevitably caused deterioration of the rubble core over time. Why is this a surprise? It is only detectable after removing several inches (upwards of 8 inches) of mortar, which is the approach being taken by today's comprehensive restoration. So while the team had drilled and analyzed the mortar without damaging the building to estimate the repointing costs, there was no way of knowing what was behind until deep mortar was removed during construction. See the visual aid below for more detail:

Once the problem was revealed and assessed, the only logical thing to do was to complete the repointing restoration properly with structural integrity. As part of an overall safety and building longevity strategy, the architect and historical analysts devised a plan to install the right product to repoint the exterior stones. With five different mortar colors on the building, the team also had to determine the appropriate color for the new mortar. Luckily, there was another unexpected item the building would reveal. After climbing up a narrow set of stairs and over a three foot barrier into the Town Hall attic, there is a barely weathered section of the original building façade upon which the natural cement mortar original surface has been preserved in time (see picture.) This small section was enclosed after less than two years of exterior exposure and appears to have a pale tint of pink which likely informed previous restorers to use the widely known pinkish mortar color seen on much of the building. Upon further investigation, the team revealed that the “tint” was actually brick dust which had attached to the surface giving the façade of pink when in fact it was a deeper brown.
