MORSES POND BEACH & BATHHOUSE FEASIBILITY STUDY

May 7, 2024

Weston & SampsonSM
design studio

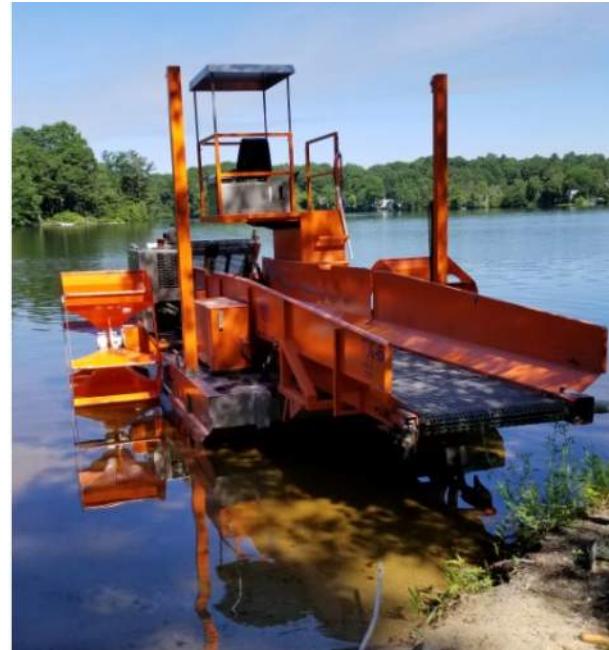
The Town has been managing this issue with the assistance of a weed harvester, which collects the weeds daily during the summer season and hauls the material off site to be composted. The Wellesley Department of Public Works manages and maintains a phosphorus inactivation system to help combat the weed growth in addition to the weed harvesting.

Weed harvester in the pond

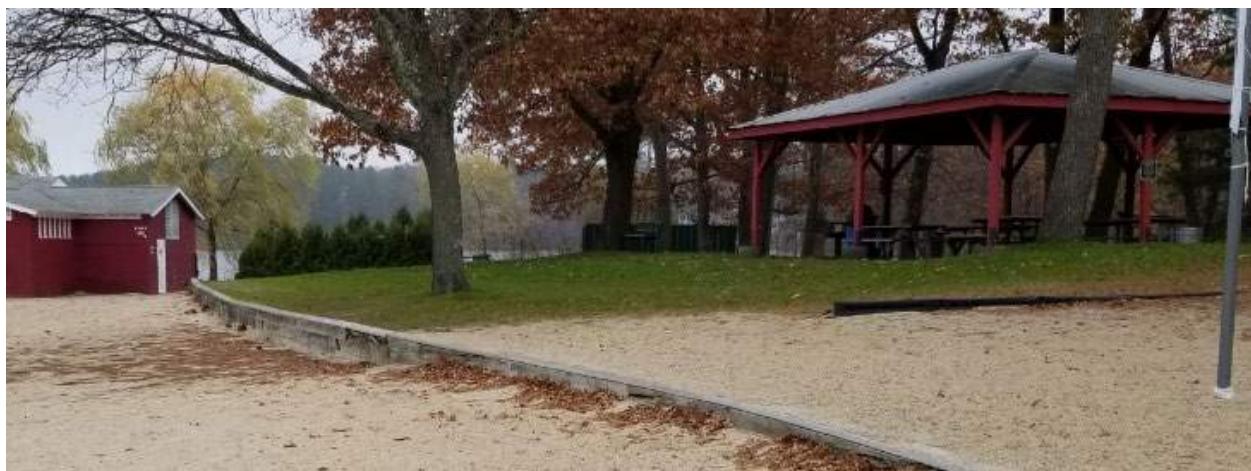
The site is divided between a lawn area and the sandy beach area by a pressure treated timber retaining wall which is starting to fail. Guests enjoy the ability to lay blankets on either the grass or the sand. The height of the wall varies from approximately 18" to 8" in height.

The walls make the transition from the lawn to the beach difficult for some users because of the step down. Small amounts of CCA can also leach into the surrounding areas over time which is not ideal for this natural resource environment utilized by people and wildlife.

Existing retaining wall looking toward the shelter

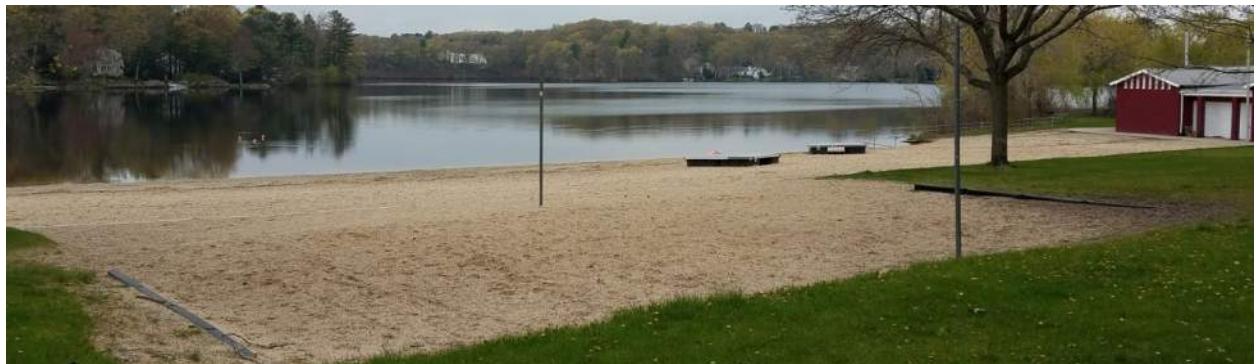
There is also a sand volleyball court located approximately in the middle of the beach front, within the grass area. This is used primarily by day campers, but only periodically.

Volleyball area adjacent to the beach

The sand volleyball court could be relocated to roughly the location of the existing play equipment which is typically a lesser populated portion of the beach.

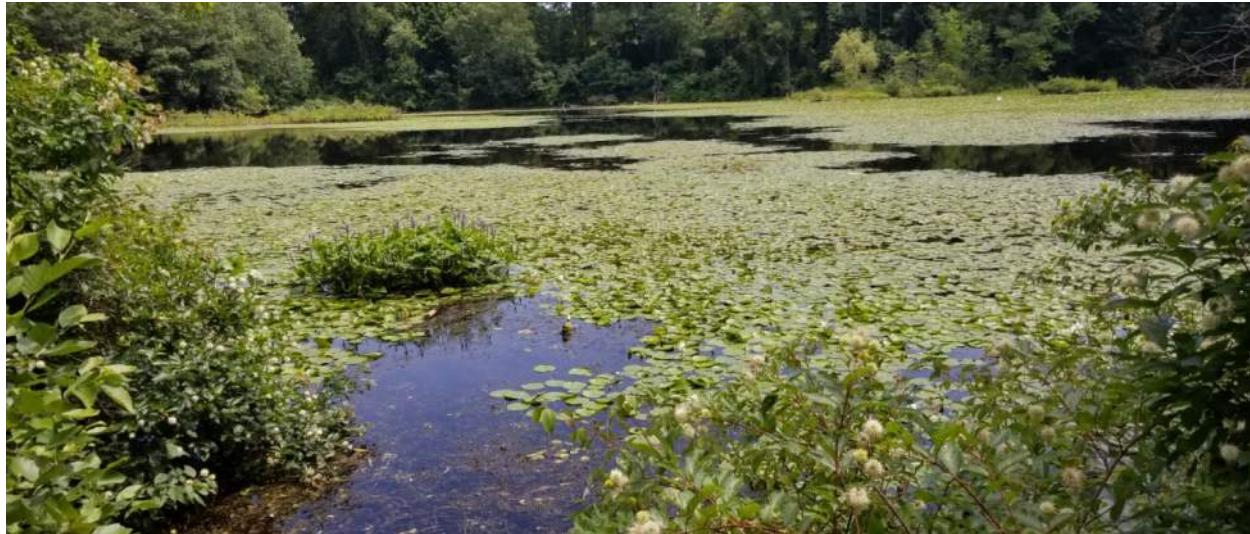
Ice House Pond looking north

In conjunction with dredging, invasive species removal, and other measures this small pond could have improved water clarity, and biodiversity, and create additional opportunities for recreation such as fishing, ice skating, and interacting with the wildlife that is drawn to this area.

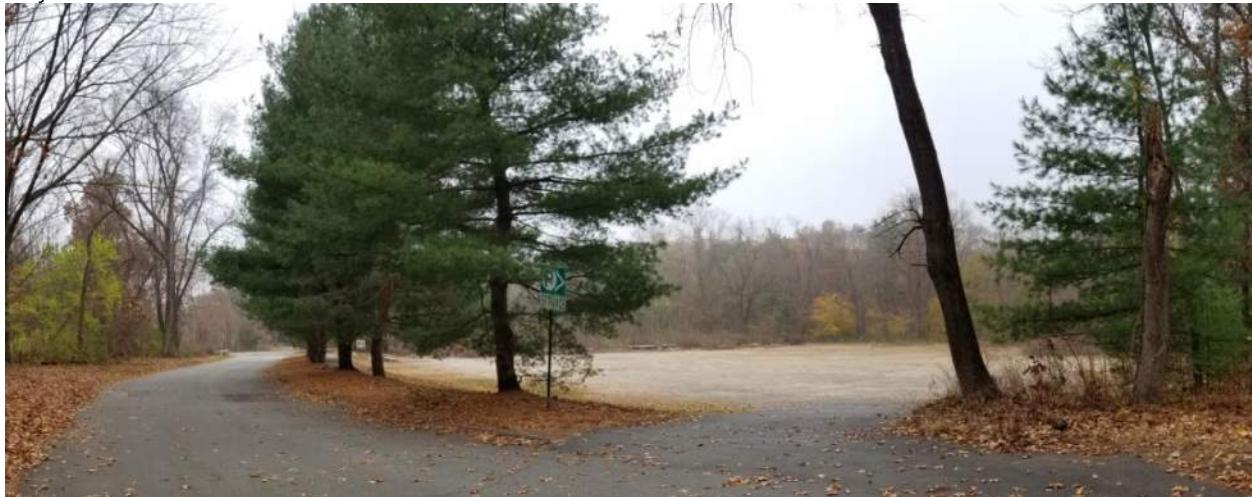
signage to help the organization of the lot, and this leads to inefficient parking congestion on busy days.

The existing entry drive to the main public parking lot

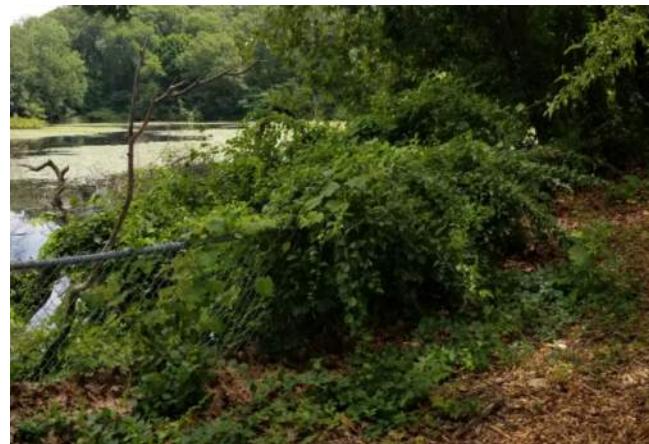
There are several invasive species that affect the property, but oriental bittersweet (*Celastrus orbiculatus*) has had a particular impact on the aesthetics and openness of Ice House Pond. By eliminating this pervasive climbing vine, wide areas of currently inaccessible shoreline would be opened up and would prevent further damage to the surrounding landscape. Other invasive species to be controlled include buckthorn, multiflora rose, poison ivy, bush honeysuckle, autumn olive, and black locust.

Invasive species at Ice House Pond
