July 21, 2025
Updated October 13, 2025

Re: Engineering and Cost Estimating Services
Wights Pond, Hundreds Road, Wellesley, MA

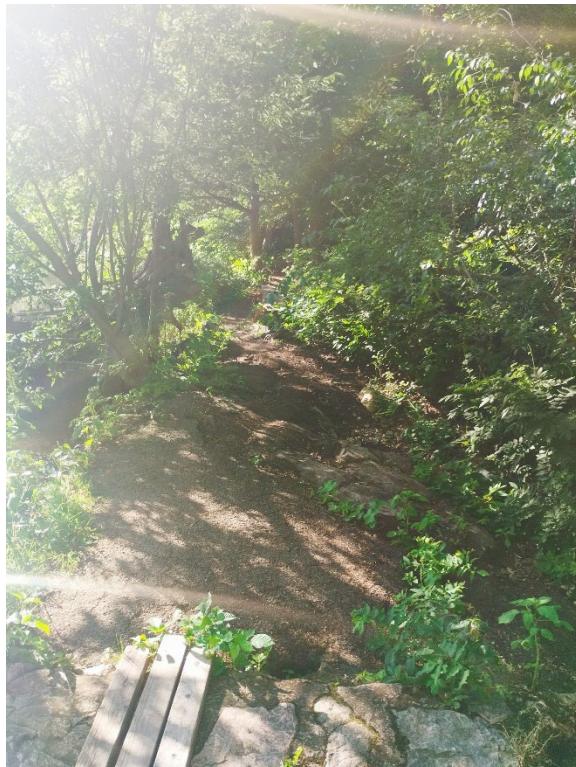
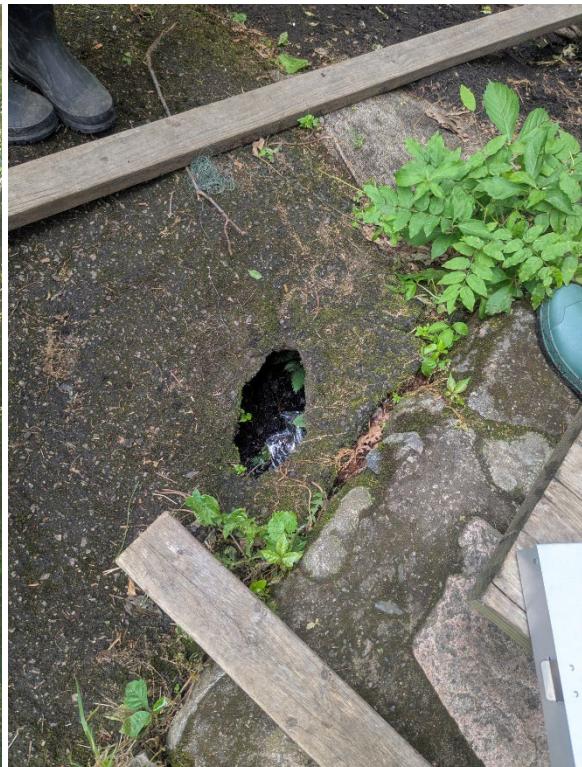
There was some erosion noted along the eastern edge of the property in the area sloping down from Hundreds Road. To the north of the weir, there is an area of denuded vegetation and asphalt paving, where the majority of the erosion was noted. This area was also noted in the April 2025 Jurisdictional Determination by Fuss and O'Neill. The asphalt, as well as the surrounding sandbags, appear to be a temporary repair, and during our site visit we could see water actively flowing through the hole in the asphalt and behind the box culvert walls.

Photos No. 1 and 2 – Area north of the culvert where temporary fix and erosion were observed.

Should the Town decide to take over this property, we would recommend removal of the asphalt and revegetating the slope areas. The embankment area along the edges of the spillway should be reconstructed with a more long-term fix, to keep water from eroding the surface and collecting up against the box culvert. If the area is going to be part of a walking path, a geotextile could be laid to reinforce the ground and prevent against erosion.

- Remove and replace the asphalt surrounding the walls and re-grade the area so runoff doesn't flow towards the box culvert. Water collecting behind the culvert walls could increase pressures on the walls and cause bowing/defamation, thereby compromising the structural integrity of the walls.

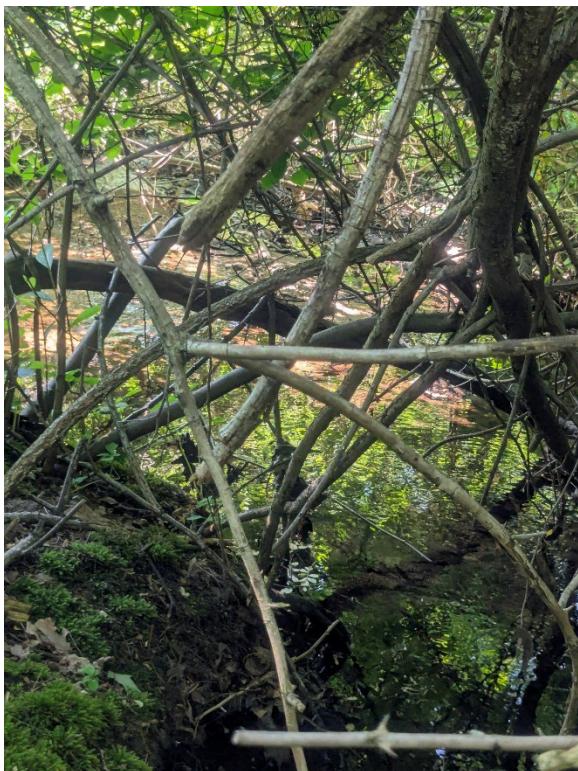
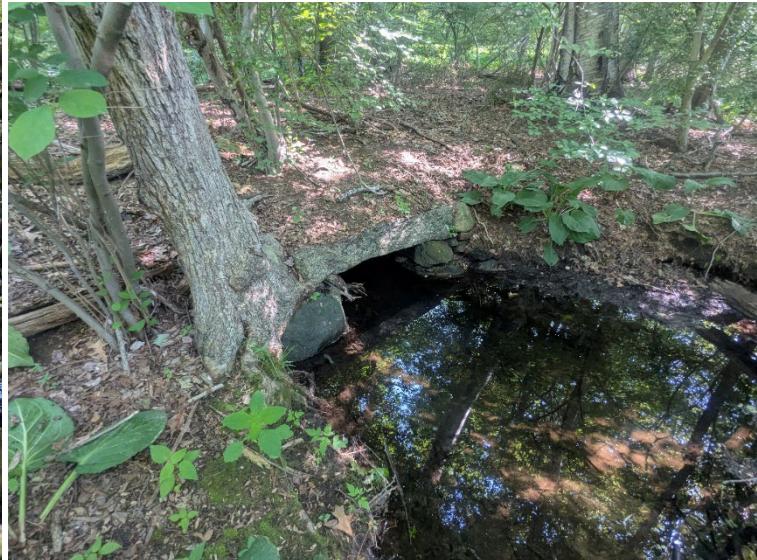
There is dense vegetation that surrounds the property and in order to walk completely around the Pond while remaining on the property, would require cutting the way through, particularly in the south, southeastern portion of the property. Any path surrounding the property would need to be cognizant of that. There are also several downed trees along the property and within the Pond itself.

Photos No. 3 and 4 – Dense growth and inflow channel to the west and southwest of the Pond.

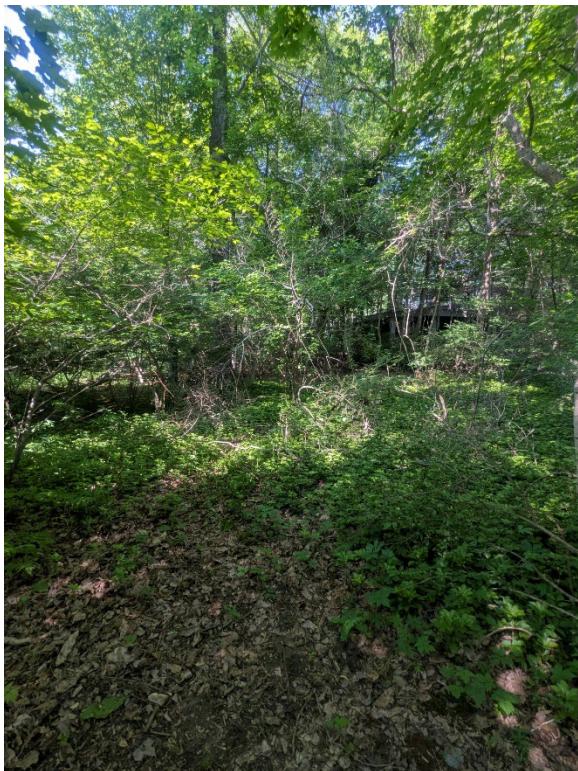
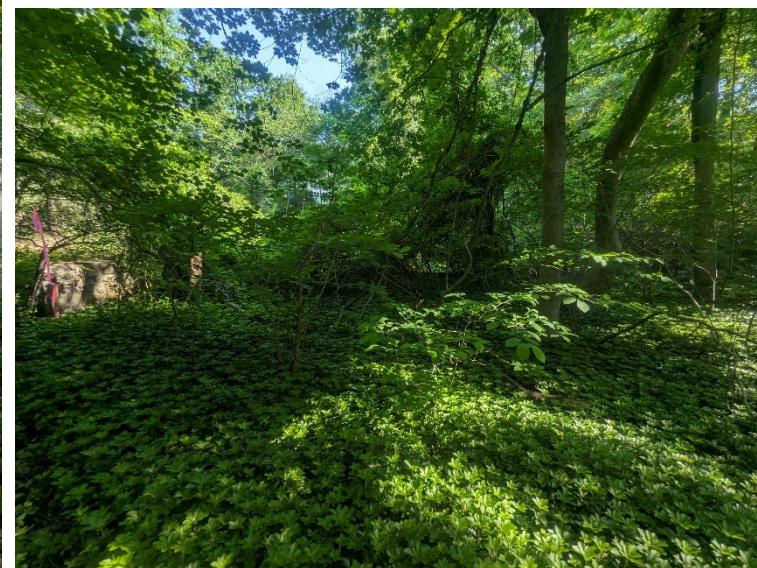
Photos No. 5 and 6 – Typical vegetation communities surrounding the Pond.

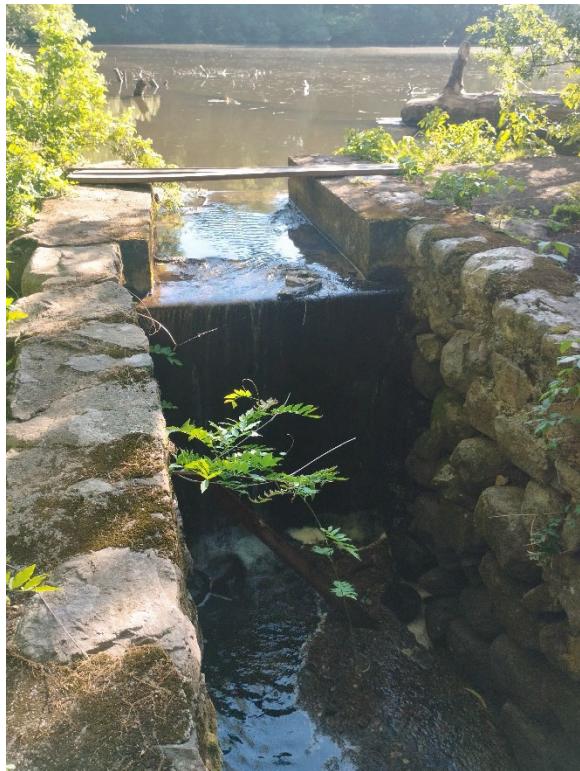
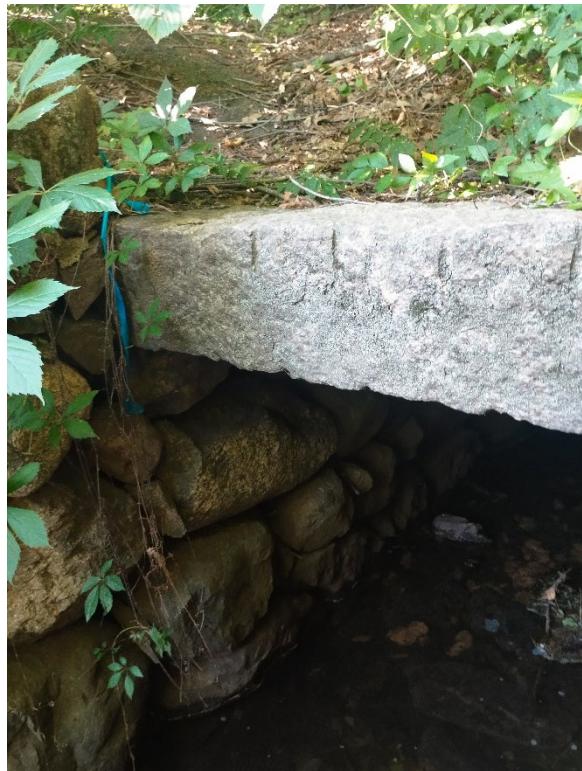
The box culvert is comprised of cobbles and boulders held in place by gravity, without any apparent mortar (with the exception of the surface layers). The boulders appear to be firmly set and while some of the soil infill of the voids has appeared to have washed away along the surface, the stones don't appear to have moved or be displaced from the original installation. The walls did not appear to be bowing or significant deflection of the walls in the area that was visible for inspection. The large boulders placed at the base of the spillway area appear to be performing properly by reducing outflow velocities. Downstream of those boulders, where the flow was turbulent, the flow through the covered culvert turned to smoother, more laminar flow, which will cause less stress and impact on the culvert. Based on the dimensions of culvert and the weir the box culvert has more than sufficient capacity to handle the majority of outflows. The rectangular broad crested weir has a flow capacity of between approximately 3 and 9 cfs based on its dimensions and varying potential flow depths. Conversely, the box culvert, assuming there is a slope of 0.02 ft/ft (2%) through its bottom, has a flow capacity of between approximately 85 cfs and 162 cfs, showing the culvert has more capacity than the weir and thus unless the weir is overwhelmed with flood waters, has capacity to handle the flows it could be produced.

Photos No. 7 and 8 – View of the broad crested weir and spillway, as well as box culvert stone cover.

- The stones at the base of the spillway serve an important function in breaking up the velocity of the outflow. Should flows increase or prove to be more turbulent, the Town could place additional, larger stones at the base of the spillway to further decrease the energy of the outflow.

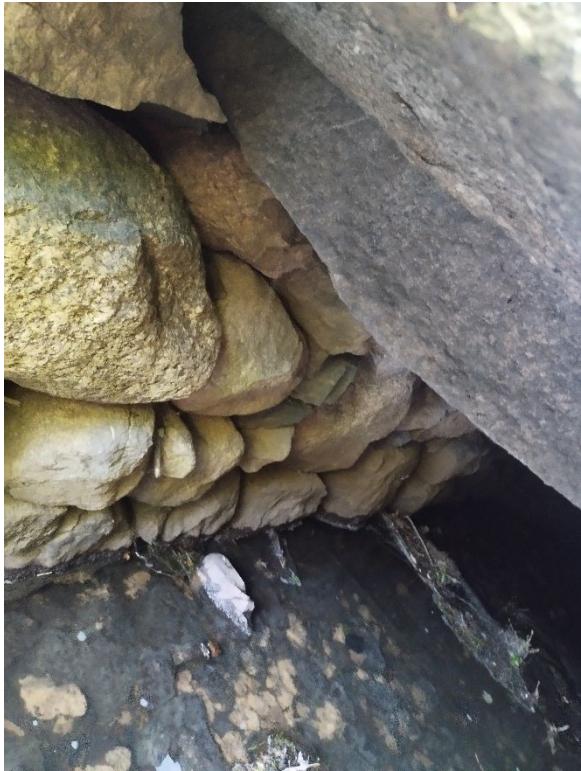
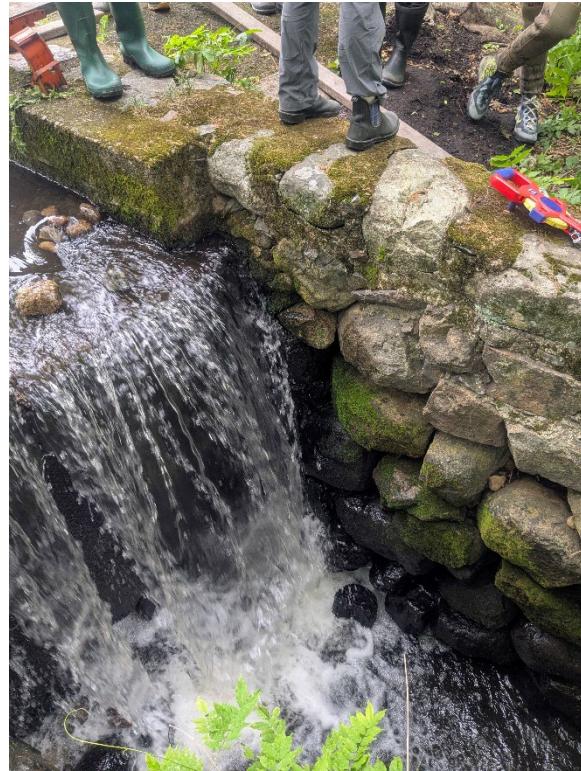
Photos No. 9 and 10 – View of boulders placed along box culvert walls

- The Town should regularly monitor the box culvert stone walls for loss of material and/or heaving or bowing of the walls. If problem areas develop, they could be mortared in patches to reinforce, or in the extreme condition, slip lining the culvert with a slurry concrete, which would reduce some flow capacity, but provide additional structural support. Based on the current conditions, this is not recommended.

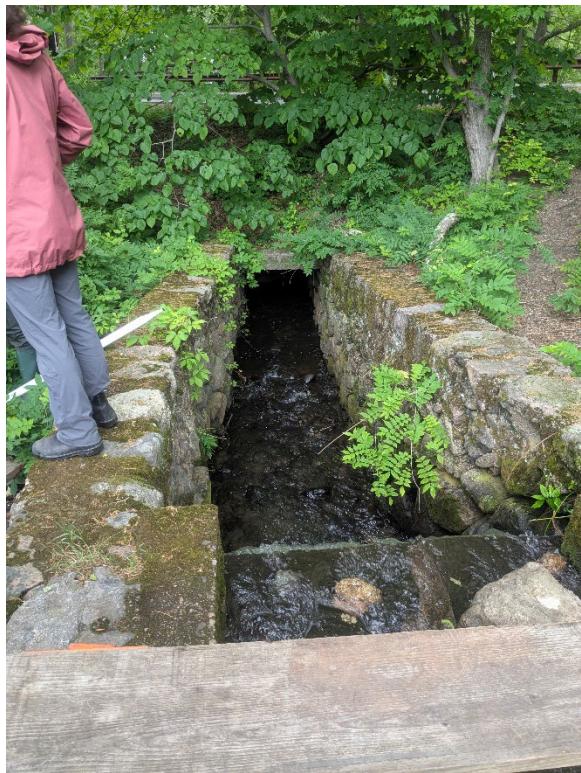
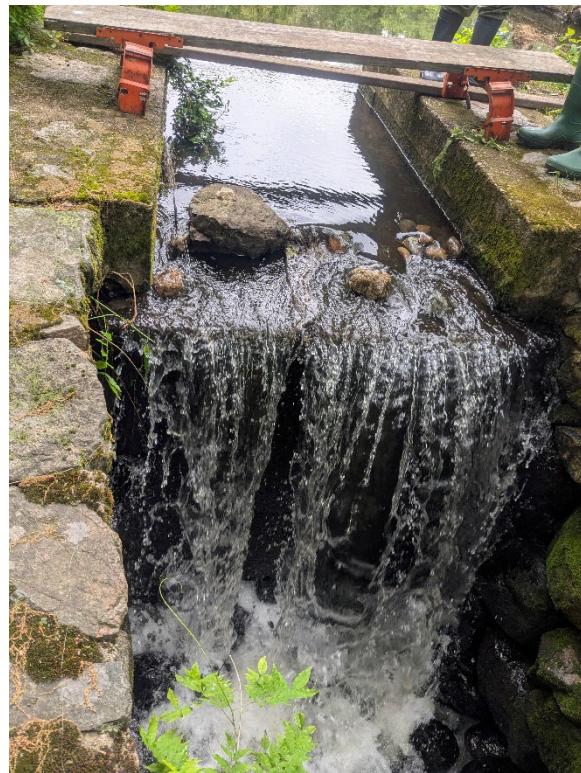
Photos No. 11 and 12 – Additional views of spillway and outlet towards Farm Station Pond.

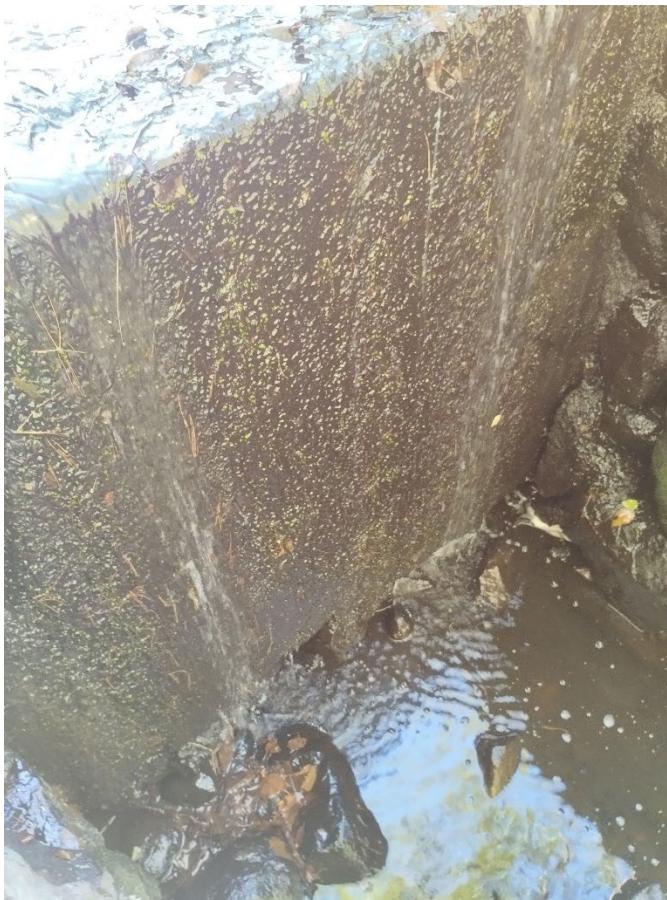
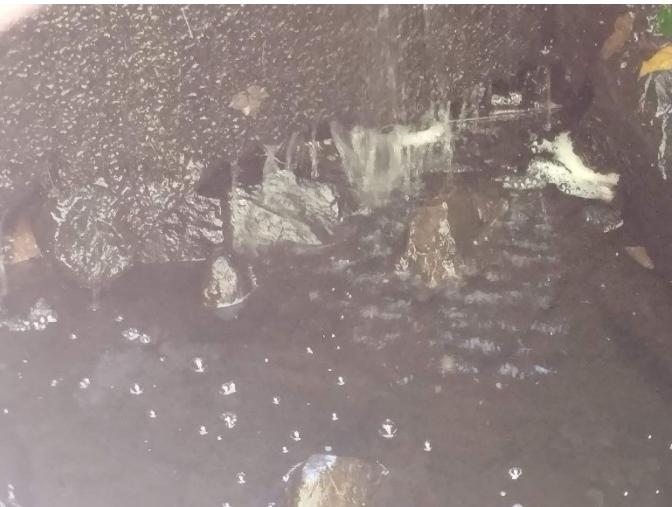
MME observed a much reduced outflow passing over the weir and into the box culvert, and at the base of the spillway structure, we observed that part of the soil and base of the spillway had eroded, likely from backsplash occurring from the flow hitting the boulders at the base of the spillway that is intended to break up the energy velocity of the overflow. The conditions on site at the time of the visit showed about 12" from the bottom of the spillway structure to the base of the stream, and had approximately 6-8" of soil eroded from underneath the spillway structure. (Precise measurements could not be made due to safety considerations for the visit).

The face of the spillway structure did not demonstrate any cracking or spalling or features that would indicate a structural impact. In reviewing the structure itself, no joints were visible, indicating that the spillway could be a monolithic structure. If it is indeed a monolithic structure, that would support the fact why there is no cracking or signs of structural impacts to the spillway.

Photos No. 13 and 14 – Views of the base of the spillway showing erosion of material from the base of the structure.

This does represent an area of concern to monitor. Should the Town take over the property, there are several options. A more thorough geotechnical/structural assessment could be made, but would likely require significant dewatering to allow access to inspect the structure. A short to medium term fix that could be performed by the Town would be to backfill and grout the area at the base of the spillway that has occurred and then supplement the bottom of the spillway with additional larger stones and boulders (as noted above) to break up velocity but also direct the energy away from the base of the spillway structure.
