# Morses Pond Erosion Study Wellesley, MA

FINAL - October 2016

**Prepared by:**  
Horsley Witten Group, Inc.

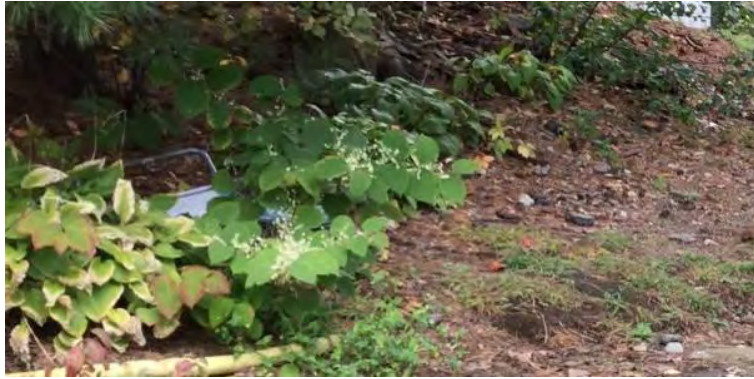
Japanese knotweed at site MP-15

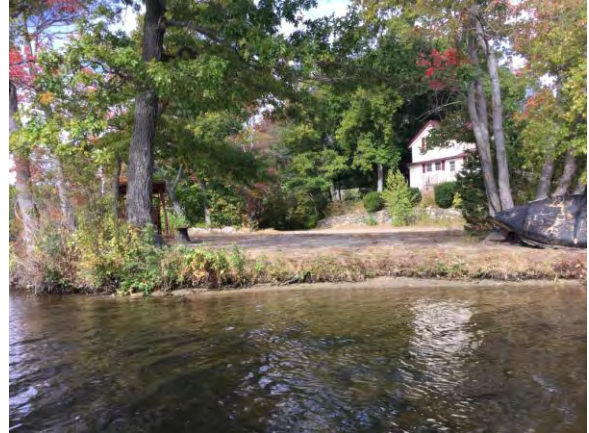
Popular access point to pond at end of Pickerel Point in an aesthetically pleasing location. Evidence of boat launching and fishing. Good parking. Swing and bench adds to use of location. The site would benefit from pathways, steps, etc. to concentrate foot traffic and to reduce erosion. Plant native vegetation buffers along shore outside of water access location(s).

End of Pickerel Point from water.

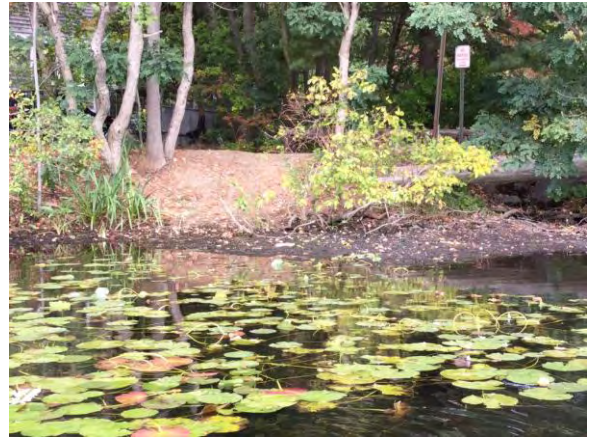
Access point and roadside pulloff on south side of Pickerel Point. Also used for launching boats. Evidence of sediment deposition and road runoff reaching pond from hill. Manage foot access and stormwater flows reaching the pond at this location.

Access point along Pickerel Road.

**Cause of Erosion or Deposition:** Erosion/sediment from road

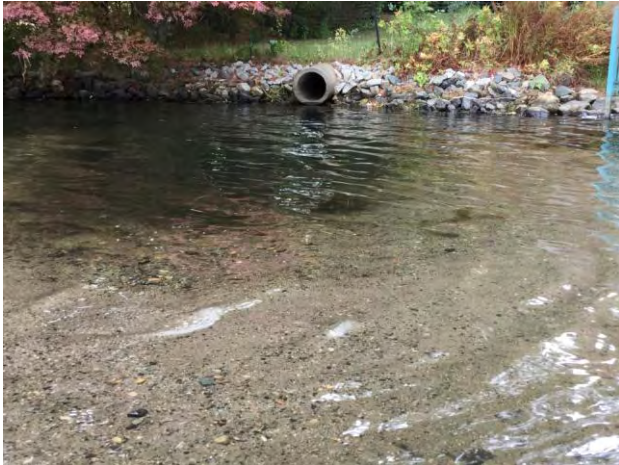
**Cause of Erosion or Deposition:** Large sediment apron at mouth of outfall

Outfall and sediment deposit in pond.

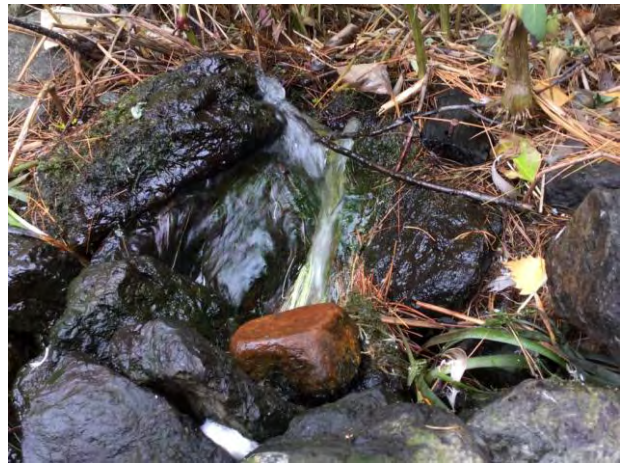
**Other Observed Impacts:** Water source of unknown origin entering pond

Water bubbling from shoreline near outfall, which is dry.

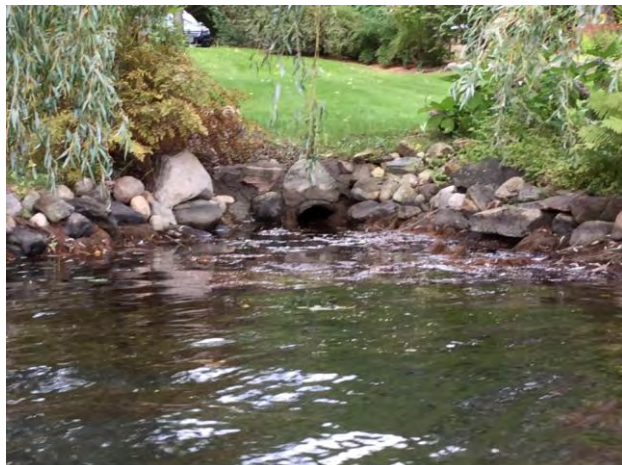
Outfall near residence.

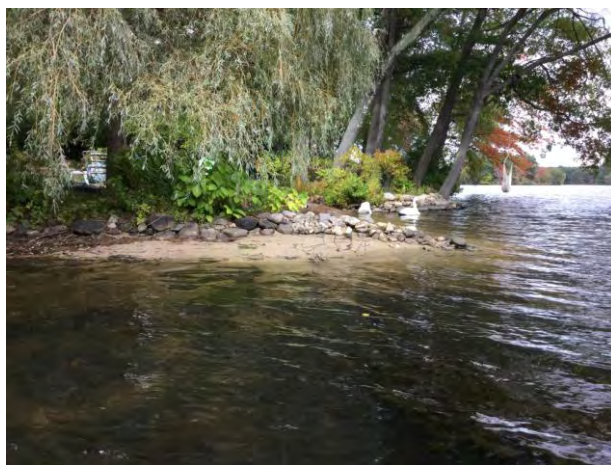
Private beach and shoreline for residence along College Road. Beach sand and rocky point appear vulnerable to erosion from wave action. 8" drain entering pond near this private beach did not appear to be conveying any drainage at the time of observation, nor was a sediment bar noted in the pond at the outfall. Explore replanting native vegetation where possible along the shoreline and reinforce the outfall with riprap. Inquire about lawn treatment due to proximity to pond.

Section of beach and rocky shoreline feature.

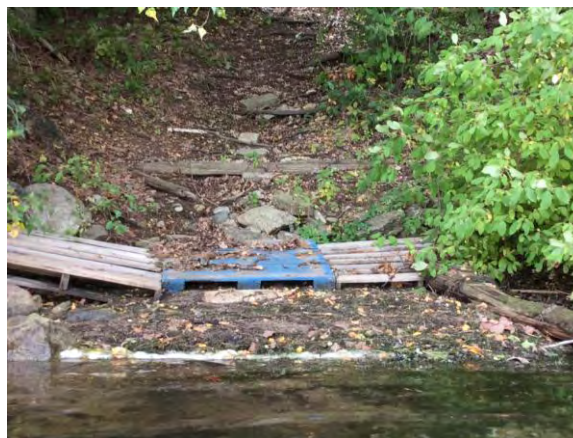
Foot and small boat access in area of steep shoreline off of Bacon Road. Evidence of moderate use, including pallets and large stones to improve footing for users. Due to steep slopes, potential for erosion is high. Signs of erosion and deposition observed.

Boat access point.

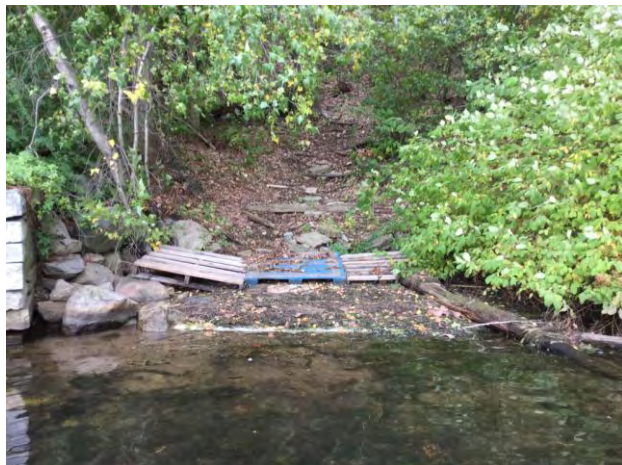
Boat access point.

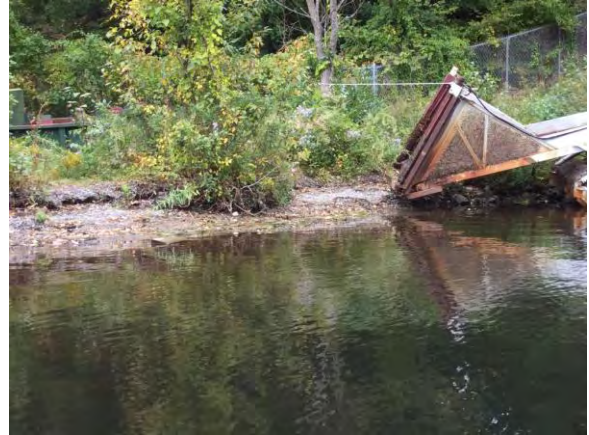
Weed pulling equipment storage area near pond outlet and Route 135. Evidence of frequent use of this location for launching and storage. Impacted shoreline, eroded banks, and vulnerability to stormwater flows into pond observed. Shoreline stabilization measures, such as coir log installation and/or buffer planting, would be potentially helpful. If possible, minimize equipment launching and storage. Manage stormwater flows from road.

Weed removal equipment storage area.

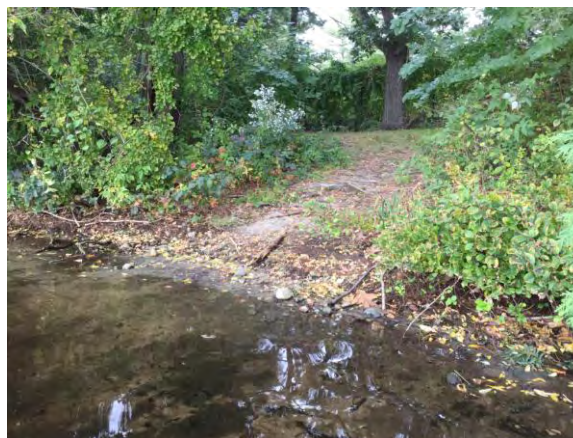
Foot access point to pond from walking path on Morses Pond Land. Heavily used, with compacted soils and trampled vegetation observed. Good location to either formalize as an established pond access point or to close off and replant for buffer continuity.

Foot access location.

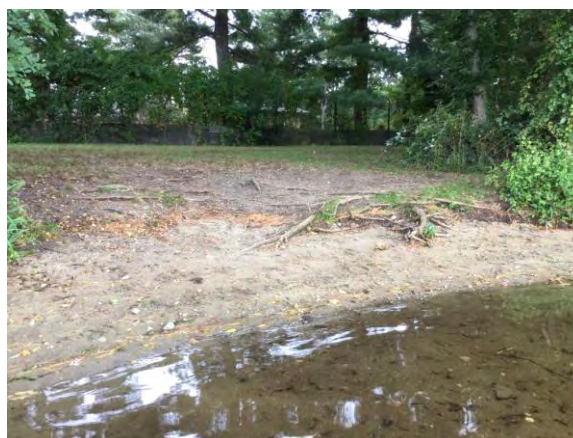
Foot access point to pond from walking path on Morses Pond Land. Heavily used, with compacted soils and trampled vegetation observed. Good location to either formalize as an established pond access point or to close off and replant for buffer continuity. Due to good access, potentially beneficial for educational purposes about pond/lake shoreline management.

Foot access location.

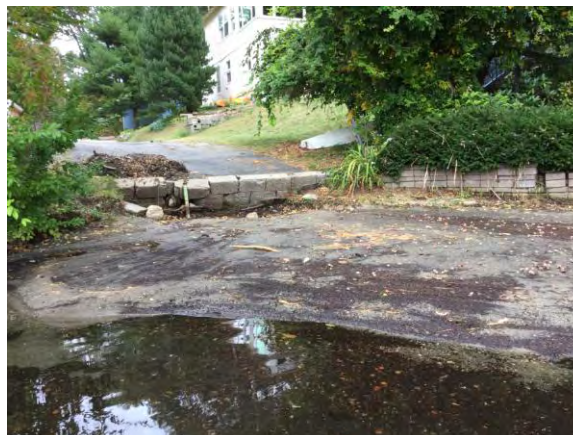
This location, where Beach Road ends steeply at the pond's edge, is vulnerable to impacts from both erosion and sedimentation. No stormwater management system was observed, and evidence of recent stormwater flows directly reaching the pond were noted. Runoff from upgradient path also contributes sediment. Potential restoration opportunities exist for stormwater management. According to a neighboring landowner, access to the pond and nearby beach is popular from Beach Road, so restoration strategies will need to be considerate of the access and use of the area.

End of Beach Road.

**SHORELINE EROSION ASSESSMENT****Exposed Soil (%):** 100**Evidence of Active Erosion?** YES**Evidence of Past Erosion?** YES**Sediment Deposition?** YES**Cause of Erosion or Deposition:** Runoff from Beach Street**Shoreline Type/Materials:** Cove**Geometry:** Cove**Eroded Shoreline Length Estimate (ft):** 30**Eroded/Deposition Area Estimate (sf):** 400**Slope Estimate:** 8%**Other Observed Impacts:** Unmanaged stormwater flows, unmanaged access**SHORELINE VEGETATION****Plant Community:** Landscaped Lawn**Dominant Species:** N/A**Vegetation Cover (%):** 0**Dominant Invasive Species:** Other**Secondary Invasive Species:** None**Invasives Coverage (sf):** 0**Estimated Thickness of Buffer Veg (ft):** 0-15**RESTORATION DESCRIPTION AND FEASIBILITY FACTORS****Restoration Type:** Erosion and sediment control, stormwater management**Description:** Redesign end of Beach Road (and evaluate Russel, Bay, and McLaren Rds) to minimize stormwater runoff from reaching the pond. Work with homeowners to implement rain gardens, rain barrels and other low impact designs for small sites). Plant shoreline buffer and stabilize upgradient path(s) to reduce sediment source.**Erosion/Deposition Severity:** High**Threat to Property/Infrastructure?** High**Ownership:** Unknown**Land Use:** Residential**Construction Access:** Easy**Public Education Opportunity?** Good**PRIORITY:** High

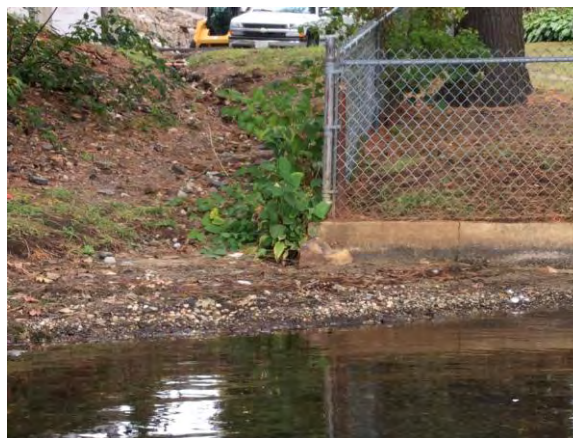
This location, where Lake Road ends steeply at the pond's edge, is vulnerable to impacts from both erosion and sedimentation. It is a popular access location for swimming; however, no stormwater management system was observed for road runoff, and evidence of recent stormwater flows directly reaching the pond were noted. Potential restoration opportunities exist for stormwater management and erosion/sediment control.

Drainage swale at end of Lake Road.

Cause of Erosion or Deposition: Stormwater runoff

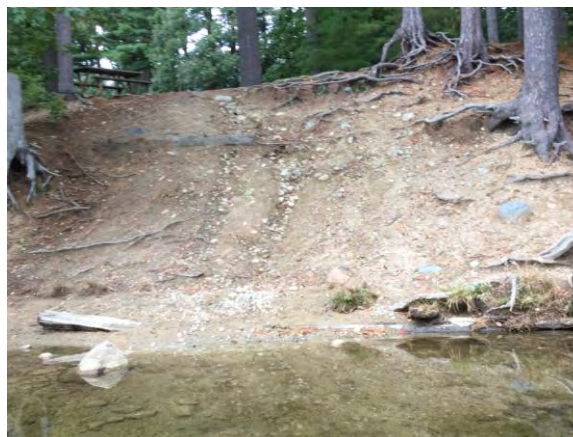
Pond access from Crosstown Trail at Pine Point. Due to scenic nature of the location at the end of a peninsula and access via public land, this area appears heavily used through foot traffic. Active erosion gullies, exposed roots, and deposited sediment in pond observed. Similar to locations along the Morses Land walking trail, this location offers the potential for erosion/sedimentation issues to be addressed and for public education to be included.

Pond access point at peninsula (Pine Point) off Crosstown Trail.

**Cause of Erosion or Deposition:** Unmanaged access; steep slopes

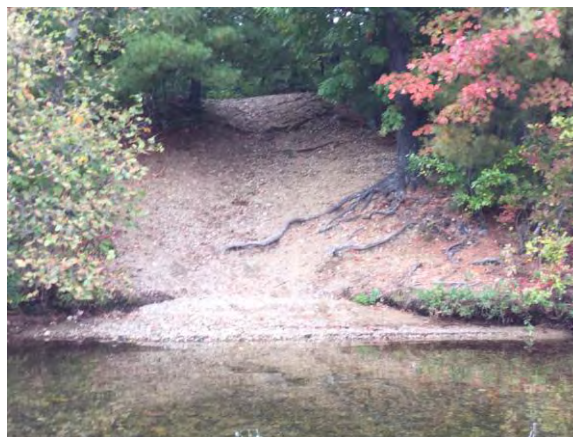
Pond access from Crosstown Trail at Pickle Point Sanctuary (Wellesley Conservation Council Land). Location at end of a peninsula, similar to Foot Access Point #1 from the Crosstown Trail at Pine Point. Due to the scenic nature of the location and the fact that it is accessible to the public, this area appears heavily used through foot traffic. Active erosion gullies, exposed roots, and deposited sediment in pond observed; however, not with the same severity as Foot Access Point #1.

Pond access point at peninsula (Pickle Point) off of Crosstown Trail.

**Cause of Erosion or Deposition:** Unmanaged access; steep slopes

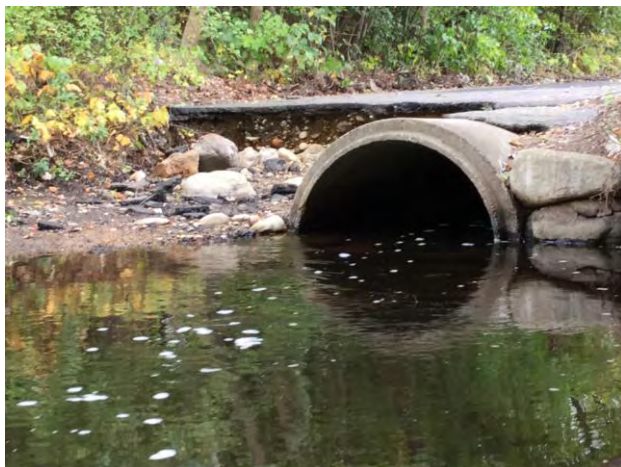
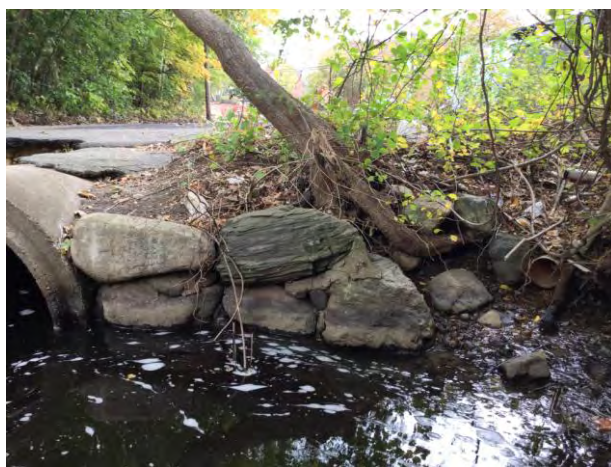
**Cause of Erosion or Deposition:** Gully next to 48" ID culvert

**Description:** Repair pavement, backfill with approved materials, install riprap around culvert, manage stormwater runoff from adjacent parking lot/commercial building/and slope to prevent overland erosion at edge of outfall. If possible, pull the parking lot away from the water's edge and plant a vegetated buffer.

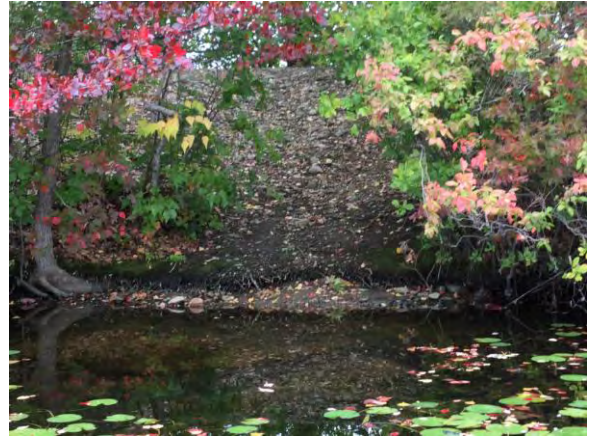
A narrow, steep path for foot traffic and boat access to easternmost of two islands (Bird Island) due north of Pickerel Point. Slope and bank stabilization methods are appropriate restoration strategies, however due to access issues the impacts via foot traffic are less than areas around pond shoreline.

Narrow, steep path for foot traffic and boat access to Bird Island.

**Cause of Erosion or Deposition:** Unmanaged access

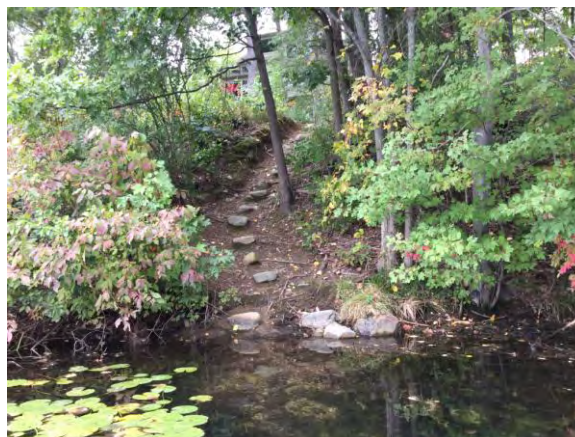
A narrow, steep path for foot traffic to pond shoreline along Crosstown Trail. Slope and bank stabilization methods are appropriate restoration strategies, especially due to the steep slopes in this area. Heavily used, with compacted soils and trampled vegetation observed.

Narrow, steep path for foot access to pond from Crosstown Trail.

**Cause of Erosion or Deposition:** Unmanaged access; steep footpath

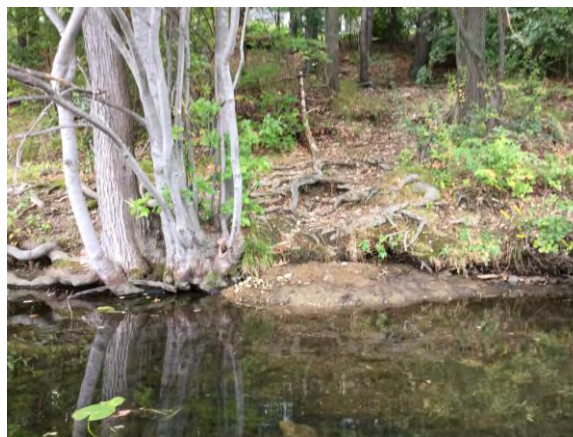
A narrow, steep path for foot traffic to pond shoreline along Crosstown Trail. Limited boat launching available also. Slope and bank stabilization methods are appropriate restoration strategies, especially due to the steep slopes in this area. Heavily used, with compacted soils and trampled vegetation observed. A short walk to Russell Road parking area.

Narrow, steep path for foot traffic and boat access to pond from Crosstown Trail near Russell Road.

**Cause of Erosion or Deposition:** Foot traffic
