48 Livermore Road Large House Review (LHR)

Town Of Wellesley

Hawkey Residence
 48 Livermore Road
 Wellesley, MA

ARCHITECTURAL SITE PLAN
TREE SURVEY

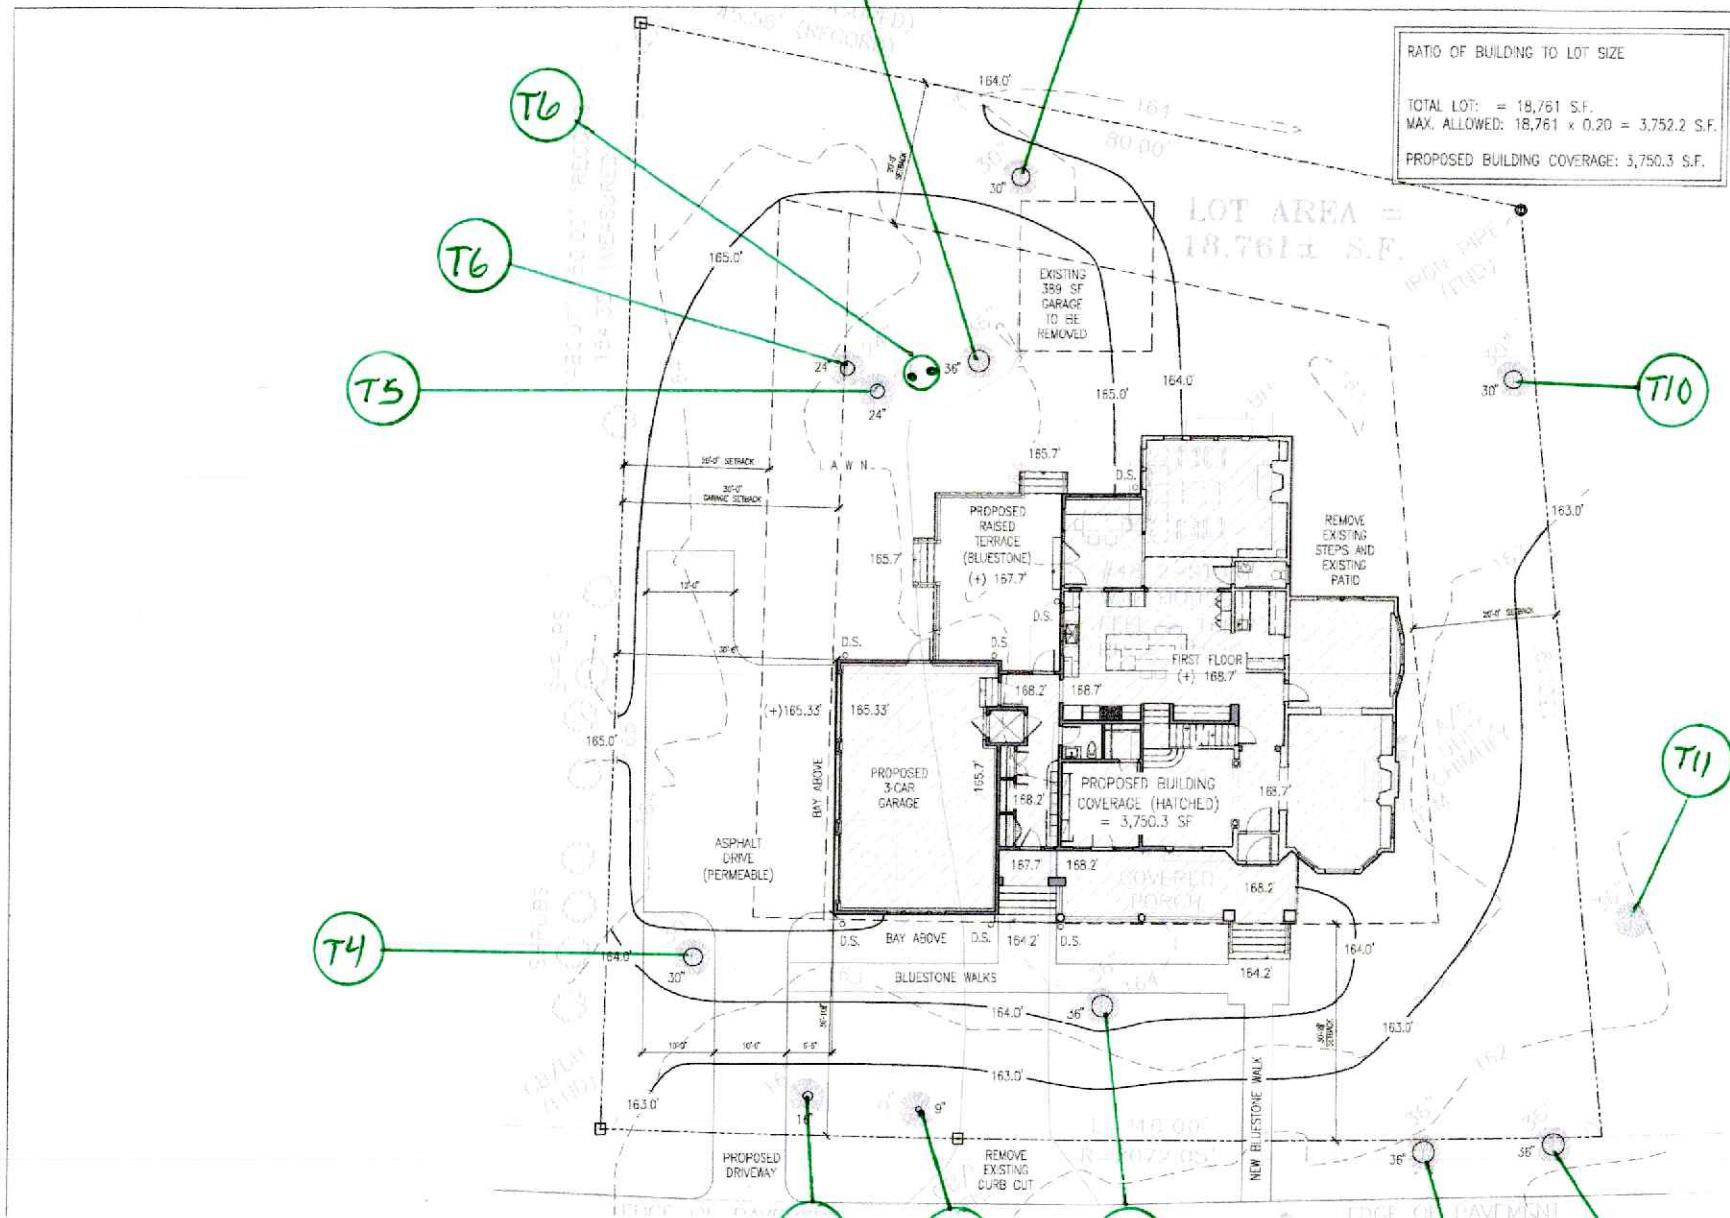
All trees 6 inches and larger have located and numbered on engineers print **Job #3176**; provided by Jillson Company Inc., P.O. Box 2135, Framingham, MA, 01703.

48 Livermore Road has 12 trees 6 inches and greater and are discussed as follows:

Mitigation Plan of protected trees within the tree yard:

Planned Removals of protected trees:
