# MORSES POND ANNUAL REPORT: 2018

**PREPARED FOR THE TOWN OF WELLESLEY**

**BY WATER RESOURCE SERVICES, INC.**

**DECEMBER 2018**

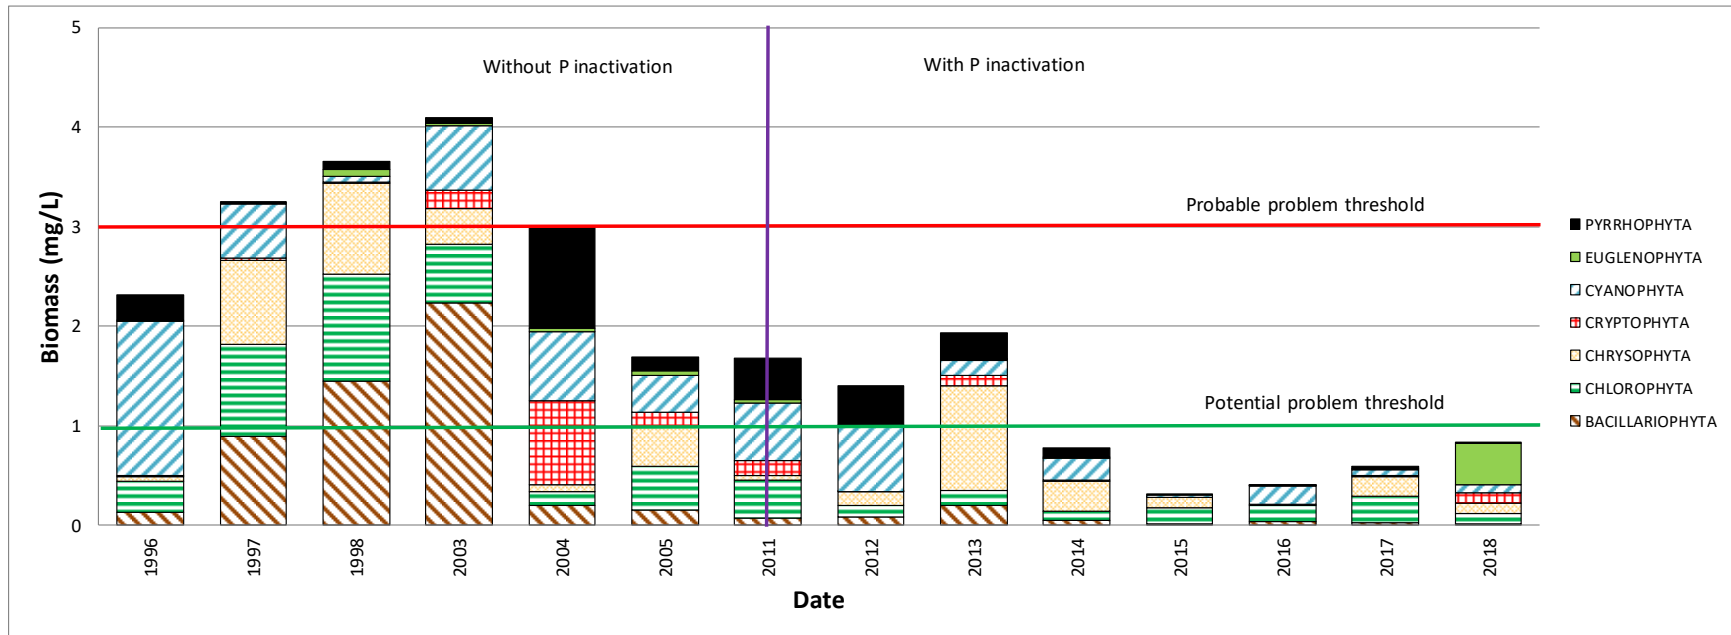
Figure 4. Summer average algae biomass divided into major algae groups for 1996-2018

Algal data for 1996-2017 illustrate processes in Morses Pond over the summer (Figure 4). Algae biomass and composition can be very variable, depending on combinations of nutrient levels, light, temperature and flushing. Morses Pond phytoplankton was frequently elevated prior to spring phosphorus inactivation, but since then biomass values have not exceeded the general threshold of 3 mg/L that signals low clarity (note that there is no official threshold for algae, but the red line in Figure 4 is a useful limit). Phytoplankton biomass as an annual spring/summer average has been below the 1 mg/L threshold indicative of low biomass since the system adjustments of 2014 and cyanobacteria have represented only a small amount of biomass each year. There have been small peaks in biomass at times. In June of 2018 there were some cyanobacteria particles in the southern portion of the pond, but they did not remain long. In early September the deepest part of the pond exhibited greenish water and had both cyanobacteria and euglenoids, yet the surface water was quite clear and had minimal algae.

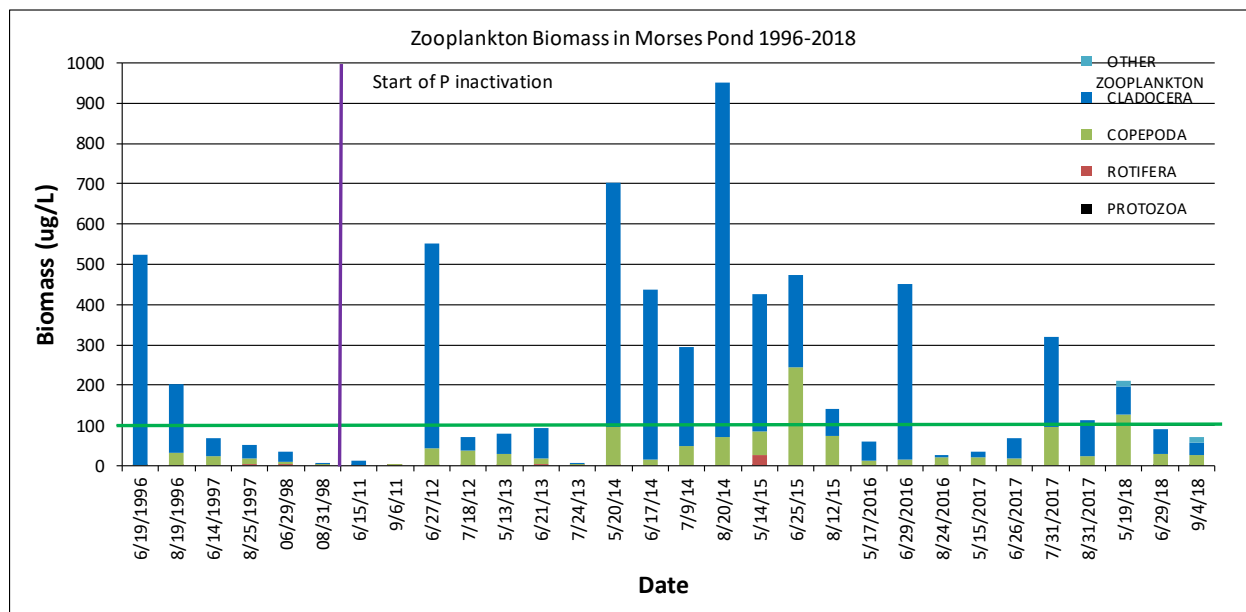
**Figure 5. Zooplankton abundance for 1996-2018.**

Zooplankton have also been sampled, and while not as tightly linked to nutrients, provide important information on the link between algae and fish (Figures 5 and 6). Zooplankton biomass varies strongly between and within years. Values <25 ug/L are low and values higher than 100 ug/L are high as rough thresholds; Morses Pond values span that range and more. Values in later summer are expected to be lower than in late spring or early summer, as fish predation by young-of-the-year fish (those hatching that year) reduces populations of zooplankters. Spring levels will depend on water quality, predation by adult fish, and available algae, which are food for zooplankton. The dominant zooplankton tends to be cladocerans and copepods, both groups of micro-crustaceans. *Daphnia*, among the larger cladocerans, filters the water to accumulate algae as food, and can increase water clarity markedly.

*Daphnia* were present in Morses Pond in all monitored years, a good sign, and abundance was elevated many samples. The late summer zooplankton population was sometimes low but overall the zooplankton community has adequate biomass to support the food web and provide substantial grazing capacity for algae consumption, which helps maintain water clarity. There is no indication of any aluminum toxicity to zooplankton; the treatment protocols minimize this probability.

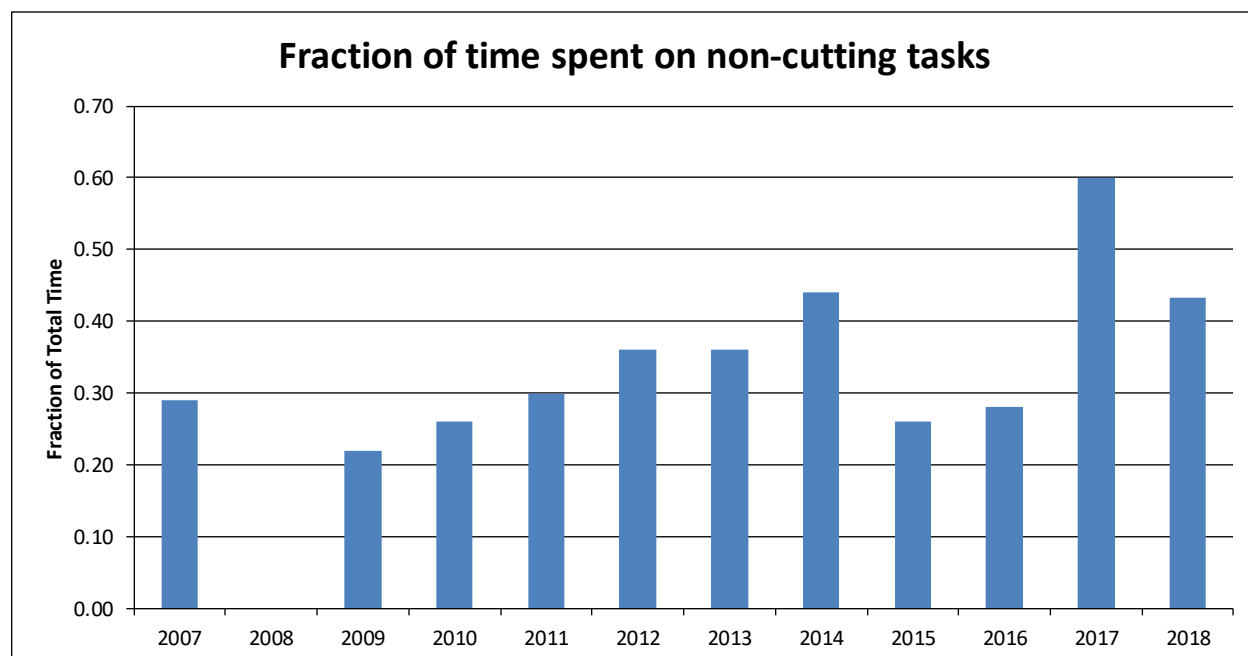
**Figure 8. Non-cutting hours associated with the harvesting program.**

An increasing number of non-cutting hours was observed from 2009 until 2015 (Figure 8) and appeared related to increases in time for maintenance and travel. From 2014 through 2017, records were kept for non-cutting hours in categories including transport time on the water, transport time on land, and maintenance. With a renewed emphasis on efficiency, the 2015 record indicates that non-cutting time was roughly cut in half. Non-cutting time increased very slightly in 2016 but was still far less than in 2014. Non-cutting time increased markedly in 2017, as the large harvester was not working properly, resulting in low efficiency and an eventual breakdown. Non-cutting time was not tracked by task in 2018, but was reduced from 2017; however, it was still higher than most other years.

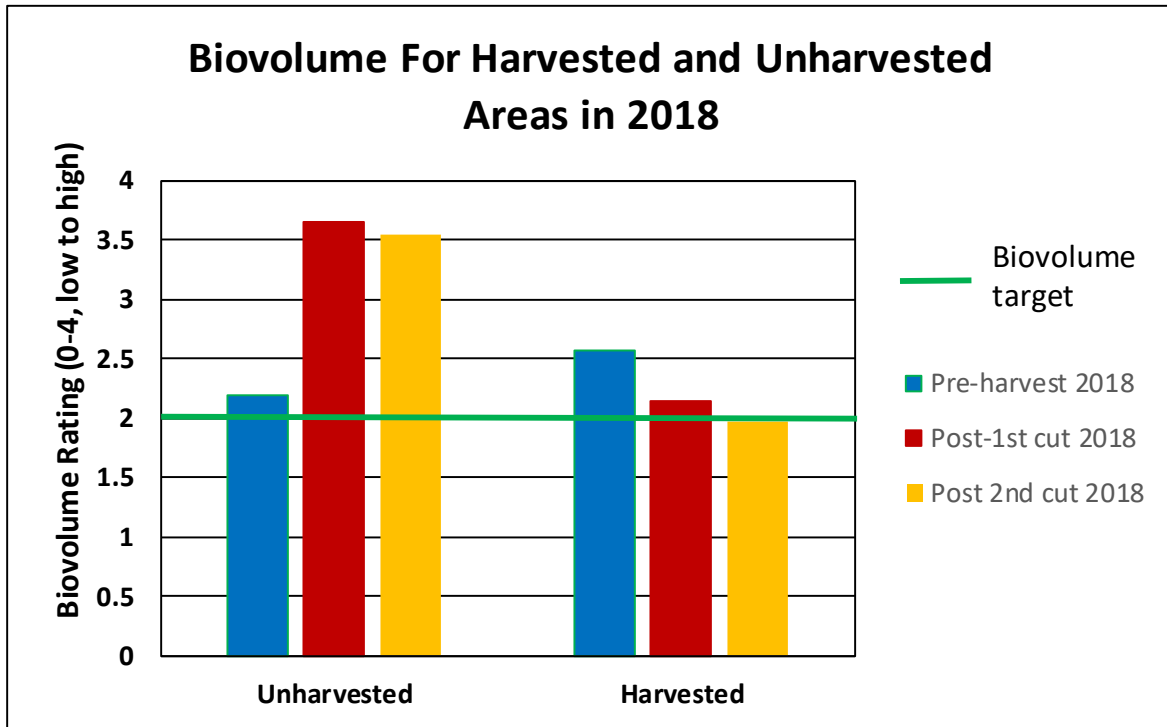
Figure 9. Biovolume comparison in areas with and without harvesting over time in 2018

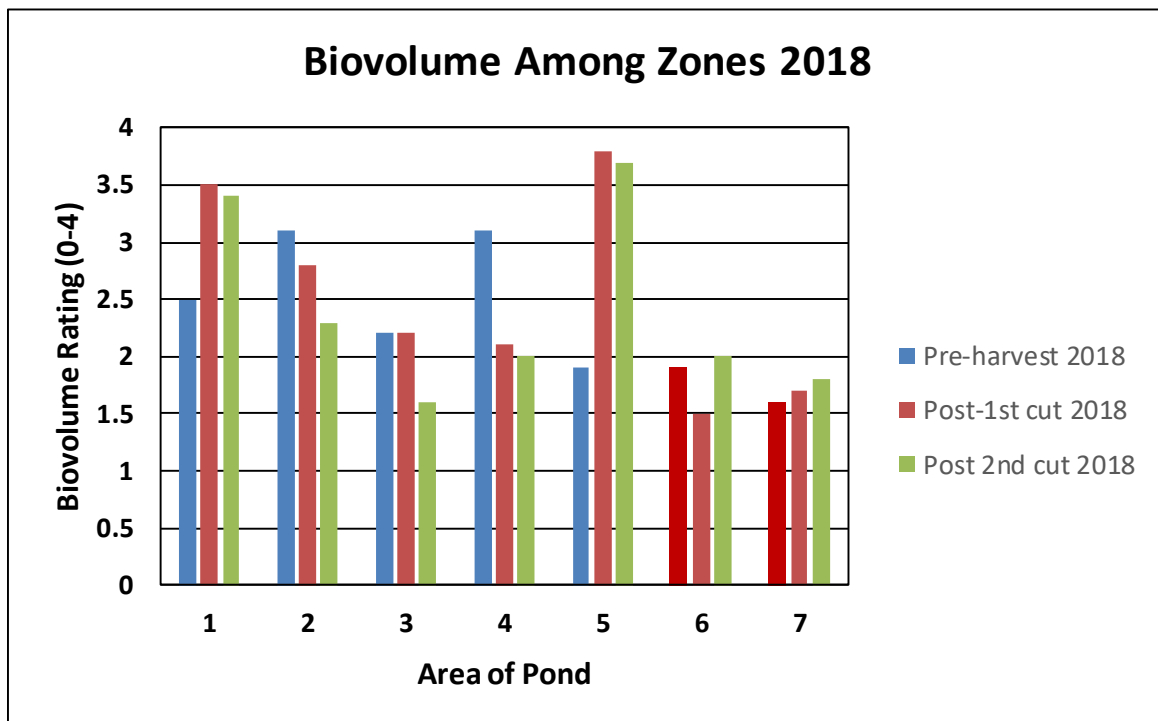
Figure 10. Biovolume comparison over time for each zone in 2018

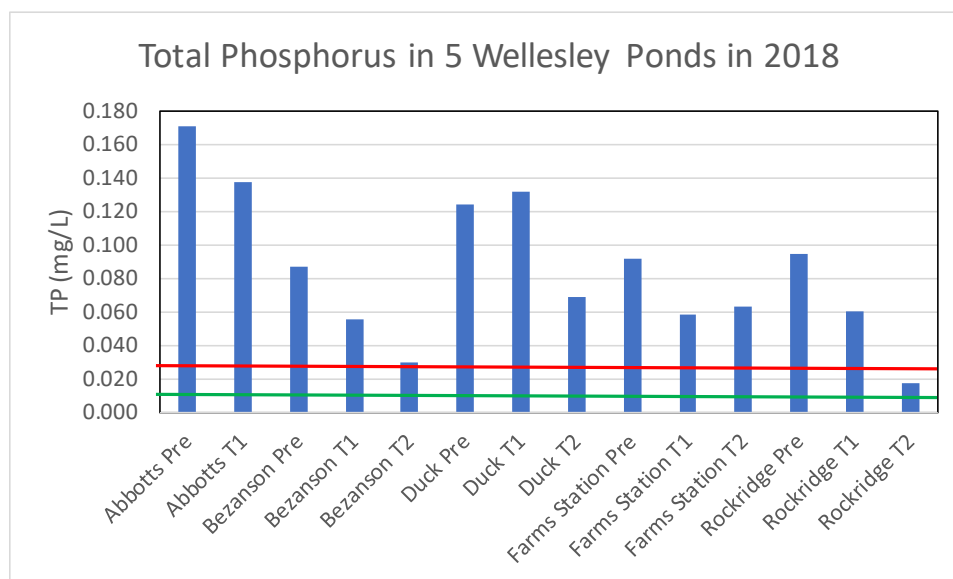
**Figure 11. Phosphorus before and after two aluminum treatments of five Wellesley Ponds**

Abbotts Pond showed limited response to its single treatment (Table 6, Figure 11). Access was limited and coverage may not have been adequate. Bezanson Pond exhibited a desirable response, showing declines in phosphorus and algae (chlorophyll-a in Table 6 and biomass in Figure 12) to near desirable thresholds. The clarity of Duck Pond improved as a result of treatment; aluminum coagulates and settles suspended solids even if not algae. However, there were few algae in Duck Pond (Figure 12), owing to short residence time, so turbidity decreased (Table 6) as a response by suspended non-algal particles. Farms Station Pond has a problem with duckweed (*Lemna minor*), a floating aquatic plant, and while algae biomass can be high, it was not extreme in 2018 (Figure 12). The treatment did not appear to impact the duckweed, but growths were apparent even before the first treatment. Phosphorus concentration decreased, but not to the degree desired. Rockridge Pond exhibited desirable decreases in phosphorus, chlorophyll-a and algae biomass in response to treatment, approaching or achieving the target levels after the second treatment (Figures 11 and 12).

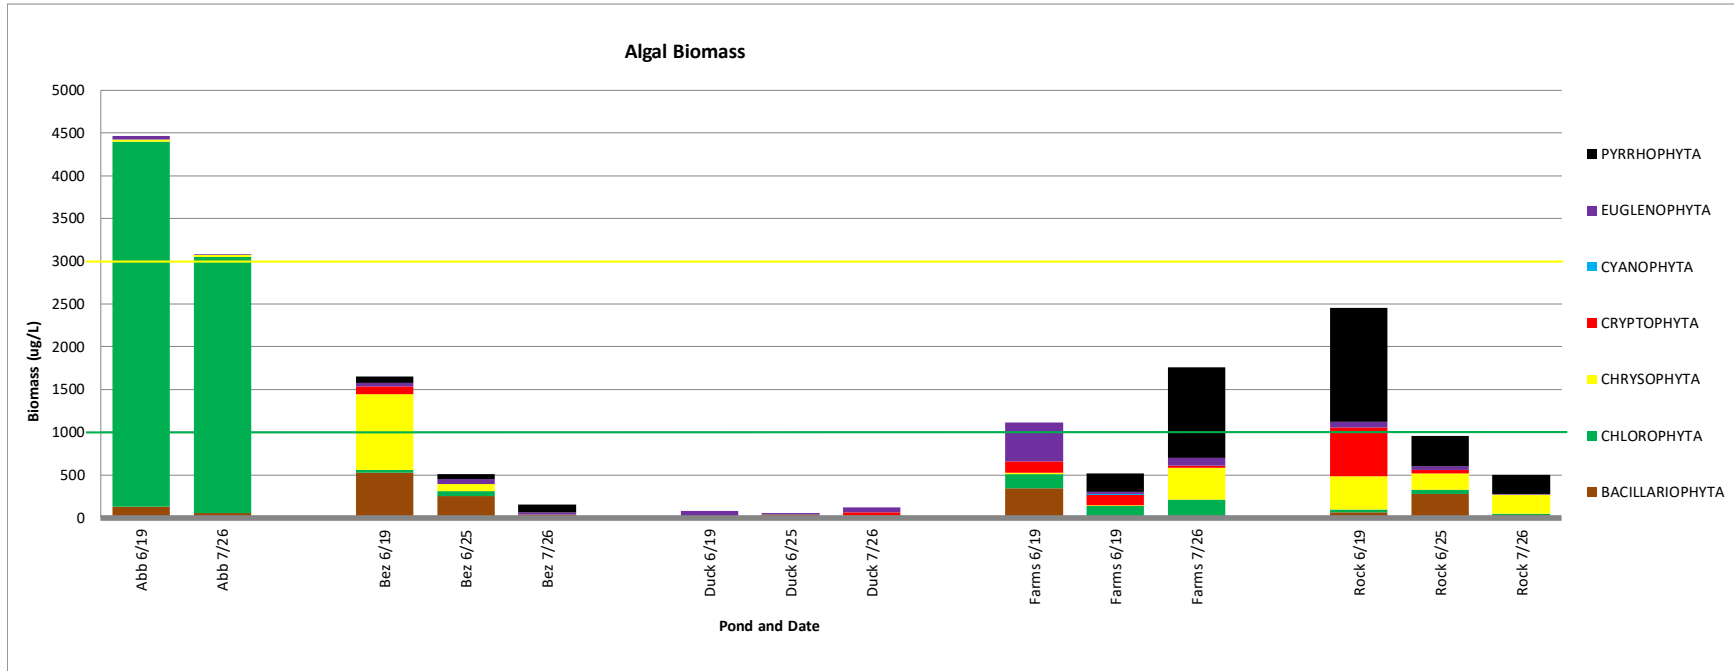
Figure 12. Phytoplankton biomass in five Wellesley Ponds in 2018
