## CHAPTER 5 – HISTORIC BUILDING MATERIALS & TREATMENTS

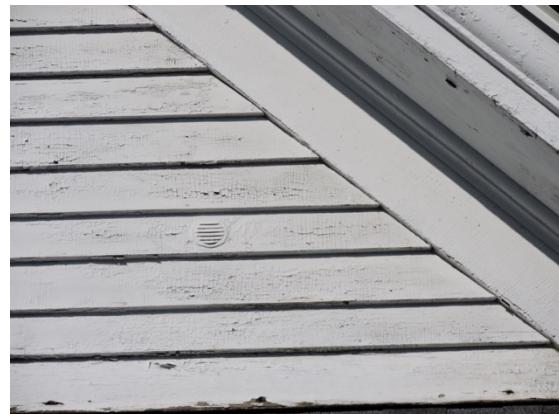
*This siding shows some indication of peeling. A small metal vent has been installed to allow interior moisture to escape, rather than allowing it to move through the wood causing the paint to fail.*

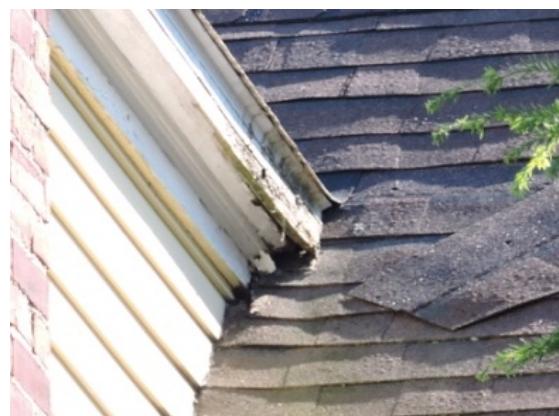
*The fascia and soffit boards of this cornice have rot due to moisture drawn from contact with the roofing. The hole in the soffit on the underside of the cornice is probably an entranceway for squirrels.*

- h. **Bird and Squirrel Holes:** Once identified, birds and squirrels should be chased out and the holes repaired. Extensive damage can be caused by the animals inside the structure, and the holes allow moisture inside the walls causing rot.

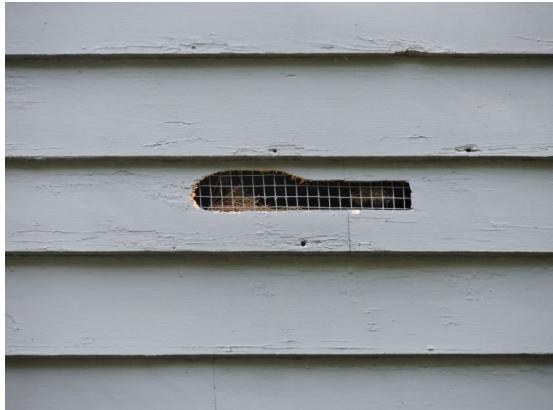
*This hole in historic wood siding may have been intentionally cut as a vent, but it has been widened by chewing animals and nesting material can be seen inside.*

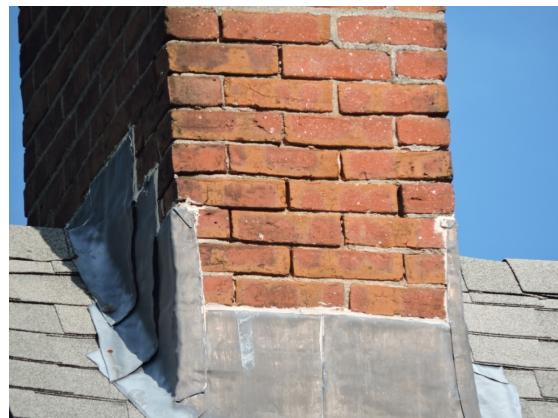
*Chimneys are the most frequently present brick features in wood buildings within the Cottage Street Historic District. Difficult to access, this brick chimney has open joints which will absorb water.*

**Open Joints** – Open masonry joints are among the most common problems observed in historic buildings, particularly older buildings with soft mortar that are not being well maintained. Open joints are particularly dangerous because they allow water to enter the wall and then freeze in cold weather. When water freezes, it expands causing cracking of the masonry and providing more ways for water to enter.

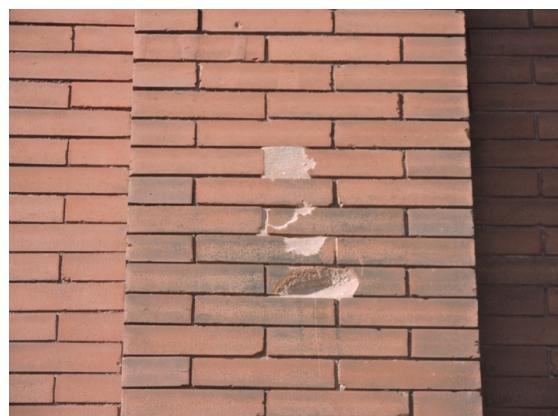
*The surfaces of these bricks have spalled.*

**Spalling** – Spalling of the surface of a brick can be caused by absorption of water in the brick which then freezes and spalls off the face of the brick. Spalling causes the soft inner core of the brick to be exposed to the weather, continue to absorb water, and rapidly deteriorate within the wall.

- f. **Spall Repair:** Remove spalled brick units and replace with new brick to match the existing in size, color, texture, and strength. Use mortar and masonry techniques outlined below in the discussion of pointing and mortar.

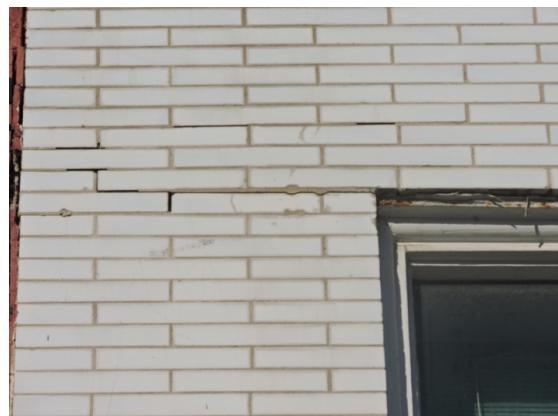
*Jacking of a steel lintel at the window to the right has caused cracking of the brick masonry at left.*

**Steel Lintels** – In masonry buildings constructed during the twentieth century, it has been common practice to install steel lintels above door and window openings. Frequently, these lintels rust over time. The rusted steel expands, causing cracking and the jacking of the masonry above the opening.

- g. **Steel Lintel Repair:** The long-term solution to the jacking of masonry over a window or door by a seriously rusting lintel is to remove the rusting lintel in its entirety. A new lintel should be installed, properly flashed, and the removed brick should be used to reconstruct the masonry facing over the window or door to match its previous appearance.

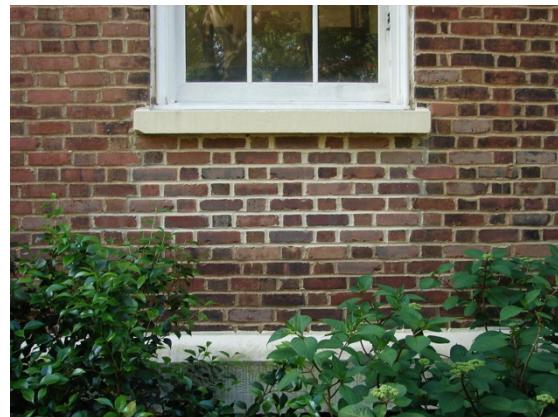
*The repointing below the window in this historic wall does not match the color, texture, or tooling of the historic mortar to the right and left.*

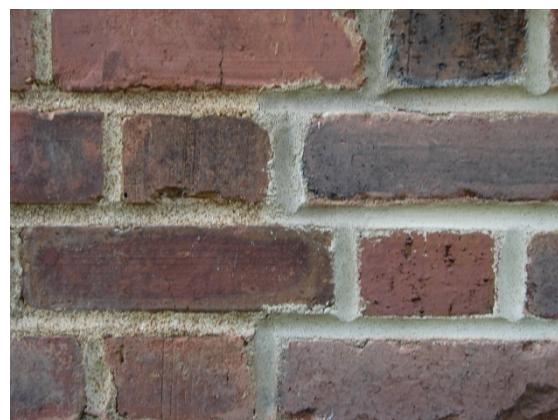
*Detail of repointed joints showing modern grey mortar to the right that does not match the rich brown color and texture of the historic sand mortar to the left.*

Today's commercial mortars are too hard – harder than historic brick. When used in historic brick walls, today's hard mortars (1) force the softer historic brick to absorb the thermal movement causing cracking of the brick wall and (2) force moisture to escape from the wall through the brick causing cracking and spalling of brick units.

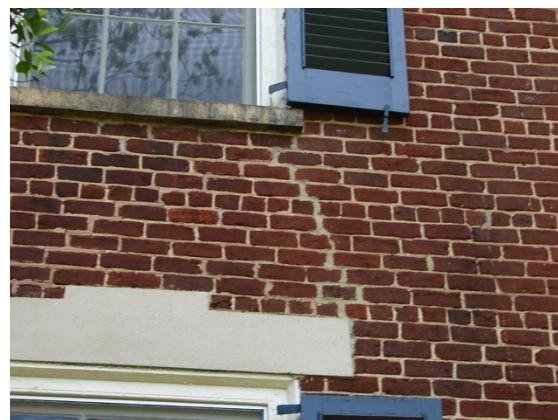
*Repair of a structural crack caused by building settlement between the head of the window below and the sill of the window above.*

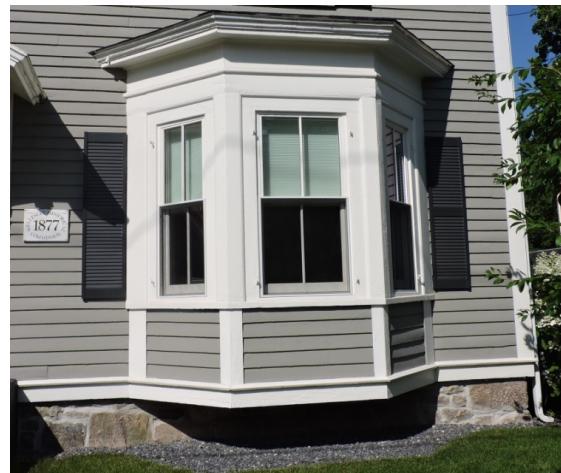
*Stone foundation of a wood framed vernacular building within the Cottage Street Historic District.*

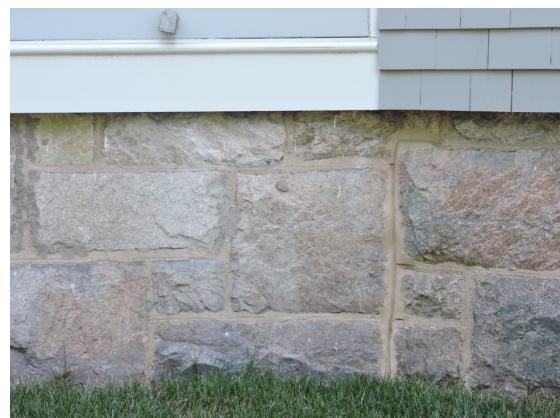
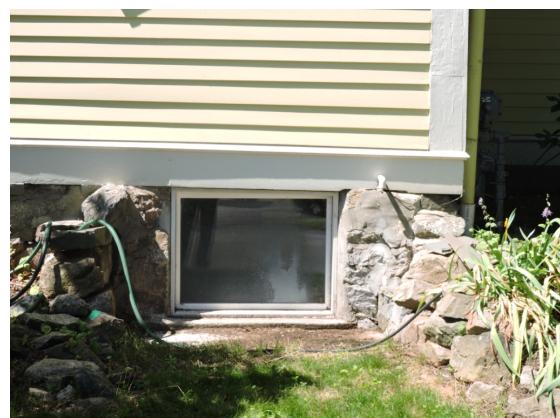
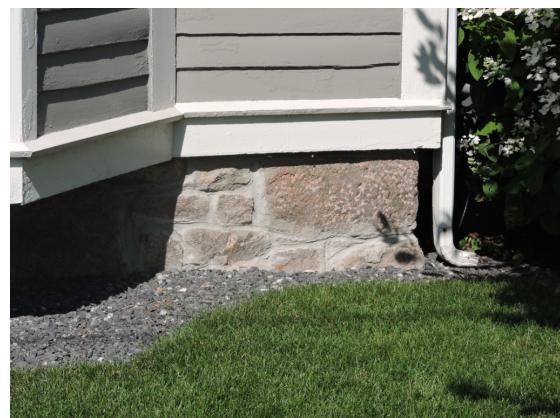
*Examples of stone foundation walls of historic buildings within the historic district.*

Stone is used most prominently in foundation walls within the historic district. In general, the walls are in good condition and are well maintained. The walls are mostly roughly coursed field stone, and some may not be original to the buildings.

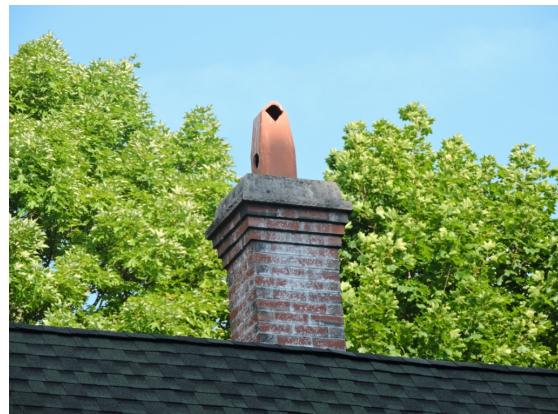
*This chimney within the historic district appears to have a custom stone cap with a terra cotta flue cap.*

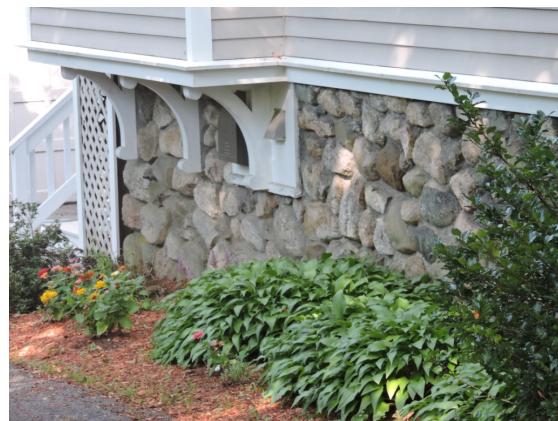
*A rubble stone foundation wall at a house within the district.*

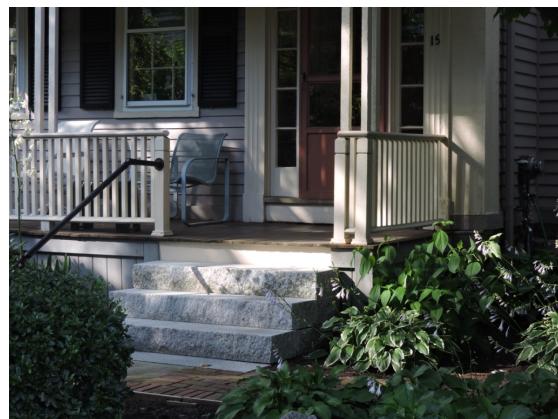
*Granite stone exterior steps have been installed on several homes within the historic district. They also appear to be later additions, but they are appropriate to the character of the district.*

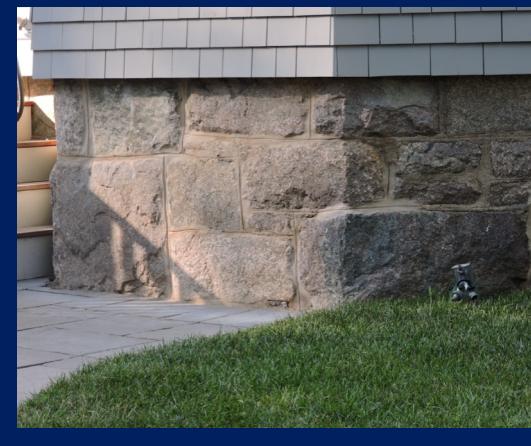
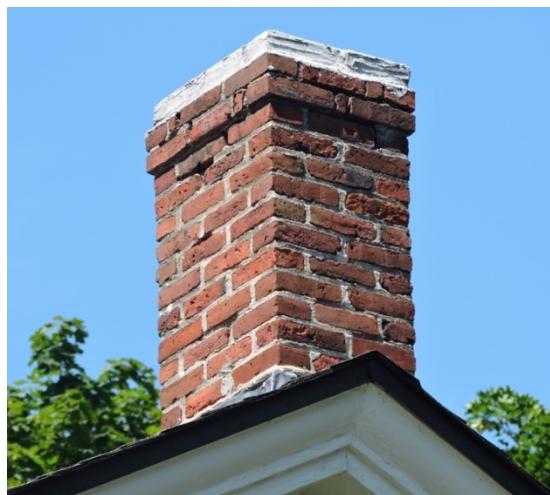
*The bricks in this chimney show their age – some are chipped and slightly spalled. They need not be repaired or replaced, however, if they do not threaten the masonry as a whole.*

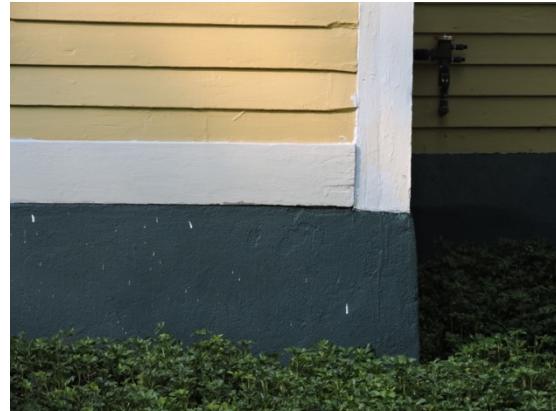
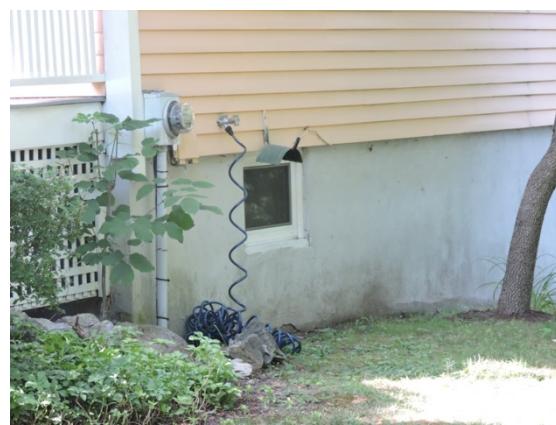
*Stucco has been used as a protective coating over vulnerable masonry foundation walls.*

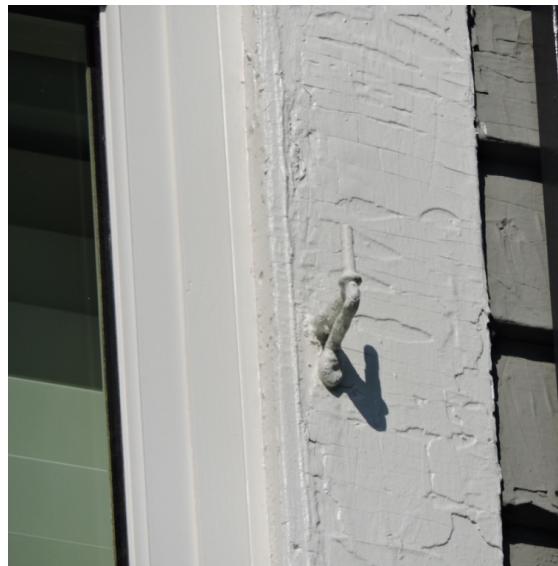
*As also discussed in Chapter 7, remnant historic metal features such as this pintle form a late nineteenth century shutter hinge should be preserved whenever possible.*

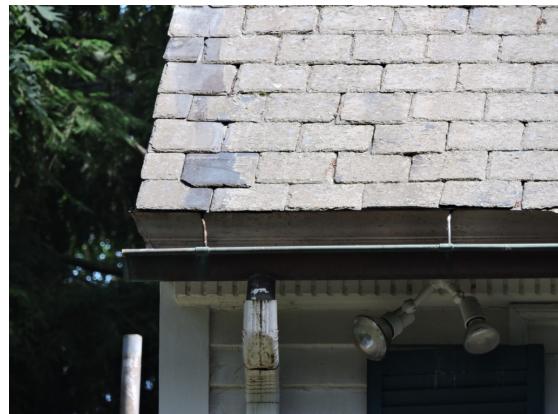
*Copper is a common historic material used for roofing, gutters, and downspouts and should be retained whenever possible.*

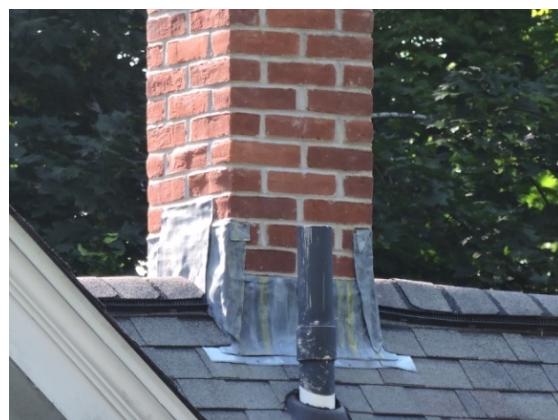
*Lead was commonly used for the flashing of brick masonry chimneys and is still present within the historic district.*

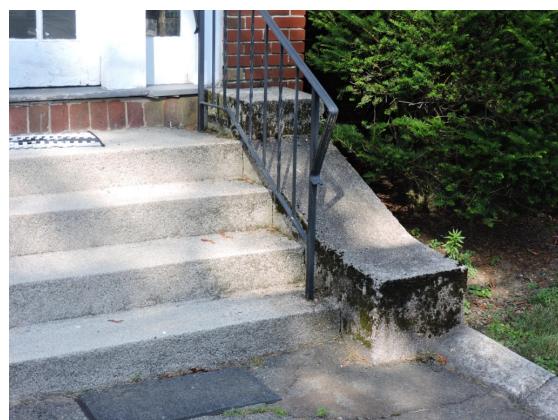
*Most metal handrails within the historic district are of modern installation. The posts of metal handrails are susceptible to deterioration where they anchor into concrete or masonry.*
