CHAPTER 6 – TREATMENT OF HISTORIC BUILDING FEATURES

This chapter addresses the treatment of historic building features, including roof features, wood siding and detailing, entrances and doorways, windows, and porches—the key character defining features of a building's exterior. Preservation and appropriate maintenance of historic features and their authentic building fabric are always strongly encouraged as a baseline treatment. The first step is understanding the feature's relationship to the building in terms of time period and historical significance, as well as the design characteristics that are significant to the feature itself.

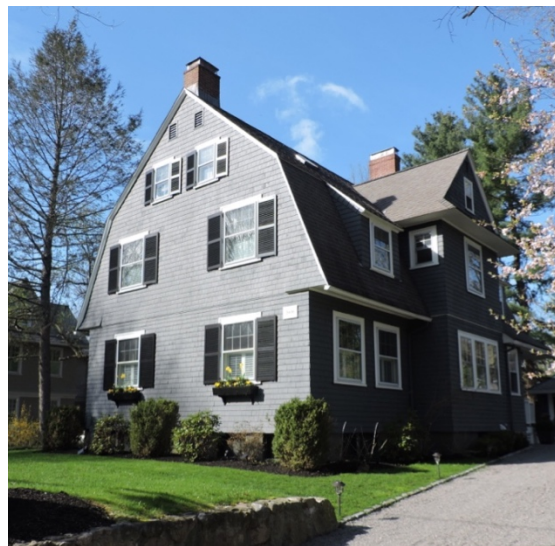
Creative roof forms give expression to the architectural character of a building.

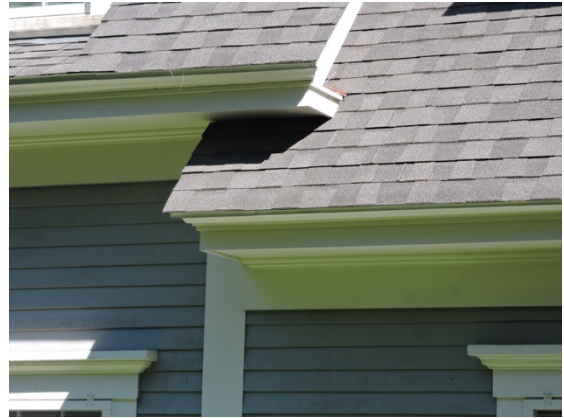
Asphalt shingles are in use throughout the historic district and are easily adaptable to complex roof intersections such as these. This roof has no gutters, a common historic condition.

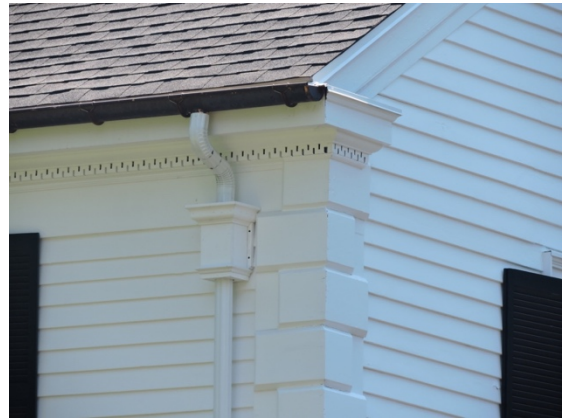
Fine detailing of a roof edge – half-round copper gutter, downspout matching the color of the wood eave and walls, and scupper box.

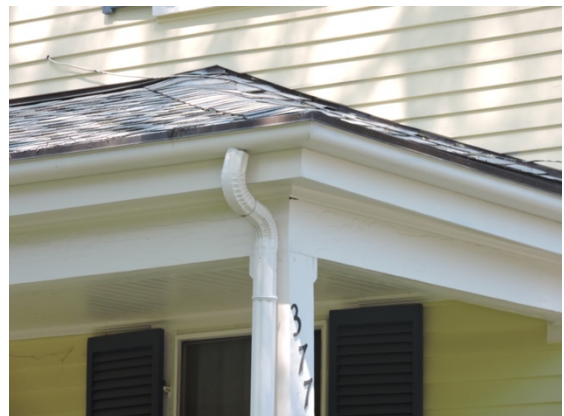
The roofs on this home have built-in wood gutters that are lined with metal, important historic features that have been preserved and maintained.

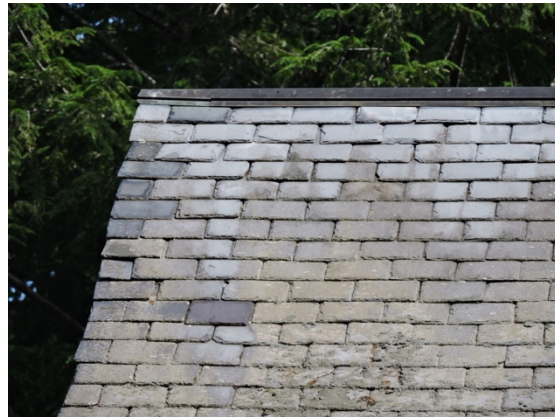
This slate roof has a copper ridge cap. Copper in the water washing down from the cap has killed lichen that is seen growing on the slates in the lower portion of the image. The dark grey slates are replacement pieces – a better color match might have been possible.

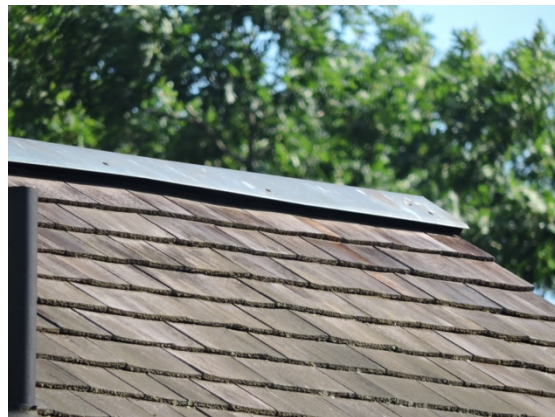
At least one wood shingle roof remains in the historic district. It has a metal ridge cap/vent, not historically accurate but acceptable for function and longevity.

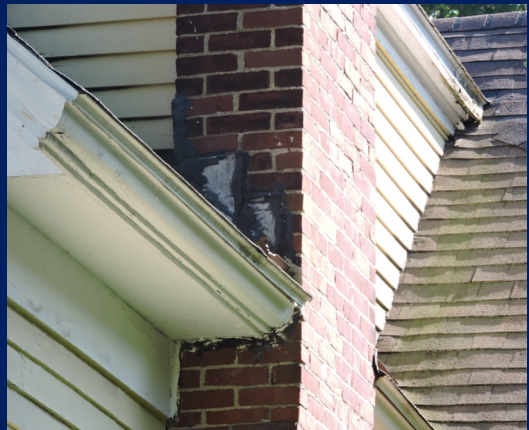
Many historic roofs have complex conditions that must be carefully maintained to prevent deterioration. Routine maintenance can prevent the need for costly repairs and replacement, which should be undertaken in-kind.

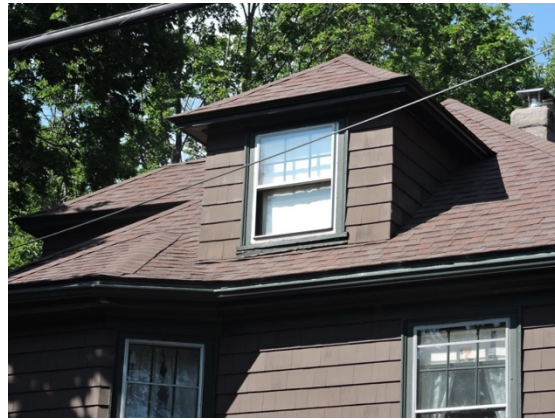
Historic dormer characteristic of the building's period and architectural style.

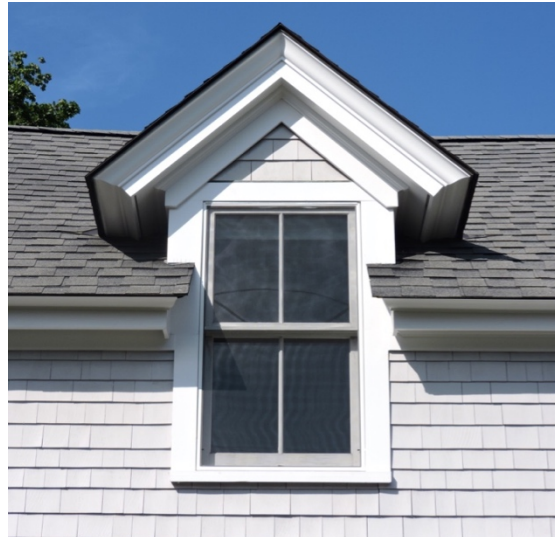
Half dormer flush with the wall and penetrating through the roof in a one-and one-half story cottage.

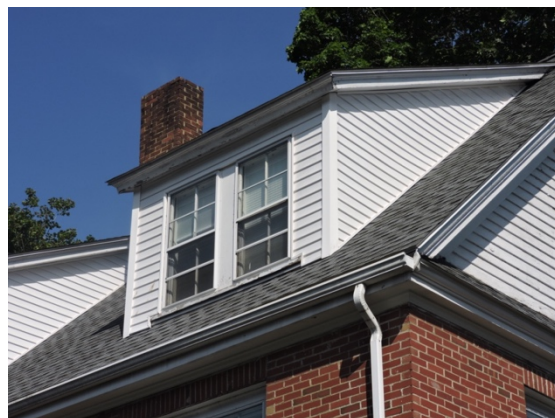
These dormers appear to have been added to the building to make the attic level habitable.

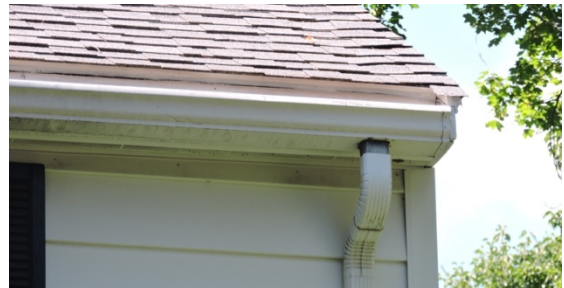
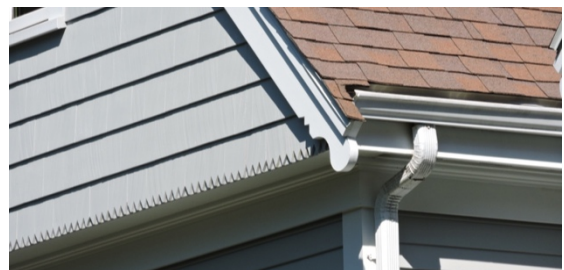
Contemporary K-style (molding shaped) gutters have been installed inside of decorative barge boards at the gable ends.

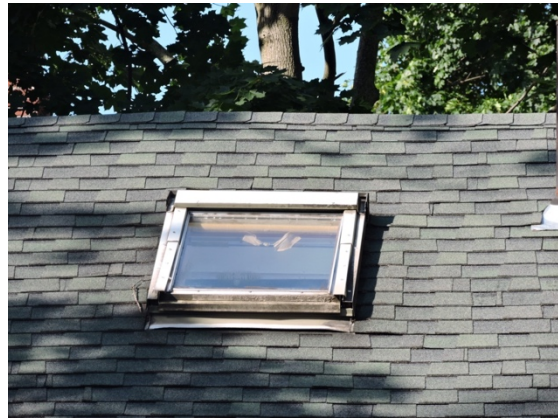
This flat skylight is an appropriate type, but was installed on a primary façade. Its color could have been darker, blending better with the color of adjacent shingles.

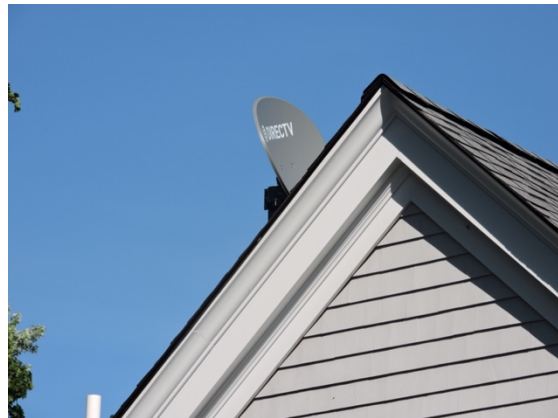
An internet/television dish was installed on the back side of this building's ridgeline so that it is minimally visible from the street.

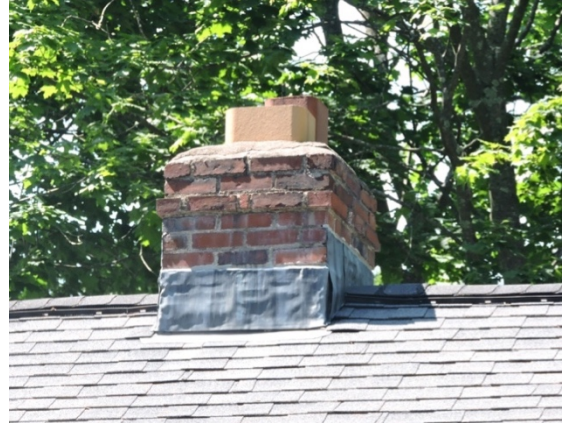
Common utilitarian chimney with original brick, copper flashing, terra cotta flue liners, and cement wash to shed water.

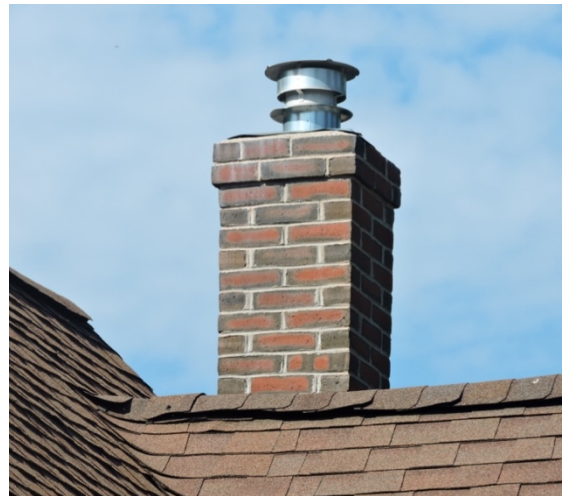
A variety of different types of metal caps have been installed on chimneys within the district, not historic but acceptable for fire safety. This chimney has been rebuilt with brick reasonably similar to the appearance of historic brick.

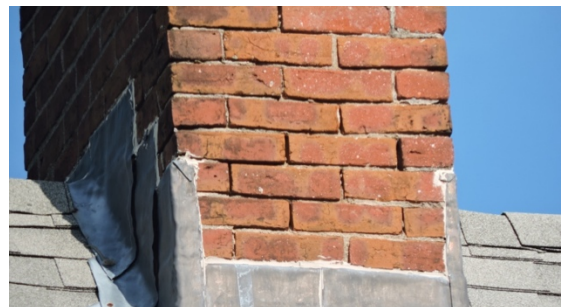
The open joints in this chimney may allow water to penetrate and deteriorate the brickwork.

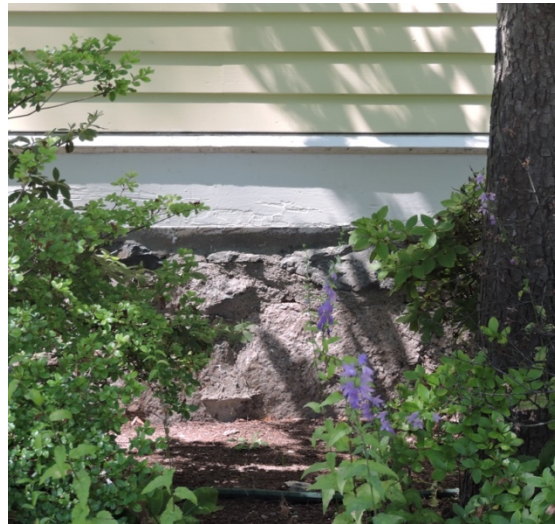
Wood detailing can be susceptible to water penetration and deterioration, such as at this drip edge and trim at the base of a clapboard wall.

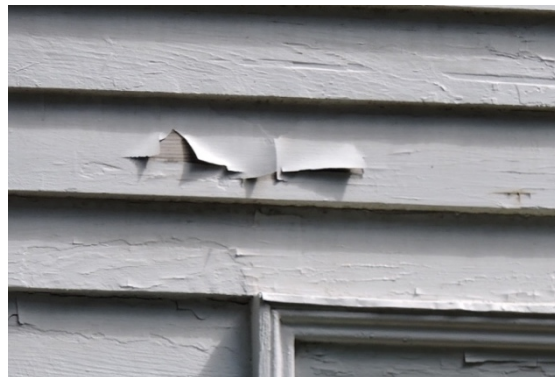
Painted coatings are necessary to protect wood. Peeling paint is often caused by water vapor moving from the interior to the exterior of the building.

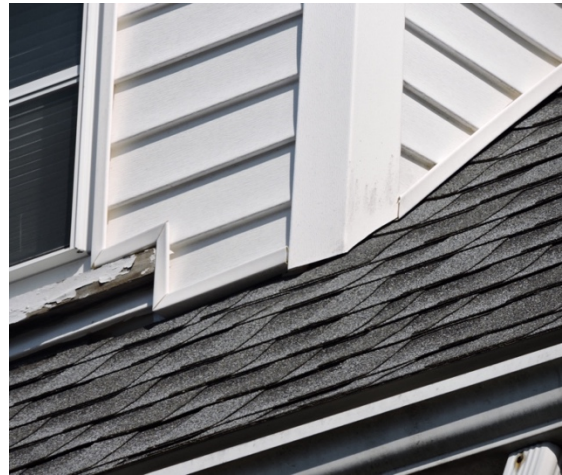
The use of synthetic materials and even aluminum siding, shown here, may be permitted at particularly vulnerable and hard to maintain locations.

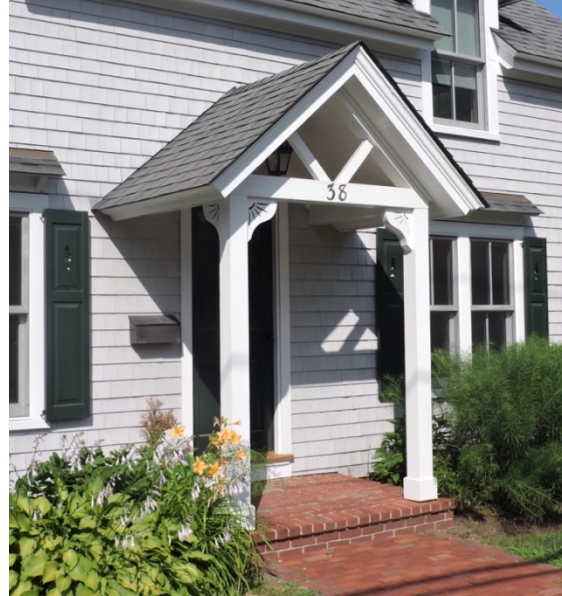
Simple entrance porch with a gable roof structure, decorative structural details, and brick step and deck.

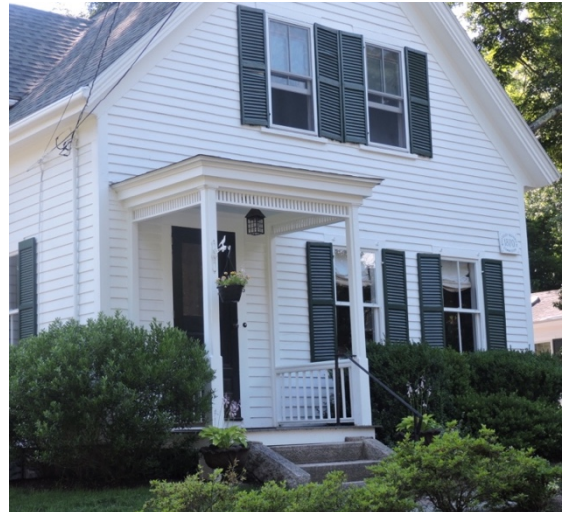
Entrance porch with a flat roof, simple wood structure, railings, wood deck, and stone steps.

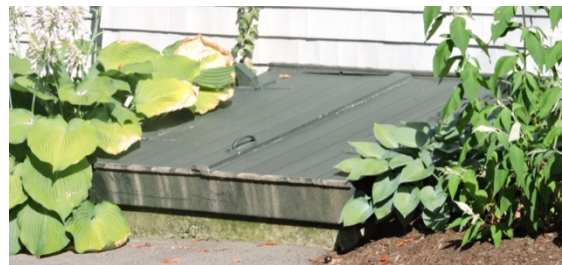
Wood basement areaway door.

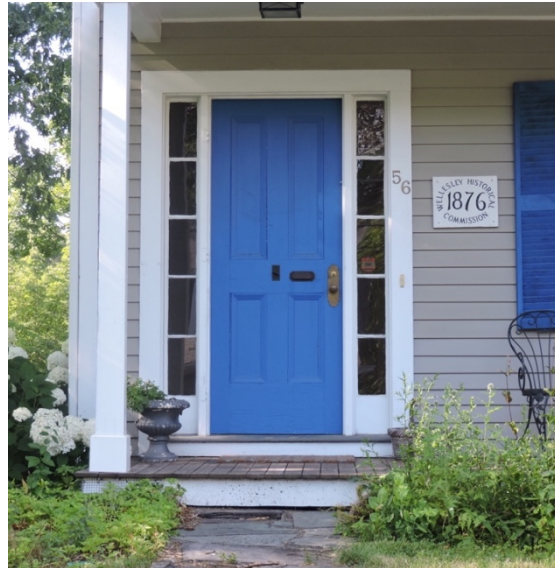
Historic wood doorway with solid paneled door, divided sidelights, and simple wood trim and frame.

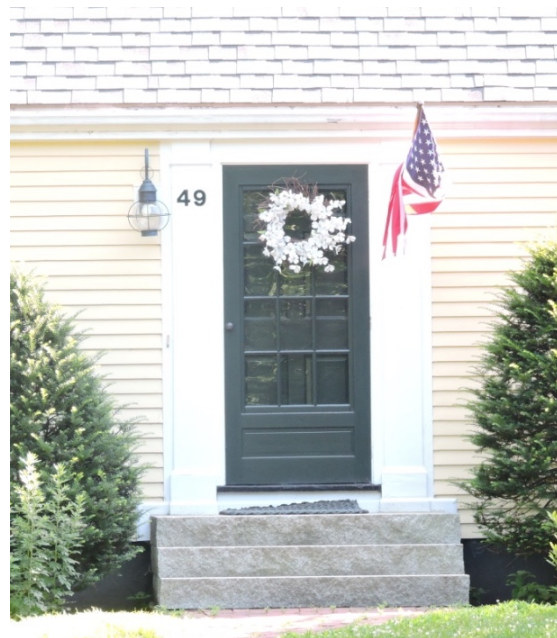
Flush wood doorway with wood side pilasters and crisp stone steps. The storm door has a large glass panel with true divided lights, a preferred treatment. The glass panel may be replaceable with screen panel in summer.

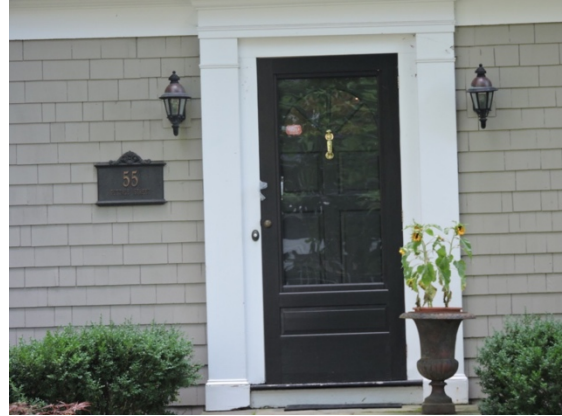
Wood storm door with a large glass panel allowing the historic door behind to be visible. Both are the same color. The glass panel may be replaceable with a screen panel in summer.

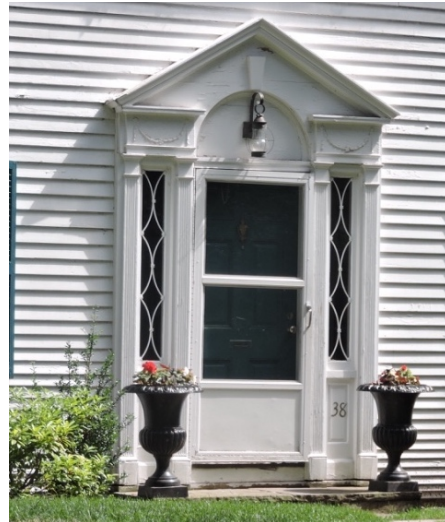
Aluminum storm door – acceptable, but wood would be preferable.

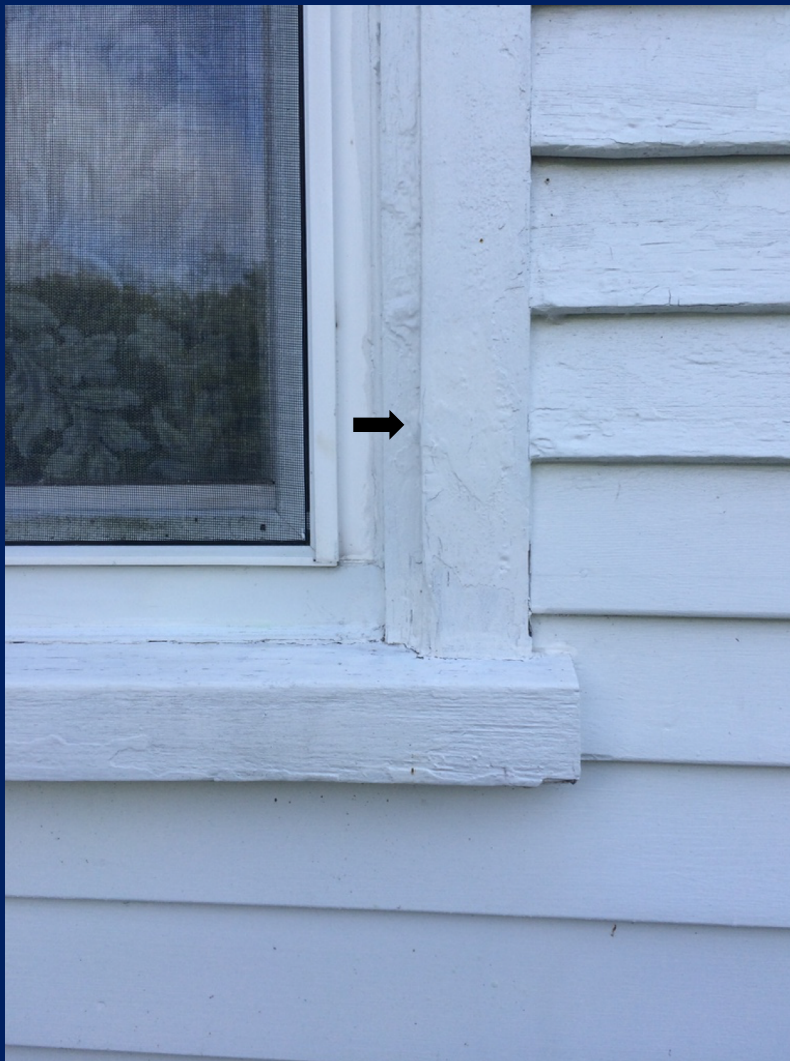
New wood siding was installed to replace deteriorated siding beside and below the window sill above. The new siding matches the historic wood siding above it, an appropriate treatment.

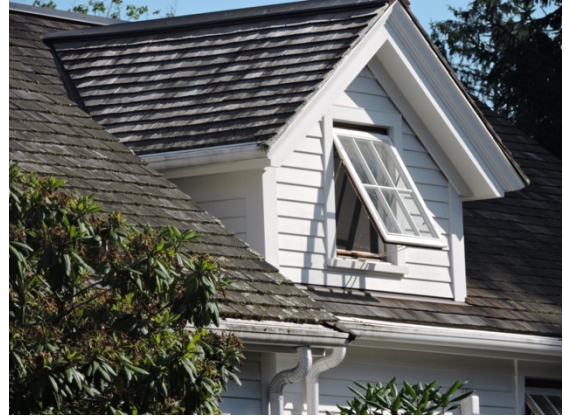
Operable awning window with the screen mounted on the inside.

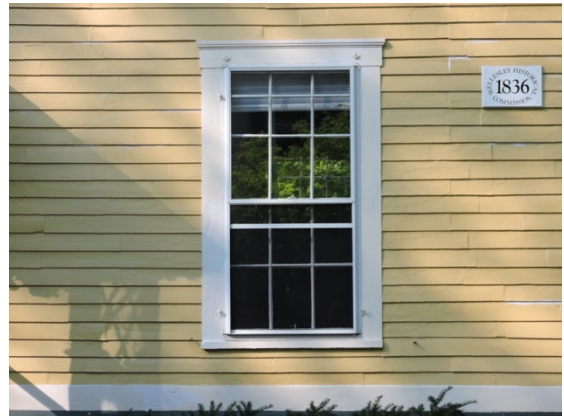
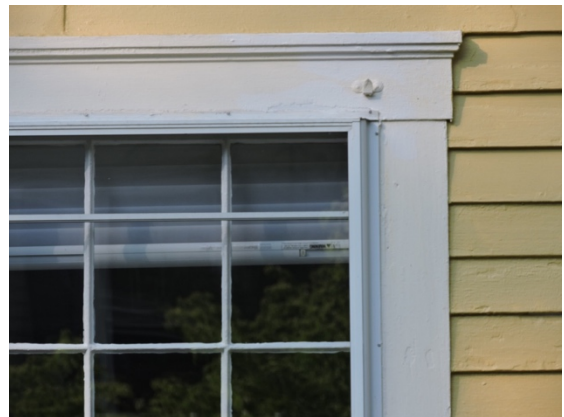
This exterior metal storm window is discretely mounted on the historic window frame, matching its size, and is barely visible.

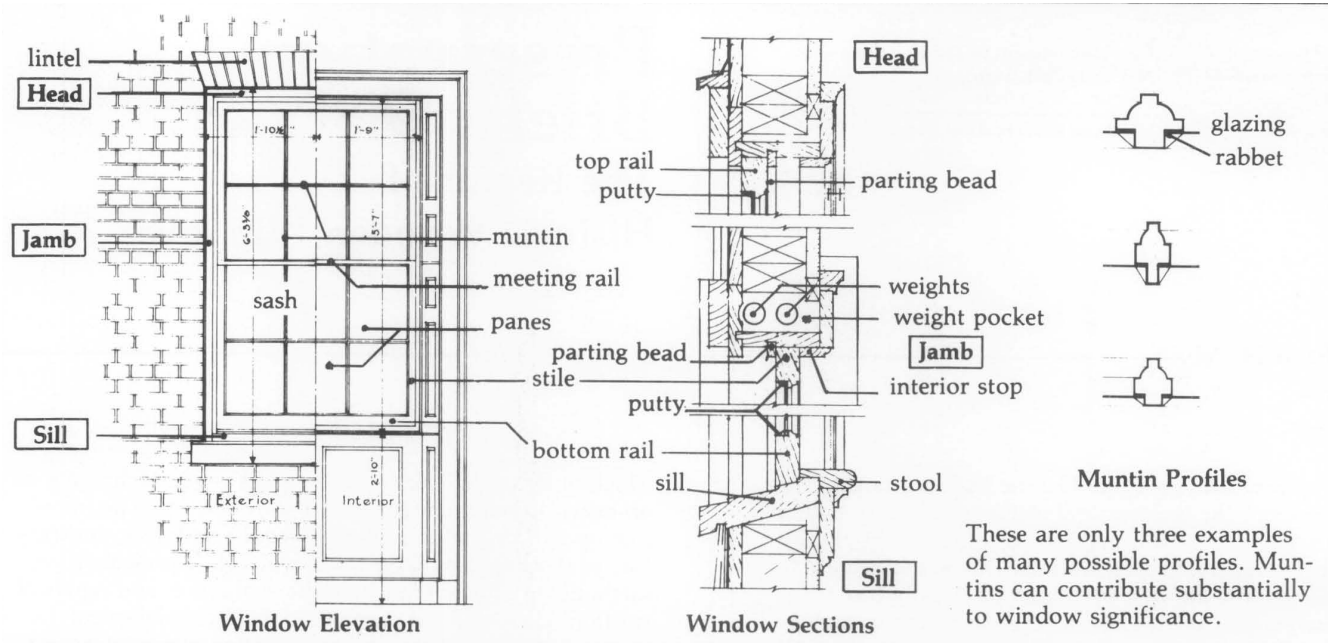
These drawings of window details from the National Parks Service's Preservation Briefs: 9, The Repair of Historic Wood Windows identify major components, terminology, and installation details for a wood doublehung window. (NPS 1981)

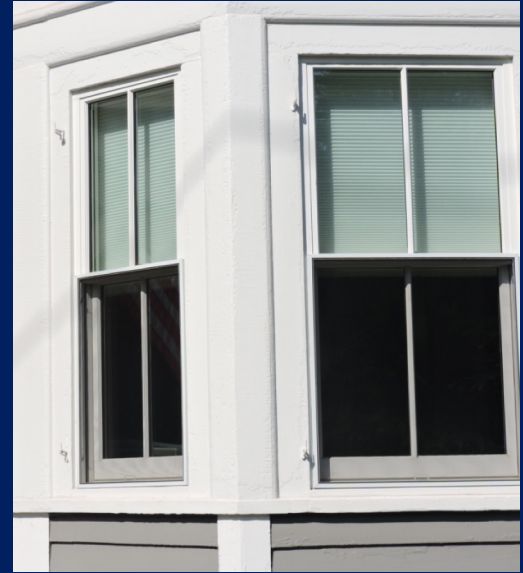
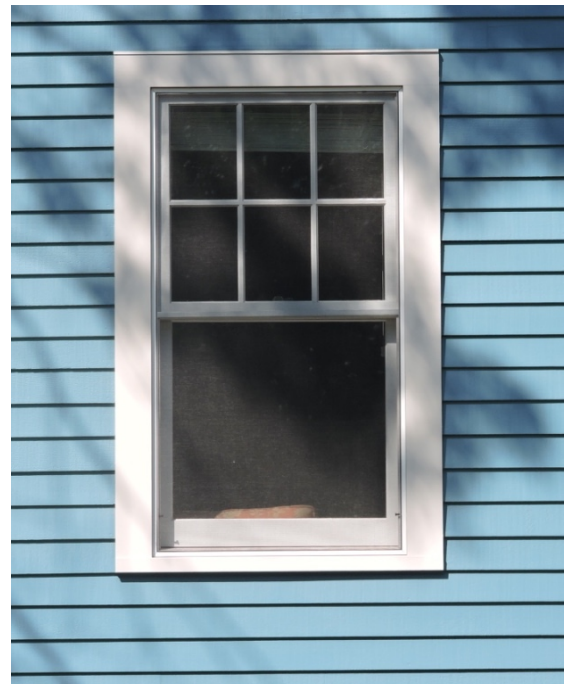
Replacement windows should match the full size of the historic window opening.

- f. **Window Size:** New windows should be custom fabricated to match the full size of the historic window openings. Do not install new windows that are smaller than the full size of the historic window opening.

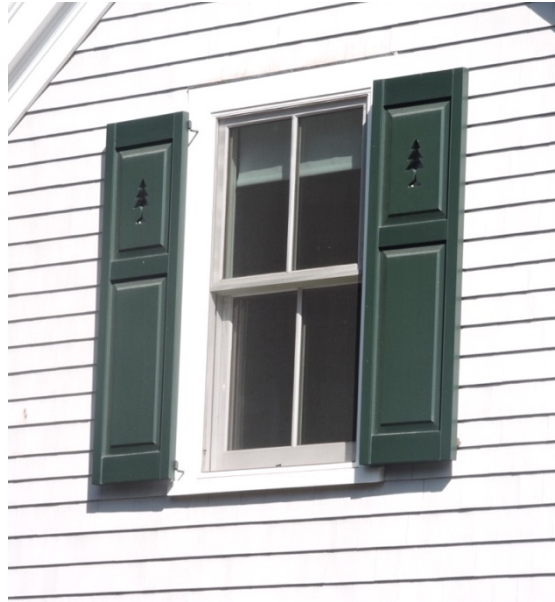
Authentic wood reproduction windows are preferred, although manufactured wood windows with finished aluminum metal cladding or factory-coatings may be acceptable.

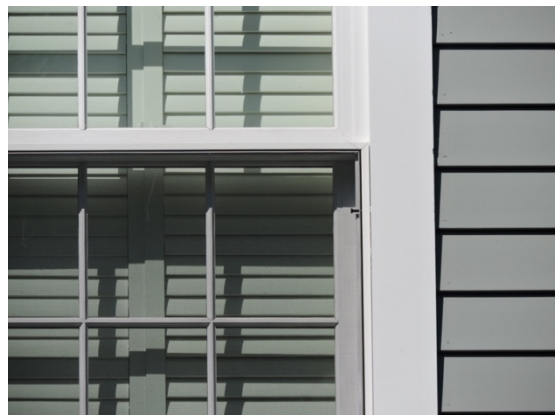
Historic muntin configurations should be used in the replacement windows, with profiles and details that replicate the historic appearance as closely as possible.

- l. **Muntins:** Match the muntin configuration of the historic windows being replaced. The use of true divided lights is preferred. However, certain types of false muntins simulating divided lights may be acceptable provided they are integral to the sash design, both interior and exterior, and are not easily visually identifiable as false. Do not install windows with applied or snap-in muntins or muntins that are on interior of insulating glass.
- m. **Inappropriate Window Types:** Do not install new contemporary windows that are not appropriate to the character of the historic building, such as stock residential windows, bay or picture windows, glass block, Jalousie windows, or others.

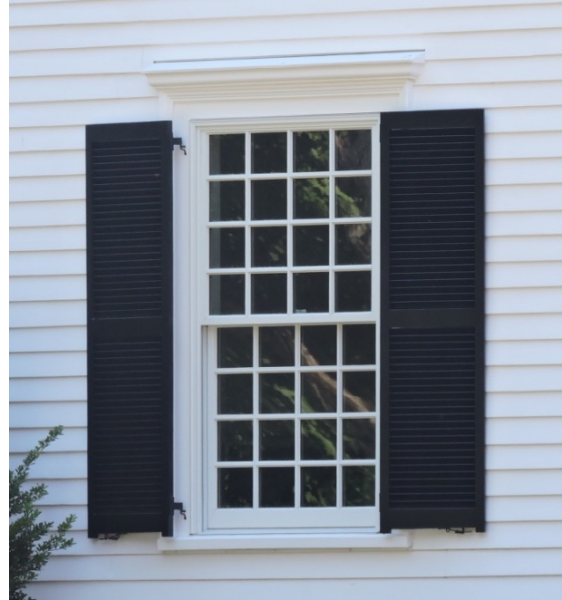
Shutters should match the height and width of the window opening and be operable or at least appear to be operable.

- c. **Shutter Size and Configuration:** New shutters should match the height and width of the window opening where they are being installed. Shutters should be mounted to be operational or appear to be operational.

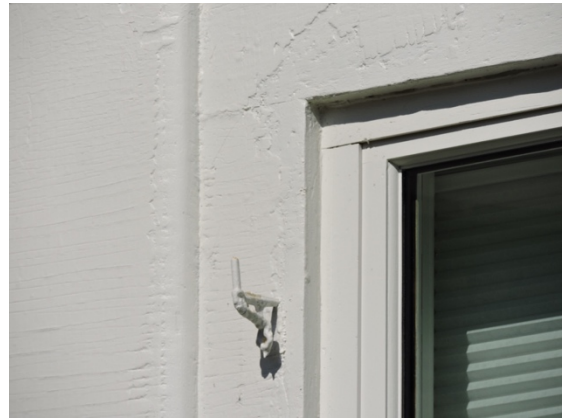
Historic shutter hardware such as this metal hinge should be preserved even when not used.

- g. **Window Hardware:** Window hardware and operating mechanisms should be retained but are often in need of repair. Elements such as the sash locks, cords, and weights of historic wood doublehung windows can be easily repaired and, if necessary, replaced in-kind.

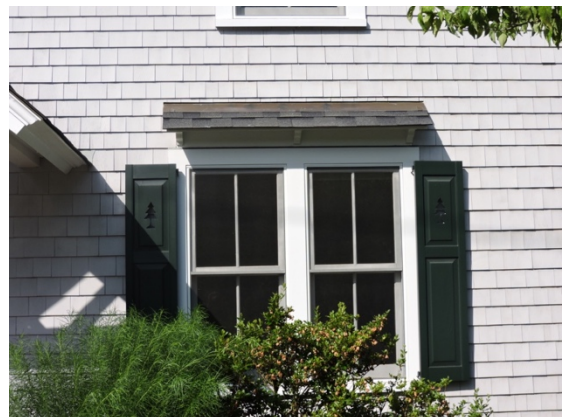
These shutters do not match the size of the historic window opening and could not be operable.

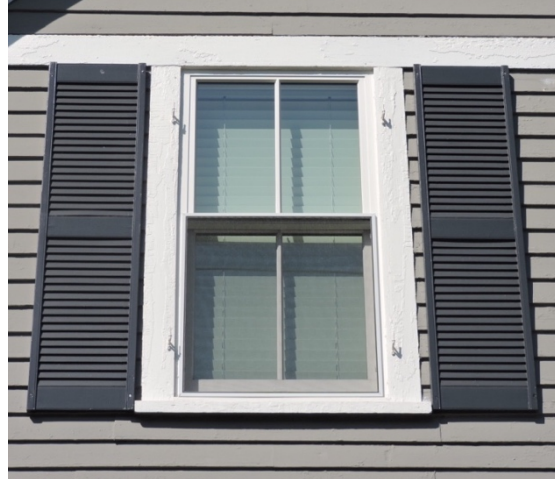
In this example, despite the presence of authentic shutter hardware on the frame, shutters are mounted flat on the walls adjacent to the window, which is inappropriate and could have been avoided.

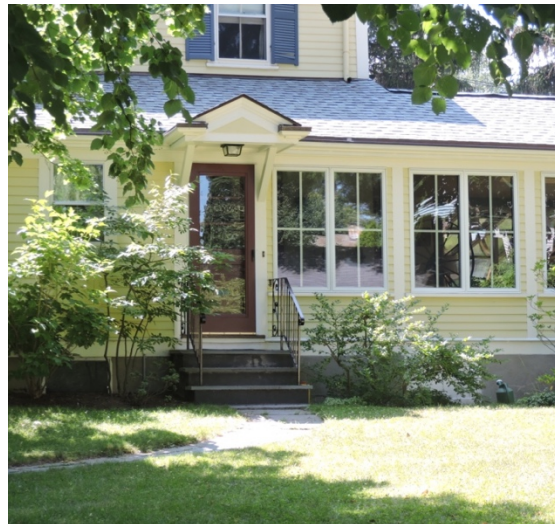
The new windows to the right of this doorway may be an addition or once been an open porch. Though different in type, their character successfully reflects the character of the overall building.

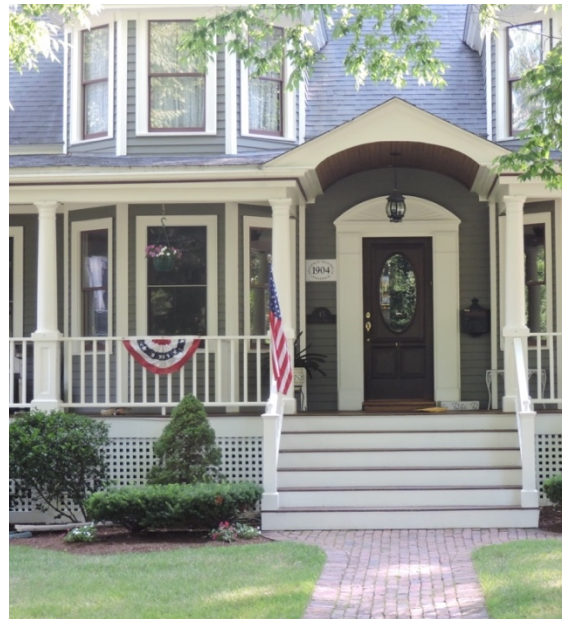
Wood porches are prominent features of many houses within the historic district. Exposed to the weather, their wood features require ongoing maintenance and occasional repair and replacement.

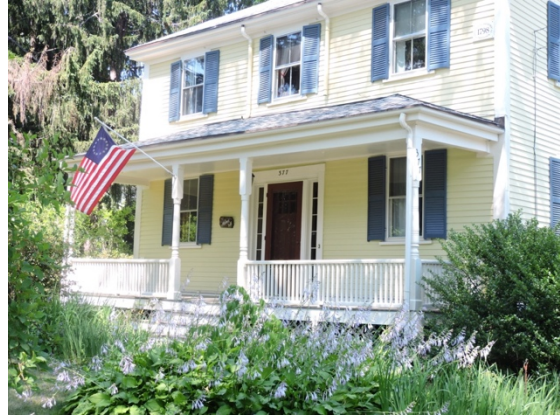
Historic front porch on a building dating to 1798. The porch may be a later addition/modification.

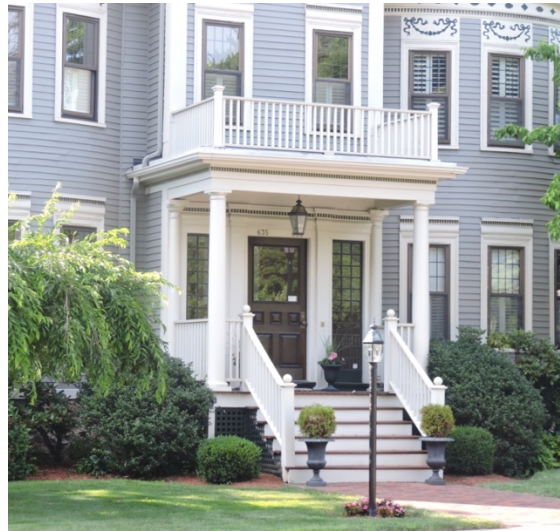
Highly detailed front porch with wood columns, roof balustrade, floor, and steps.

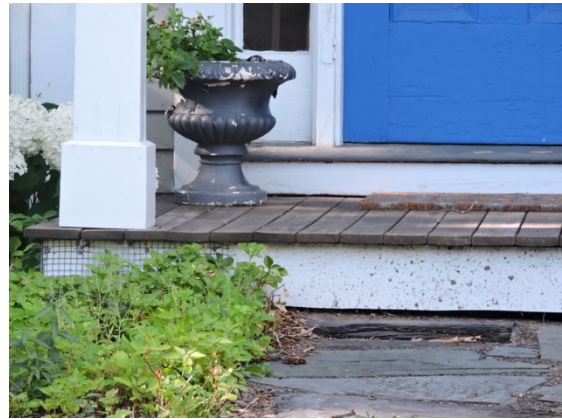
Wood porch flooring and related elements are exposed to the weather and susceptible to deterioration.

- a. **Porch Flooring:** Wood porch floors receive heavy use, are exposed to the elements, and tend to wear and weather quickly. Replacing limited sections of deteriorated flooring is preferable to total replacement. Replacement floorboards should closely match the dimensions of historic wood floorboards, which were typically between 3/4- and 1-inch thick.

- c. **Floor Installation:** Wood porch flooring should be laid perpendicular to the building wall and extend to the drip edge of the porch. A minimal slope away from the building to facilitate drainage is needed. A maximum gap of 1/16-inch should be left between boards to allow for expansion. Boards should be fastened with screws, not nails, to prevent cupping and bouncing. Wood edging should be applied to the exposed ends of floorboards to prevent moisture from entering the end grain. Surface coatings such as paint and stains that help prolong the color and condition of the wood are appropriate.

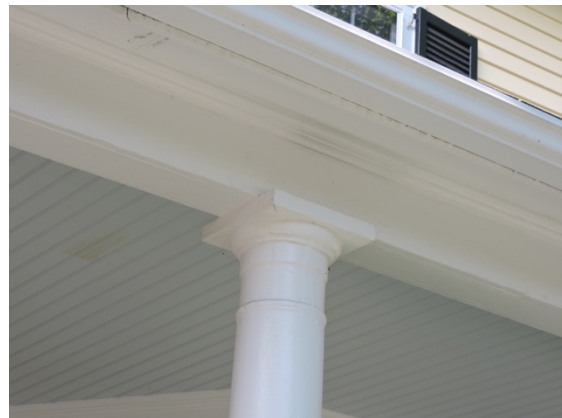
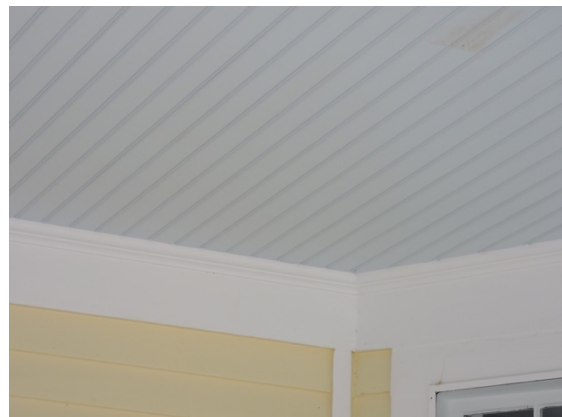
Fine wood eave, column, and beaded board ceiling, and additional detailing on a porch within the historic district.

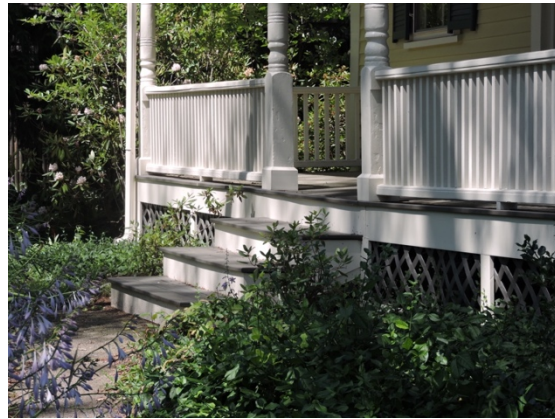
Wood steps without railings providing access to a wood porch.

- a. **Wood Steps:** Wood steps on nineteenth century buildings may have been replaced a number of times over the building's lifetime due to wear and exposure. The replacement of wood steps should be based on physical evidence and historic documentation if available, and not necessarily the current steps, which may or may not be an accurate copy of the original.

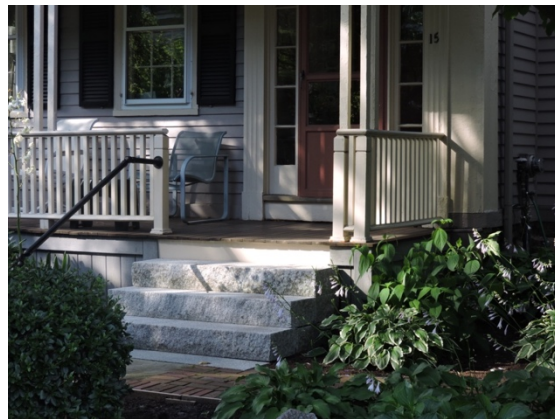
Modern granite steps with smooth treads and rough faced risers have been added to this porch. A black metal handrail has been installed for safety but is minimally visible.

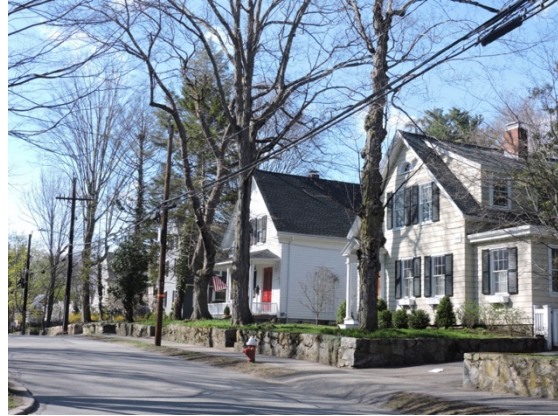
Cottage Street streetscape showing stone retaining walls that border one side of the street.

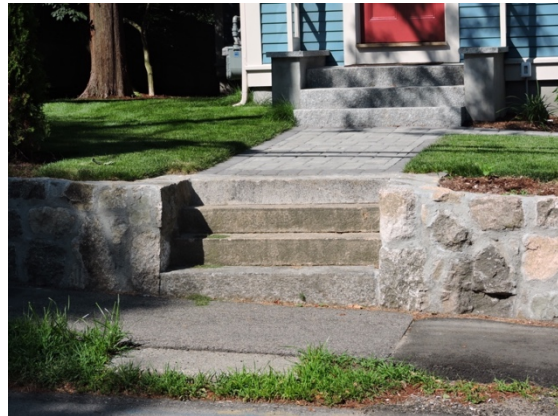
Stone retaining wall and entrance steps.

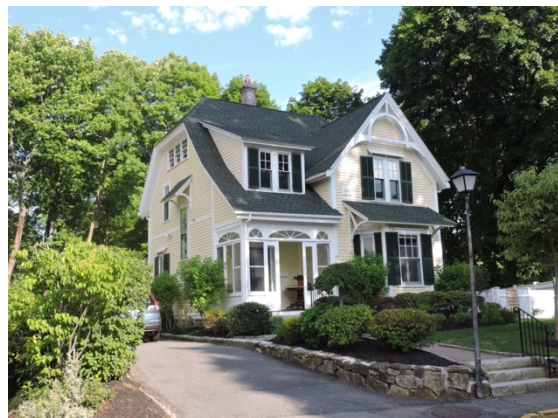
Stone retaining wall bordering the street and driveway.

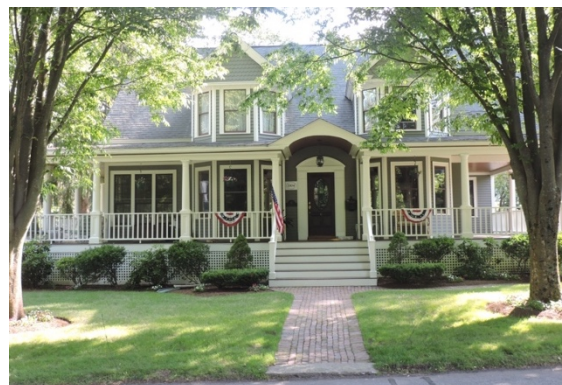
Historic brick entrance walk.

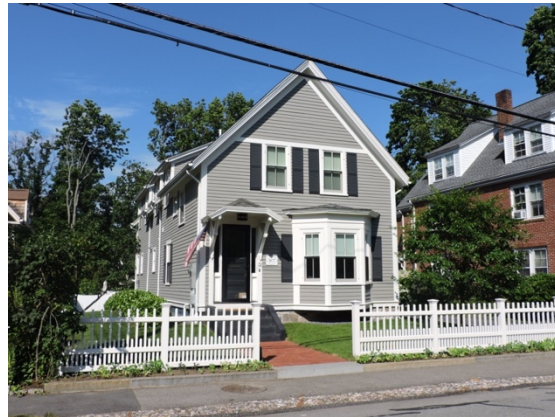
Elaborate wood picket fence bordering the sidewalk and street. Note brick entrance walk.

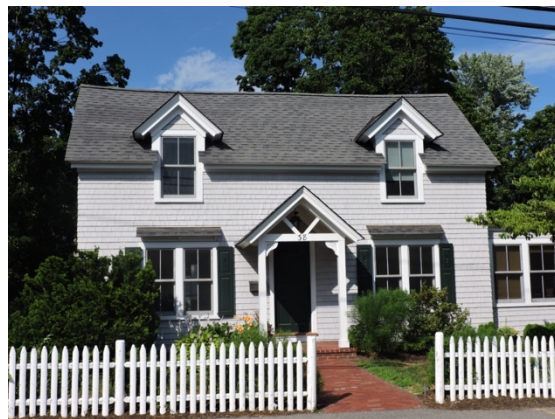
Simple wood picket fence along the sidewalk, a typical condition within the historic district. Note brick entrance walk.

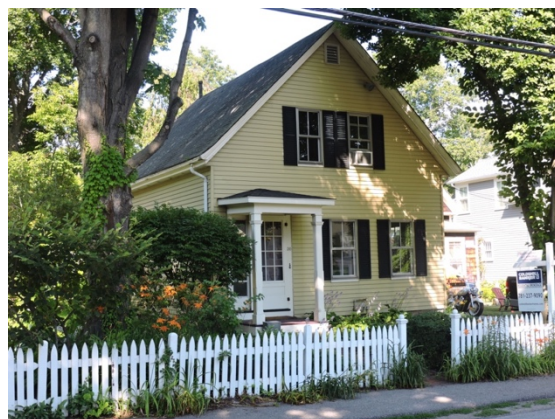
Another example of a low wood picket fence characteristic of the historic district. Wood picket fencing is in keeping with the simple vernacular design of many of the residences within the Cottage Street Historic District.

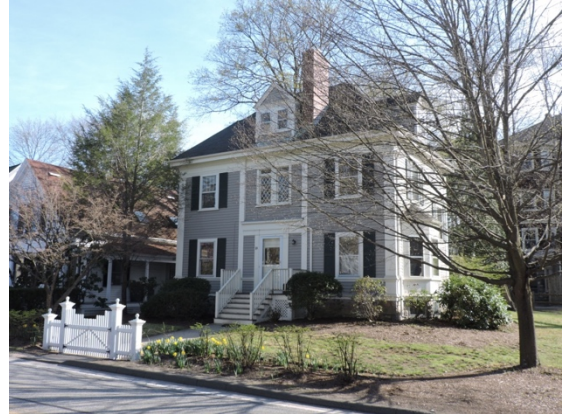
Historic residence with a wood picket entrance gate of more elaborate design, in keeping with the architectural style of the residence.

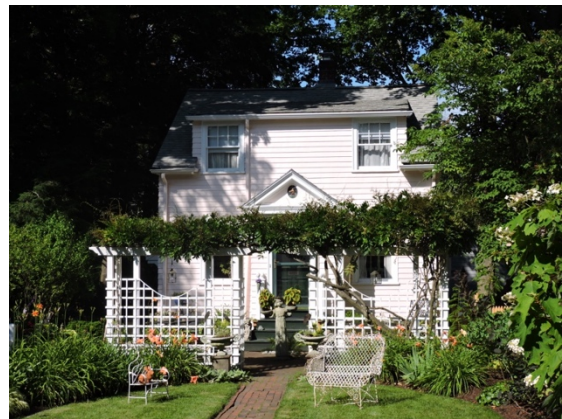
A tall wood trellis has been installed to enhance the character of the front yard of this historic home. This is probably a non-historic condition and is unorthodox. However, it adds to the charm of the residence; seems appropriate to the character of the neighborhood due to its design; and seems appropriate to the character of the property due to the degree of setback, quality of the landscaping, and the simplicity of the house.

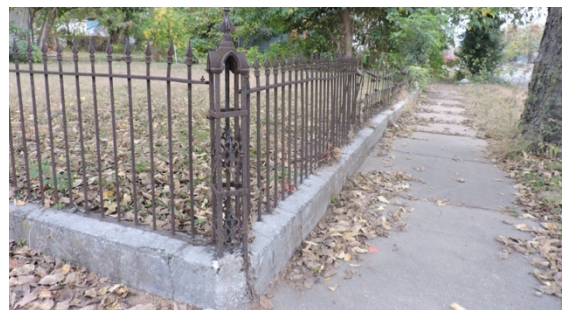
Low cast iron fencing was common in residential neighborhoods during the late nineteenth century. Where such fencing still exists, it should be retained, even if only as remnants.

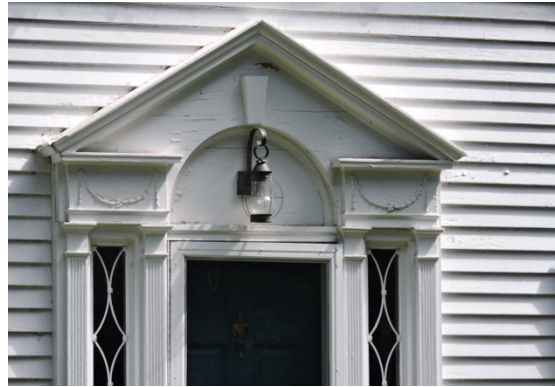
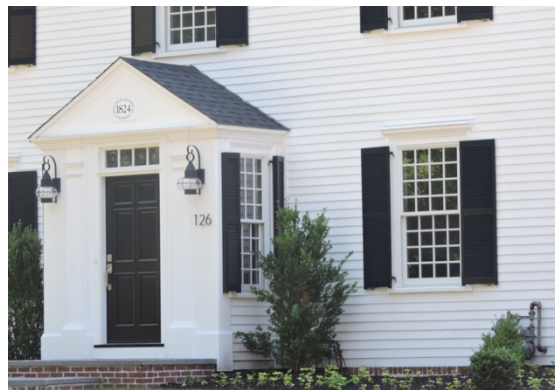
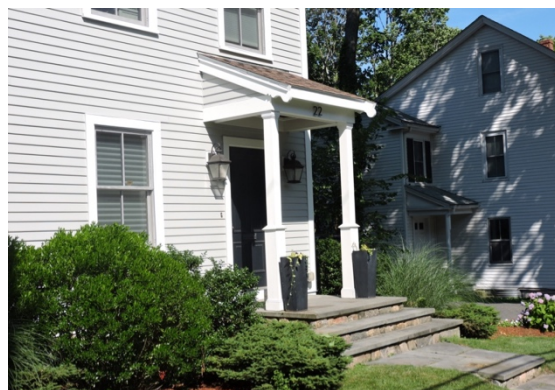
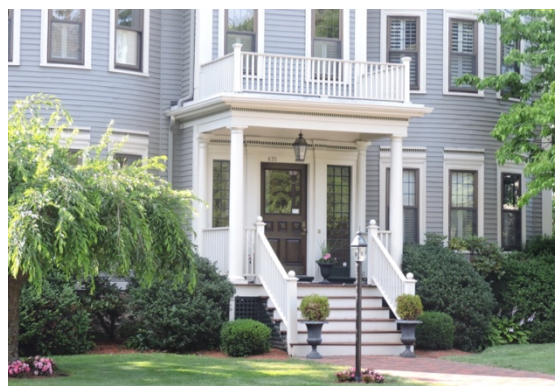
Metal lantern style light fixtures at entrances, on porches, and along walkways are common within the Cottage Street Historic District.

- f. **Fixture Style:** Metal lantern style fixtures mounted on poles or on buildings are a common form of exterior lighting within historic neighborhoods. Where lighting sources are visible, they should be of warm hue and limited strength. Many metal fixtures in use have a black finish.
