TOWN OF WELLESLEY

WELLESLEY DEPARTMENT OF PUBLIC WORKS

Weston & SampsonSM

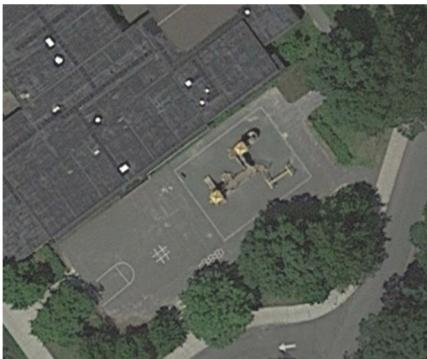
Front playground

- Play equipment is in excellent condition.
- Rubber safety surfacing is in good condition with concrete mow curb containment. Play surfacing is surrounded by asphalt blacktop on all sides.
- Clear site lines are maintained around entire structure.
- Play area is lacking shade and the play structure is in direct sunlight. Trees provide shade over perimeter benches.
- Perimeter fence is in good condition but lacks gates and this creates a safety concern due to proximity of Elmwood Road.

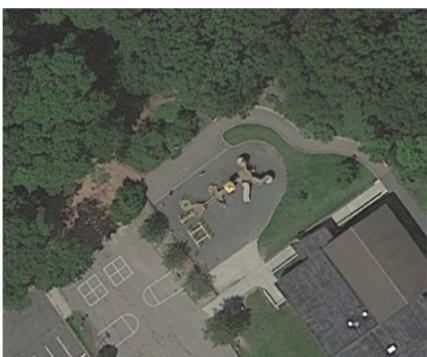
Back playground

- Play equipment is in good condition.
- Rubber safety surfacing is in poor to failing condition due to settlement. Due to rubber safety surfacing settlement, the playground is not considered ADA compliant.
- Swings and climbing wall are set in wood fiber mulch area and are in poor condition.
- The natural play area containing wood logs and boulders adds play value.
- Pathway leading to playground from main school entrance and parking lot is not ADA compliant.

The multi-functional structure and rubber safety surfacing were replaced in the summer of 2019 during this master planning process. Once demolition was complete, the play area was regraded to assure the new surfacing will remain ADA compliant. A new multi-functional structure was installed along with new rubber safety surfacing.

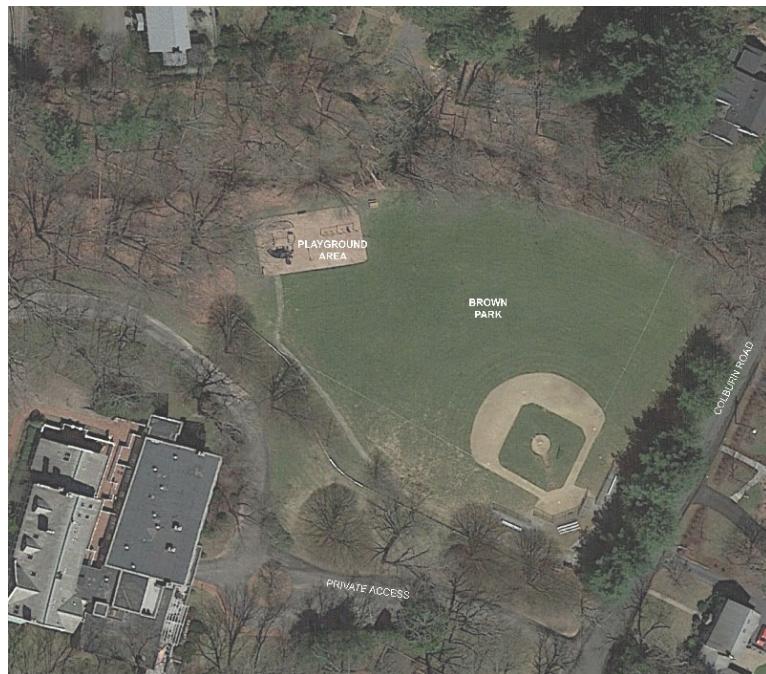
- 5-12 targeted age group
- One (1) multi-function structure
- Wood fiber mulch
- Two (2) independent play elements
- Two (2) swing bays
- Installed in 2008

The long-term major capital project for Brown Park includes replacement of play equipment and the replacement of wood fiber mulch surfacing with poured-in-place rubber surfacing. It is recommended that this renovation occurs in 2032 and is estimated to cost \$334,000 including the 5% annual inflation rate. Another item to consider during this renovation (but has not been included in the estimate) is the relocation of the playground from the baseball outfield to a safer area within the park. Refer to *Appendix E* for recommended play equipment replacement and associated cost break-down.

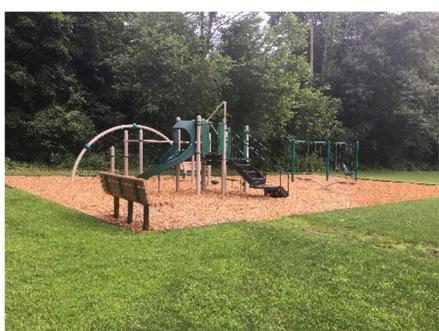
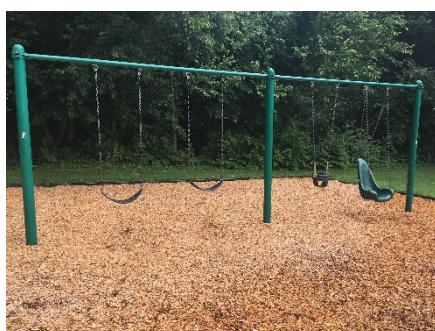
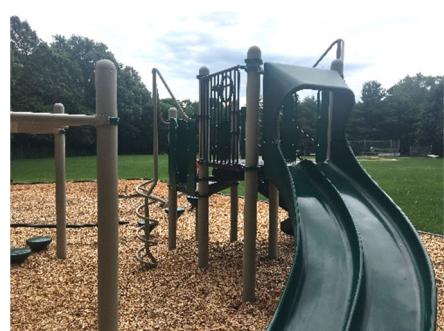
- The playground at Brown Park appears to be rarely used.
- The park is not easily accessible. There is informal on-street parking for approximately nine cars. There are no pathways.
- The play equipment and wood fiber mulch surfacing are in good condition.
- There are two benches and a table. All amenities are in good condition, but they are not located along an accessible route.
- The playground is in the baseball outfield. This location is not ideal and presents a dangerous situation when the field is in use.

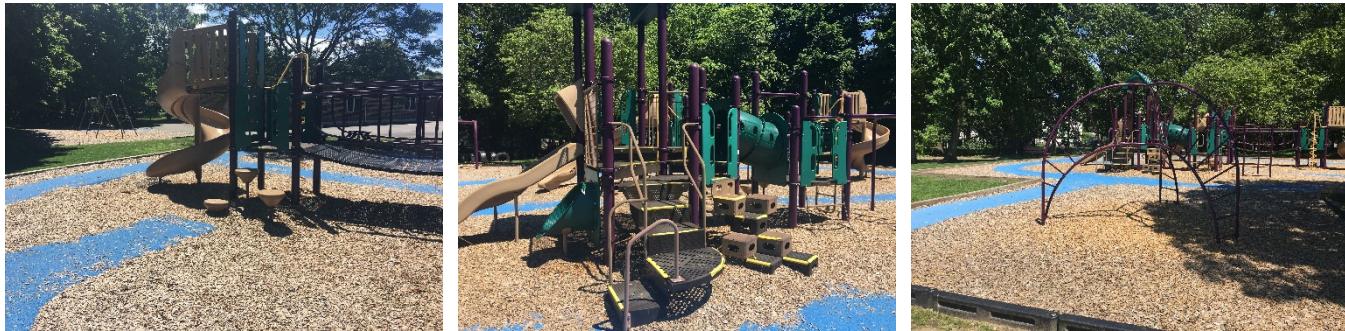
- Playground equipment is in good condition yet starting to show its age in high use areas.
- Rubber safety surfacing pathways are intended to provide accessible routes of travel to most elements yet are installed at incorrect grades.
- Wood fiber mulch is at appropriate levels and contained by plastic curbing.
- Play equipment sits in direct sunlight.

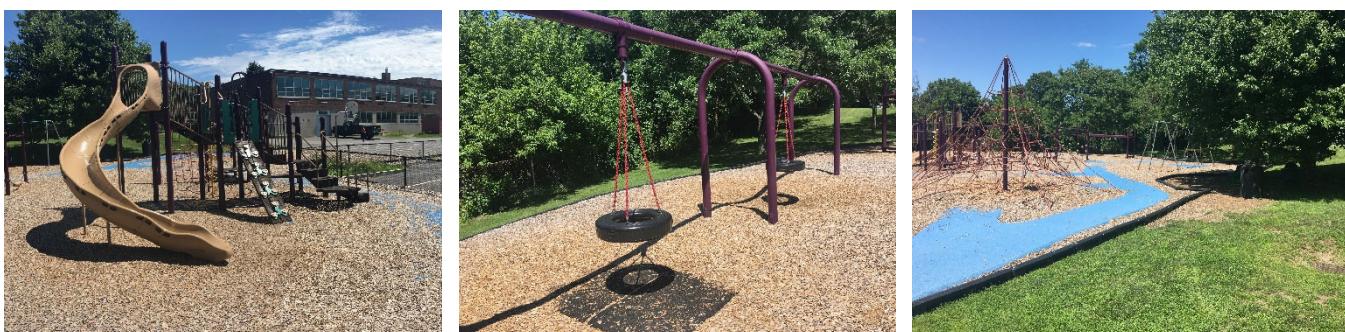
Left Playground

- Playground equipment is in fair condition, some paint has chipped, showing wear and tear.
- Rubber safety surfacing pathways are intended to provide accessible routes of travel to most elements yet are installed at incorrect grades.
- Wood fiber mulch is at appropriate levels and contained by plastic curbing.
- Benches and picnic tables are in good condition but not accessible.
- Fencing between properties is rusted with vines growing through, poor condition.
- Playground equipment is in direct sunlight.

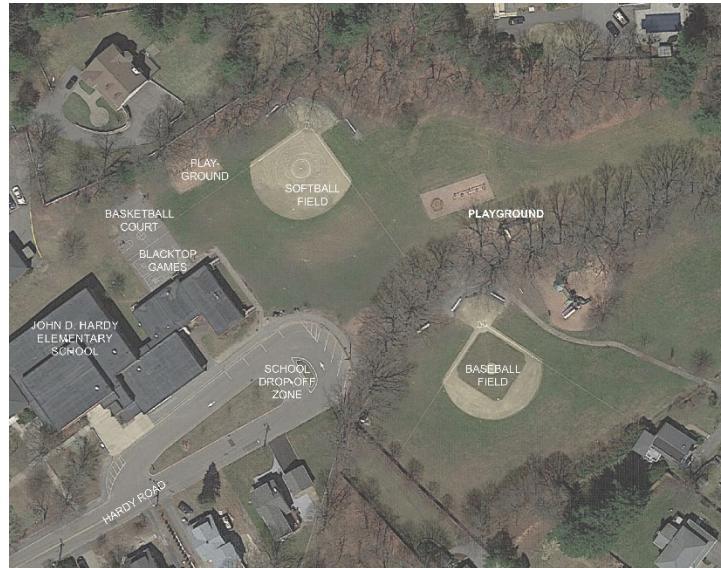
- 2-12 targeted age group
- Two (2) multi-function structures
- Nine (9) swing bays
- One (1) climbing element
- Wood fiber mulch surfacing
- Installed in 2000, 1995

- Play areas are dispersed across the field.
- All playspace areas are set within wood fiber mulch with plastic curbing.
- Apart from one swing set area, play areas are not connected by accessible paths.
- The playground equipment is almost 20 years old and is in good to fair condition but starting to show its age in high use areas.
- The 5-12 age structure is adjacent to the baseball field's left foul line, with no fencing or barrier as a protection measure.
- Accessible pathway connecting Hardy Road, to Lawrence and Hickory neighborhood roads via school playground and fields is in poor to failing condition.
- Large trees along pathway leading to play space with some branches encroaching into play structures safety zones.

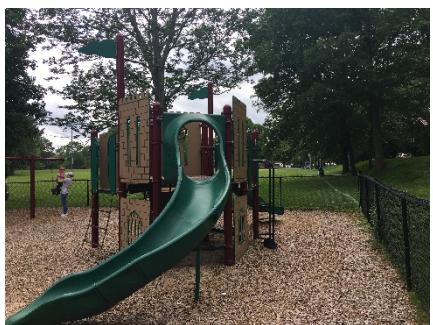
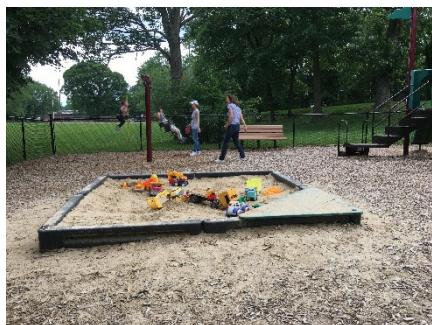
- Equipment is in good condition.
- Surfacing is wood fiber mulch.
- Sand from sandbox has migrated to other areas in the playspace.
- Pathway leading from parking lot to playspace is accessible however the sidewalk leading to the playspace is not ADA compliant and requires regrading.
- The seating is under shaded trees, but the playground equipment is fully exposed.

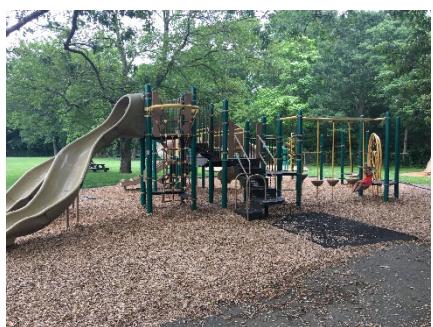
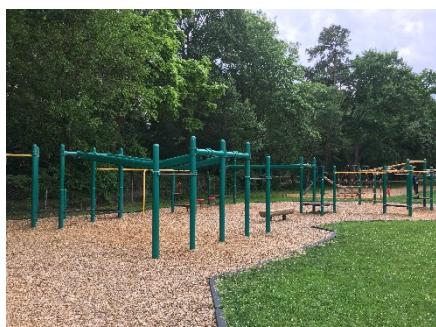
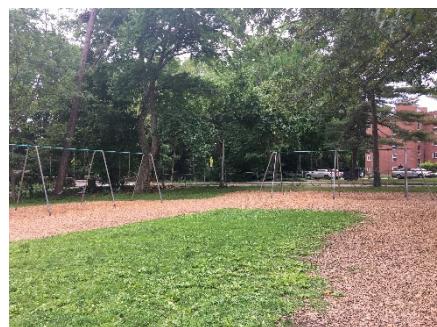
- Play equipment is showing age, with some repairs having been carried out to ropes.
- Wood fiber mulch has migrated in play areas has migrated in high use zones and from lack of plastic curbing on all sides, rendering the play areas not accessible
- Swings are in fair condition.
- All other structures are set in wood fiber mulch.
- Accessible pathways extend from main school parking lot, main entrance, and accessible side entrance towards play spaces. Bituminous path surfacing is in fair condition with cracks and divots present. Pathway condition has affected accessibility and transition to safety surfacing.
- Brook Path along Fuller Brook is behind the school fence.

- Consolidate space to provide one large play area with defined 2-5 and 5-12 play areas in lieu of separate play spaces
- Installation of equipment that support gross and fine motor skill development
- Provide shade on at least 25% of the playground using shade structures/sails or selective tree placements along the borders.

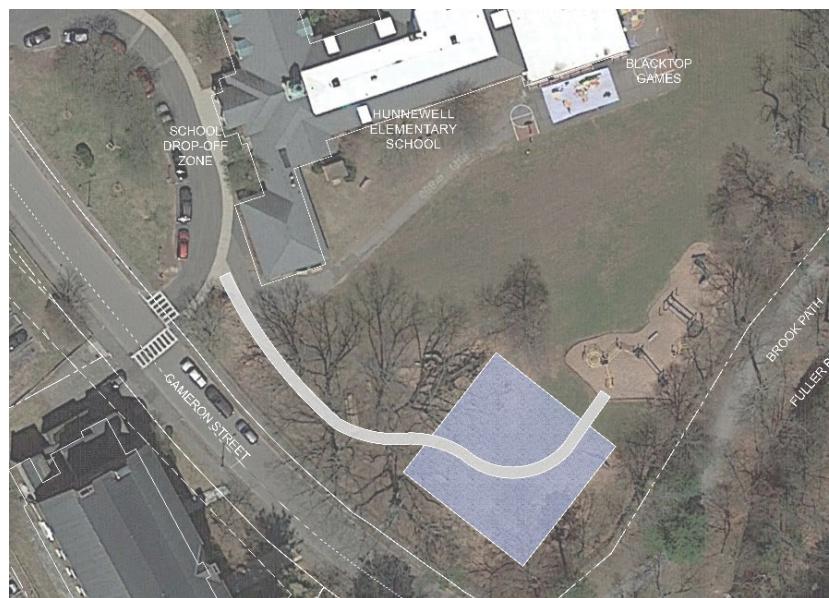
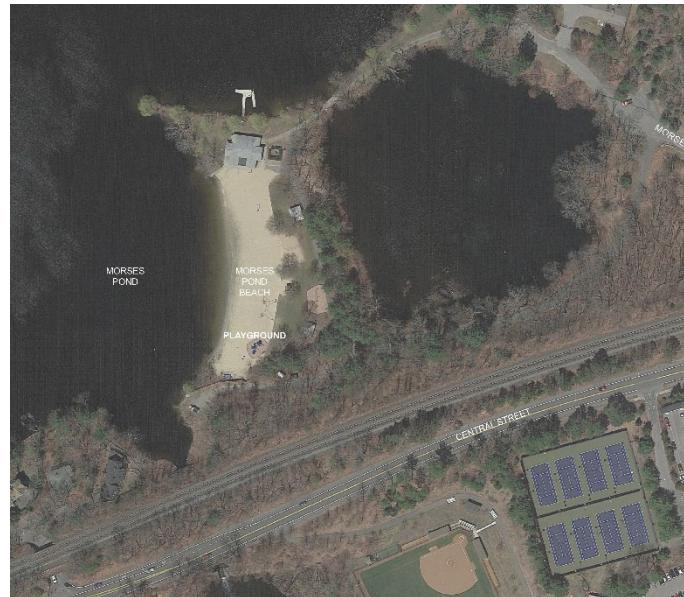
MORSES POND - EXISTING

- 2-12 targeted age group
- One (1) multi-function structure
- Three (3) swing bays
- Wood fiber mulch surfacing
- Installed in 2002

- High profile and well used site, in need of an improved playground
- The playspace is surrounded by beach sand and set in wood fiber mulch contained by with plastic curbs that restrict accessibility.
- Structure is in fair condition - slightly weathered but structurally sound. Plastic curbs at wood fiber mulch perimeter is a tripping hazard.
- Swing area is set in wood fiber mulch with an accessible asphalt pathway leading to it.
- Apart from swings, all other play elements are not ADA accessible.
- No ADA compliant parking - beach ADA drop-off zone accessible via service access road.
- Accessible pathway leading to beach from main parking lot through a land bridge.
- Benches and tables are not located along an accessible route.

- Install a 2-12 play structure and climbers that support gross and fine motor skill development adjacent to swing location
- Plant trees around relocated playground

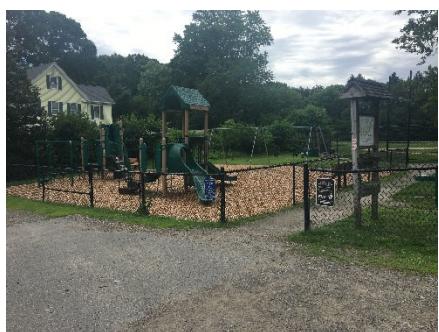
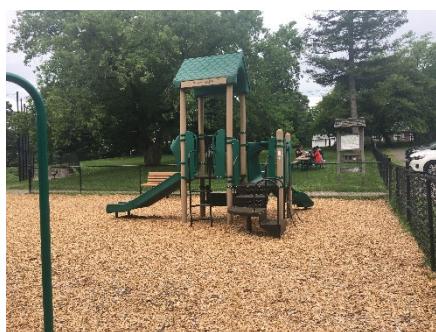
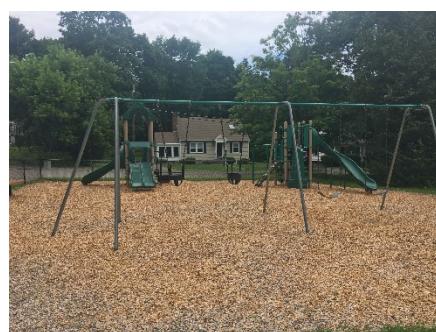
- Play structures are in good condition, swings are in fair condition.
- Wood fiber mulch is at appropriate levels, but edges are uneven, affecting accessibility to playground.
- ADA parking spot leads to stone dust pathway in fair condition. Stone dust pathway's transition to wood fiber mulch playground surfacing is worn and not flush with surrounding grades.
- Parking lot and access road are stone dust/bituminous concrete in fair to poor condition and in need of repair.
- Shrub plantings help create a visual buffer to neighboring properties.
- Benches and picnic tables are not along accessible routes of travel.

The long-term major capital project for Ouellet Park includes replacement of the play equipment and replacement of wood fiber mulch surfacing with poured-in-place rubber surfacing. It is recommended that this renovation occurs in 2031 and is estimated to cost \$363,088 including the 5% annual inflation rate. Refer to *Appendix E* for recommended play equipment replacement and associated cost break-down.

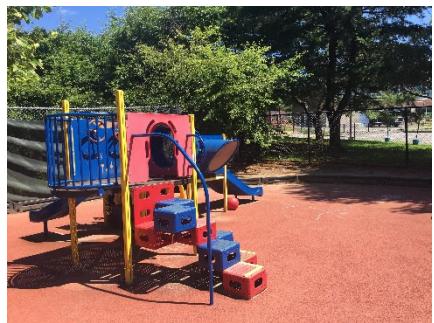
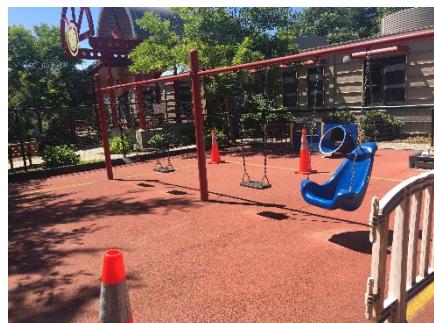
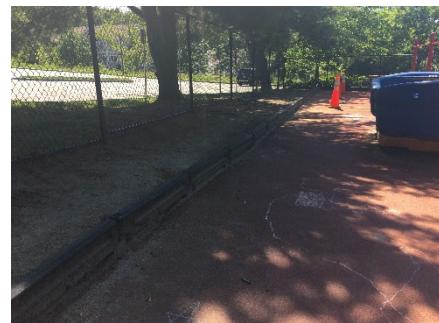
- Playground equipment is in fair condition.
- Rubber safety surfacing is uneven, with bulging mounds/air bubbles, creating tripping hazards.
- Rubber safety surfacing is contained by plastic curbs, which are not permanent and easily bend contributing to the poor condition of the surfacing.
- The strip of dirt between the fence and the rubber is riddled with large tree roots, creating an even larger risk of tripping.
- No shade within the play area and no seating.
- Routes to playground and within playground are fully accessible.
- Facility is restricted to public use: "P.A.W.S. Use Only - 8:00AM - 4:00PM Weekdays"
- Play area is small for the given number of intended users.

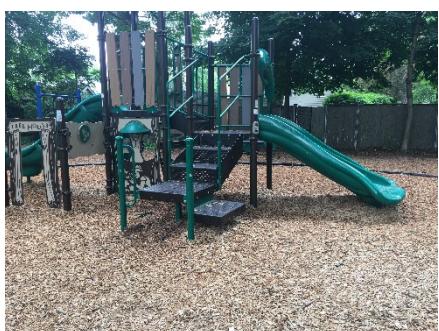
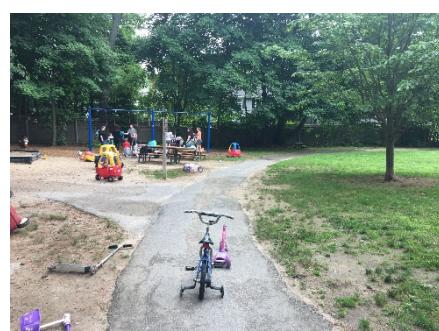
- Well used playground
- Landscape Structures elements are aging and showing rust. Multiple pieces of equipment are 20+ years old.
- Playworld equipment is newer and in good condition.
- Wood fiber mulch is in fair condition yet migrating onto lawn and walk areas due to lack of edging.
- Sand box sand migrating into play areas.
- Tree branches/trunks are close to playground equipment and within safety zones.
- Pathway connects soccer fields, basketball, parking lot and playground. Pathway adjacent to play areas have accessibility issues regarding slope and transition to safety surfacing.
- Parking is positioned around a cul-de-sac at Thomas Road.

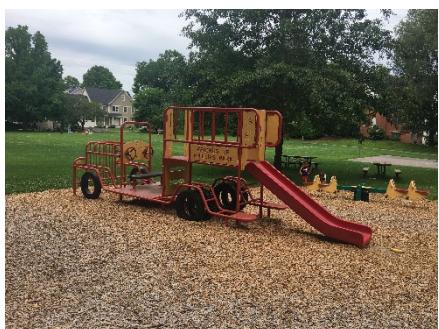
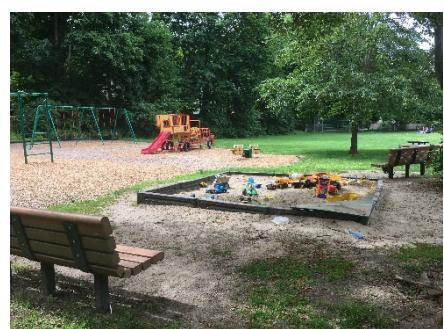
- Playground equipment is in good condition
- Playground set in wood fiber mulch with worn gravel pathway leading to it.
- Sand has migrated out of sandbox - many miscellaneous toys in sandbox.
- Parking lot is for residents only and on-street parking is metered.
- Benches and picnic tables are not accessible due to lack of appropriate pathway surfacing material.
- Brook Path connecting Phillips Park to Washington Street, Maugus Avenue and Seaward Road.
- Large trees surrounding the playground, with two located in close proximity to the sand box providing shade to that area.
- Large area of playground is in direct sun.

The long-term major capital project for Phillips Park includes replacement of the play equipment and replacement of wood fiber mulch surfacing with poured-in-place rubber surfacing. It is recommended that this renovation occurs in 2030 and is estimated to cost \$386,250 including the 5% annual inflation rate. Another item to consider during this renovation (but has not been included in the estimate) is the renovation of the existing Brook Path surfacing. Refer to *Appendix E* for recommended play equipment replacement and associated cost break-down.

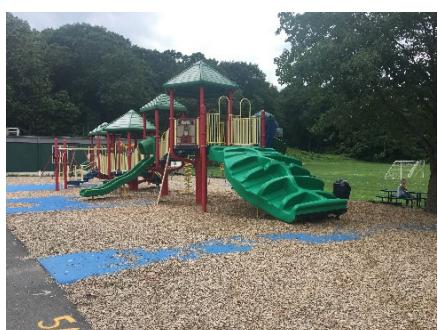
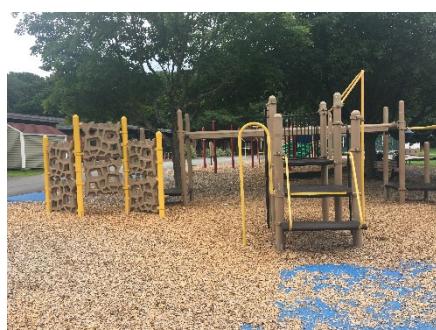
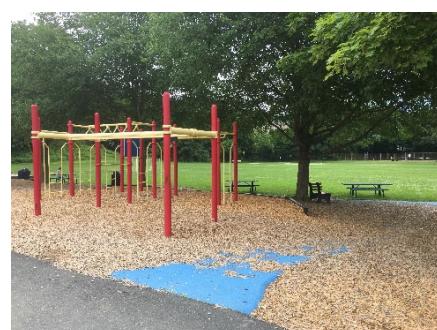
- Wood fiber mulch is at appropriate levels but migrating onto the field area due to lack of edging. The rubber safety surfacing pathways were installed at incorrect grades affecting accessibility.
- Equipment is in fair condition although it is starting to show its age with chipped paint and worn decks that still appear structurally sound.
- Accessible pathway connect the parking lot and school drop-off zone to accessible rubber safety surfacing at playground.
- Trees provide shade to structures.

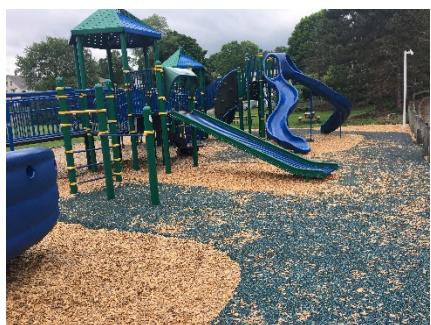
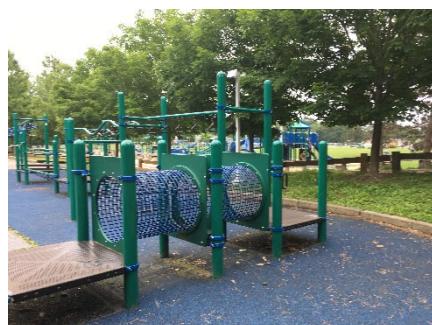
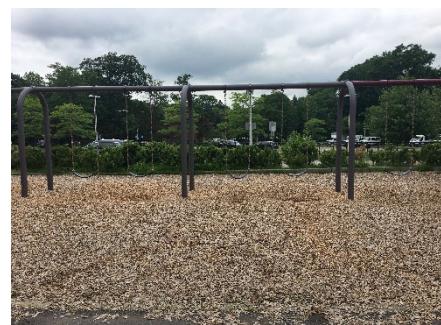
- Playground equipment located closest to the fields is in good condition. Play equipment and surfacing at the courtyard playground are in fair condition.
- The set of swings by the school building are in poor condition with chipped paint and rusted swing chains.
- Surfacing is a combination of wood fiber mulch with rubber safety surfacing connecting to accessible play structure elements.
- The rubber safety surfacing at pathways (field playground) was installed at incorrect grades affecting accessibility.
- Shrubs, trees, and fencing screen play spaces from the adjacent parking lot.

- Plant trees on field side of playground to reduce sun exposure.
- Relocate existing amenities to accessible routes of travel.
- Complete swing replacement and surfacing repairs

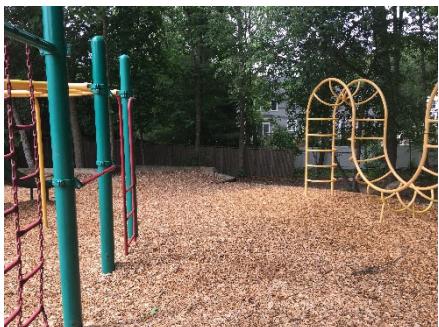
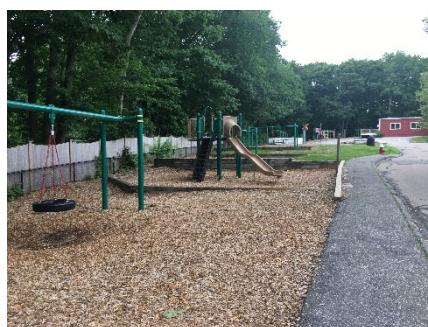
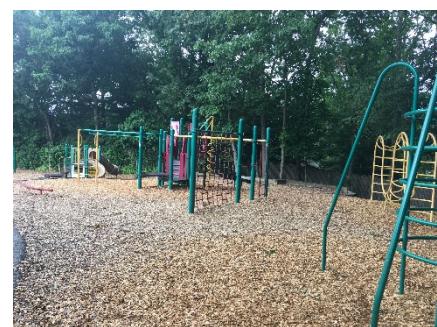
- High profile and well used site, in need of an improved playground
- Play equipment is in fair to poor condition and is approximately 20 years old.
- Surfacing is wood fiber mulch.
- Considerable grade change along site causing there to be no accessible travel route to or within the playground. The play equipment is positioned in a narrow-terraced area along school entrance roadway.
- Line of sight is affected by the linear nature of the play areas.
- There is no fence between the play areas and the entrance road. There are also multipole entrance/exit paths connecting to the play areas with no gates for containment.
- Many tree limbs are encroaching on the play equipment safety zones.
- The spectator seating and amenities are not along an accessible route.
- Identified need of play design for children with disabilities

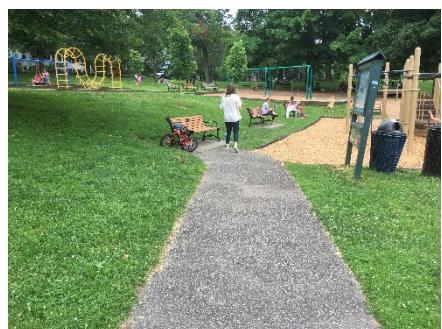
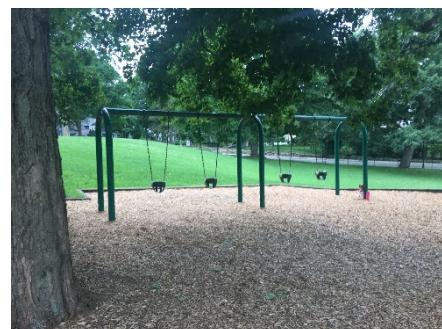
- Multiple play areas scattered across a terraced hill. Playground equipment is in good condition especially for its age.
- Wood fiber mulch has migrated outside the play areas, it is at appropriate levels.
- With the exception of the 5-12 play structure, due to grades and lack of accessible pathways leading to them the play areas are not accessible.
- Large trees and shrubs provide shade to playground and surrounding benches. Some trees are close to encroaching on safety zones of multiple equipment especially the 2-5 structure.
- Pathway leading to playground from parking lot and recreation building is accessible.

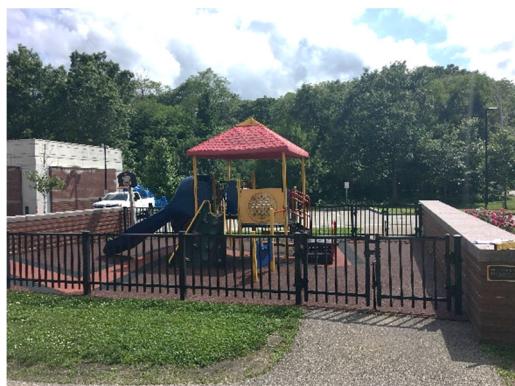
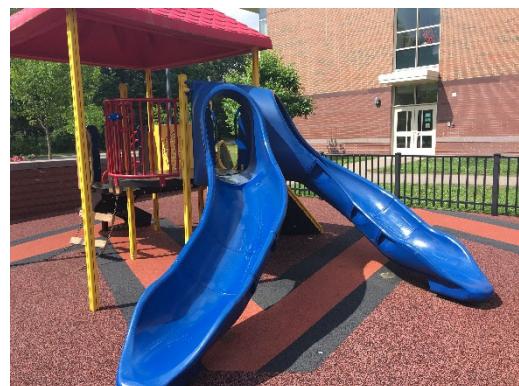
- Very small play structure/ play area in rubber safety surfacing in good to excellent condition.
- Wall/ornamental fence.
- Rubber safety surfacing in good to excellent condition.
- Shade structure over play area in good condition.
- Accessible via pathways from main school entrance and parking lot.
- All pathways leading to the play space area accessible.
- Aside from the shade structure, the remaining play area is in direct sun.

The long-term major capital project for Wellesley High School includes replacement of the play equipment and poured-in-place rubber surfacing. It is recommended that this renovation occurs in 2034 and is estimated to cost \$84,150 including the 5% annual inflation rate. Refer to *Appendix E* for recommended play equipment replacement and associated cost break-down.

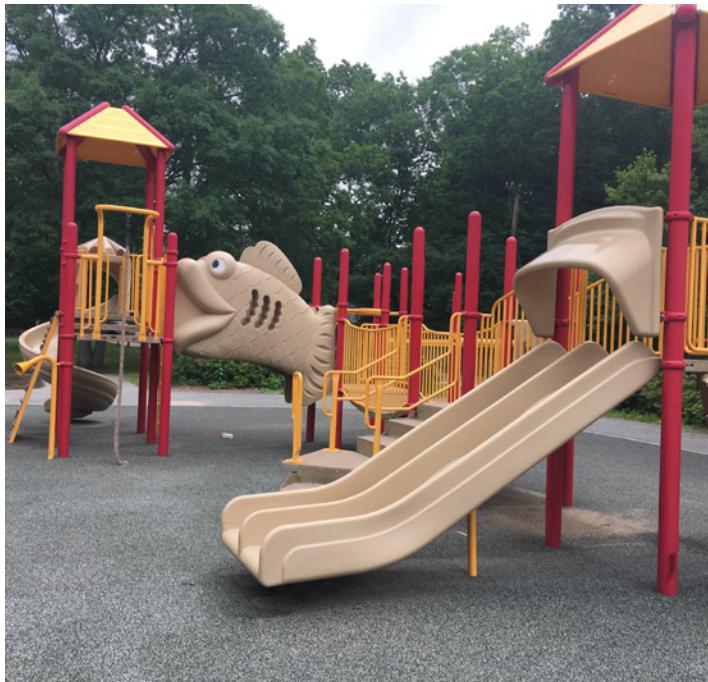
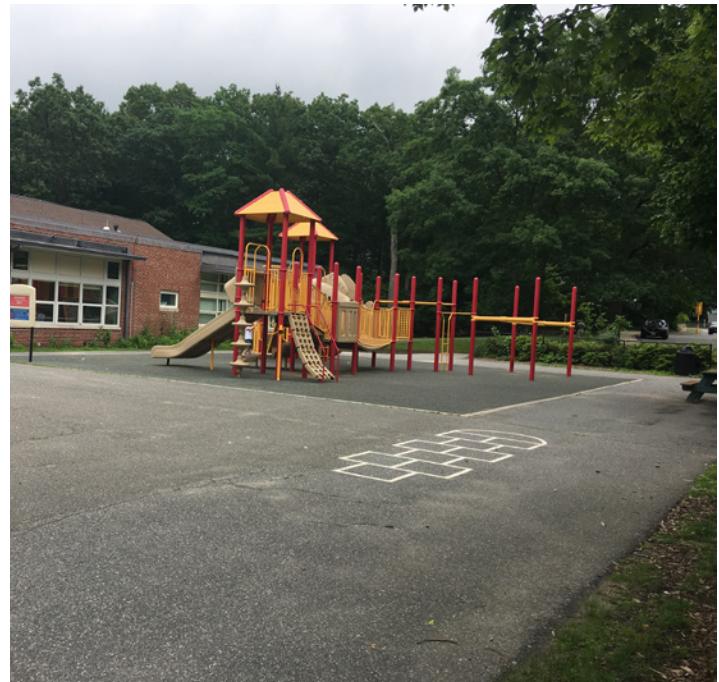
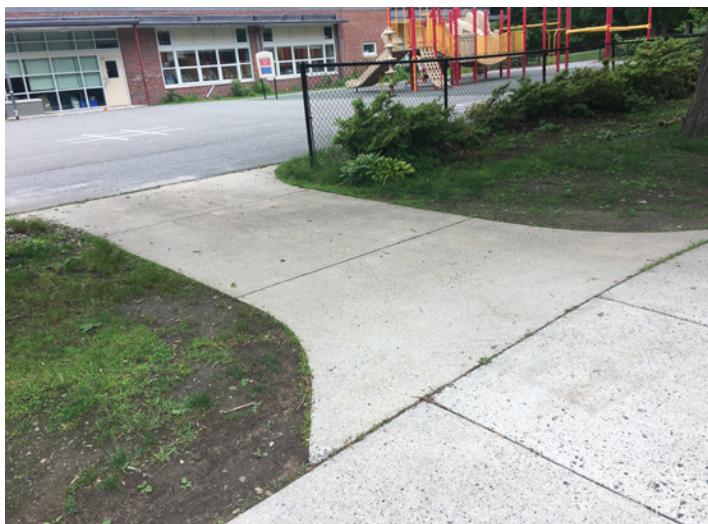
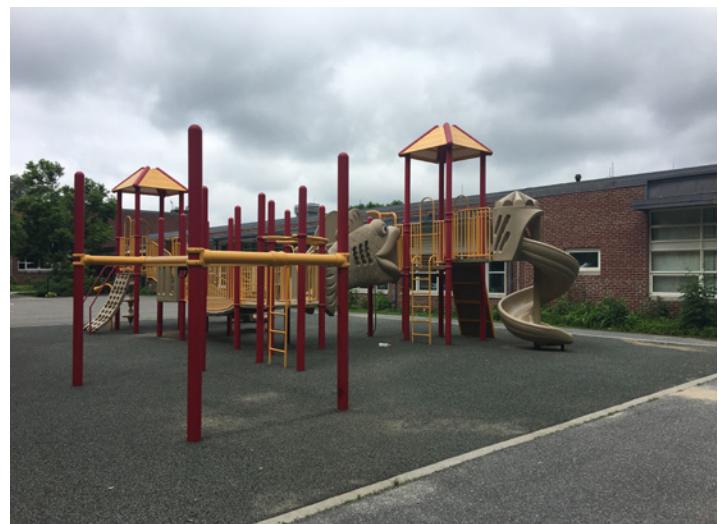
PHOTOS:

Rubber safety surfacing is in good condition, set in blacktop with a concrete mow curb all around.

Open circulation, sits in fenced blacktop area. No gates present, this is a hazard due street proximity.

The shrubs planted on the outside of the fence area growing through the chainlink fence, however, they do not interfere with the play equipment.

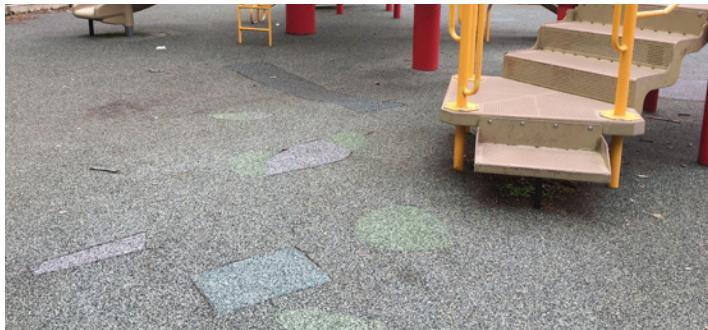
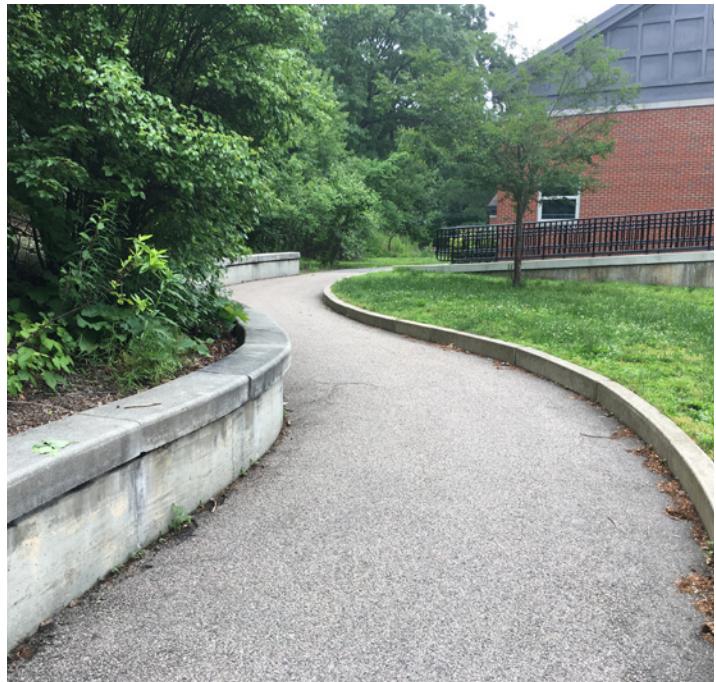
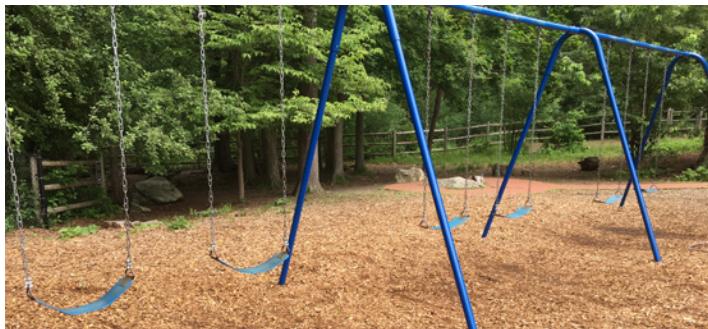
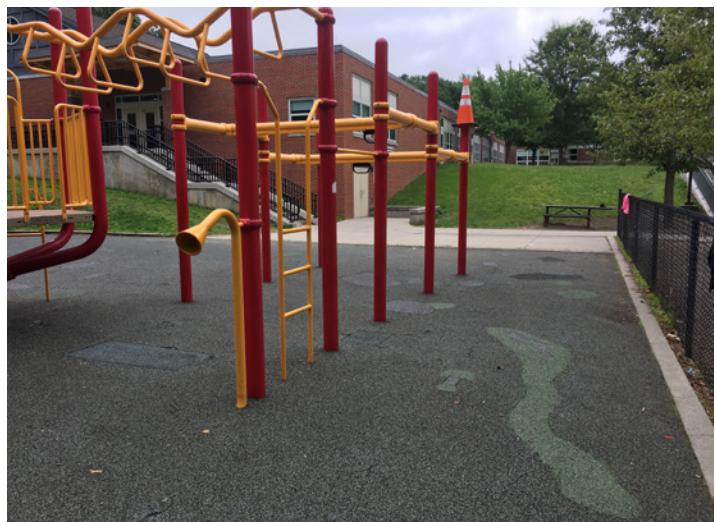
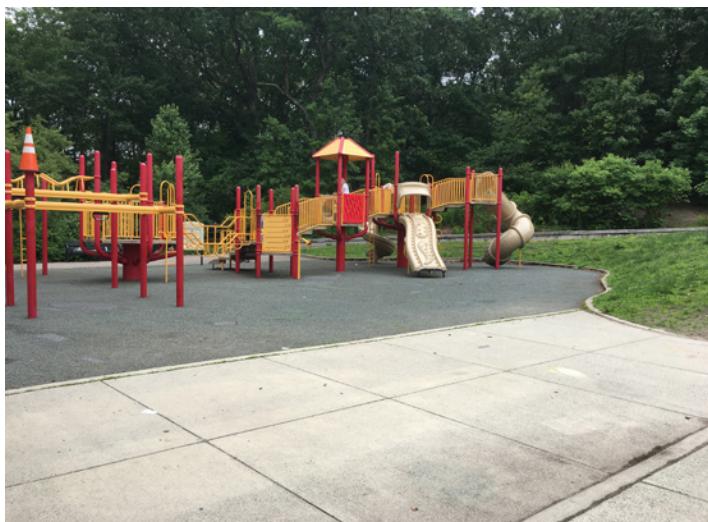
PHOTOS:

Playground in good condition.

Rubber safety surfacing is in poor to failing condition due to soil settling.

Swings and climbing wall are in wood fiber mulch area, of a poor condition.

Natural play area is set among trees and boulders.

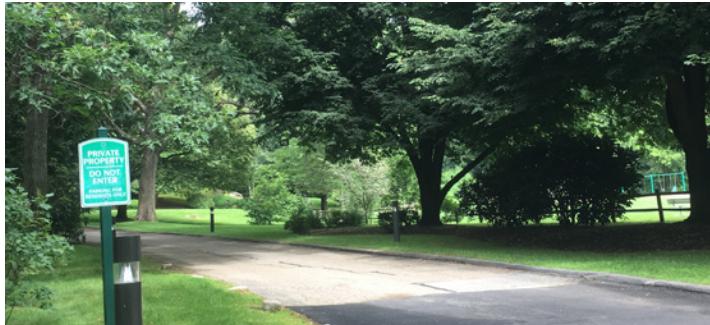
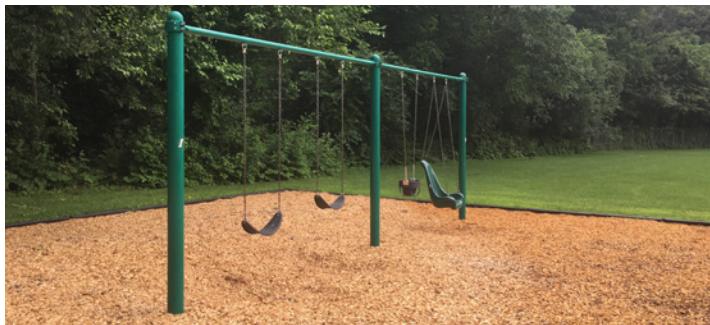
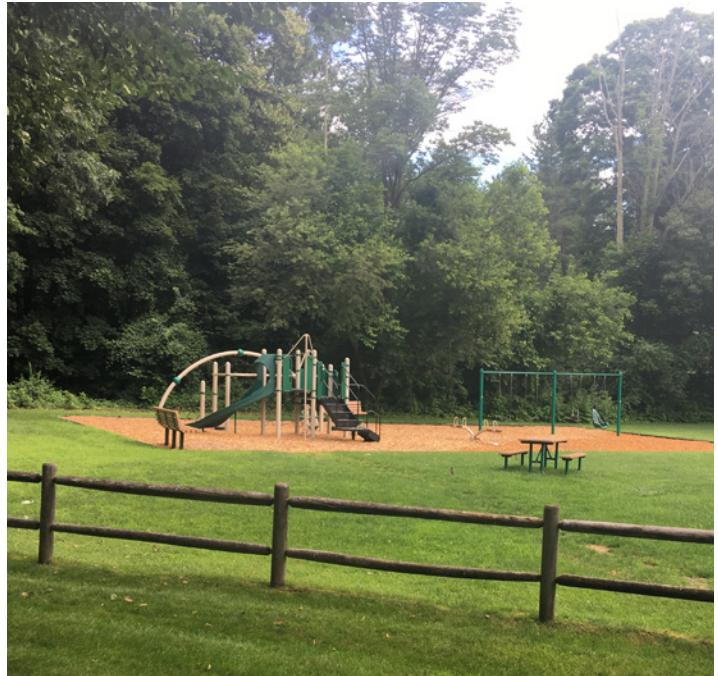
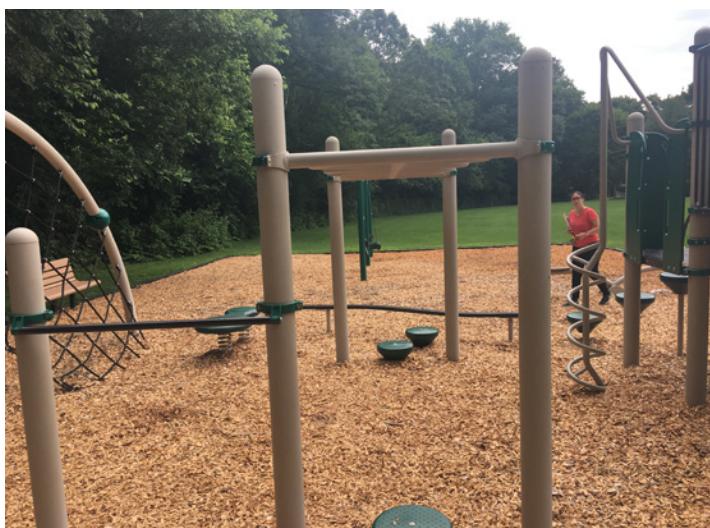
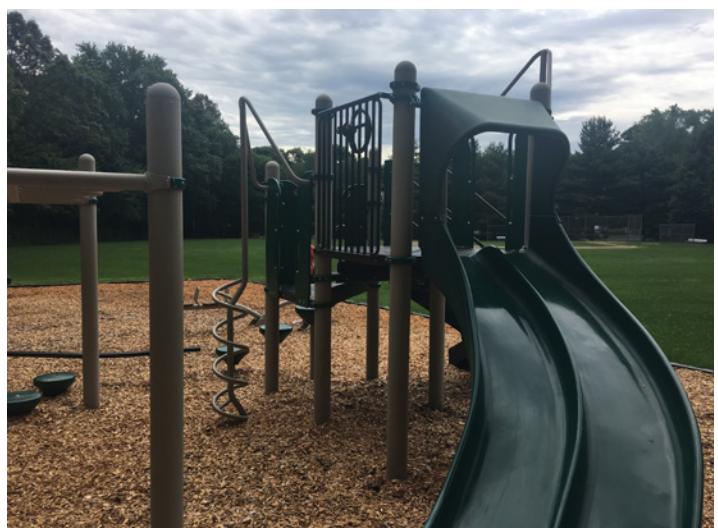
PHOTOS:

Two (2) benches and one (1) picnic table, none are along an accessible route - in good condition.

Play equipment is in good condition, transfer platform present. There is no accessible path to the playground and no clear entrance.

An old stone dust gravel pathway is in poor to failing condition.

Playground is within safe distance of trees.

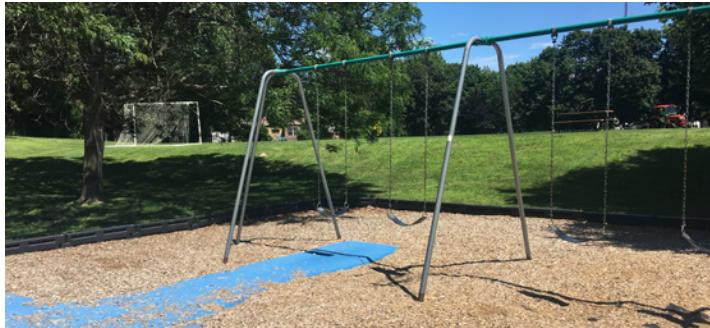
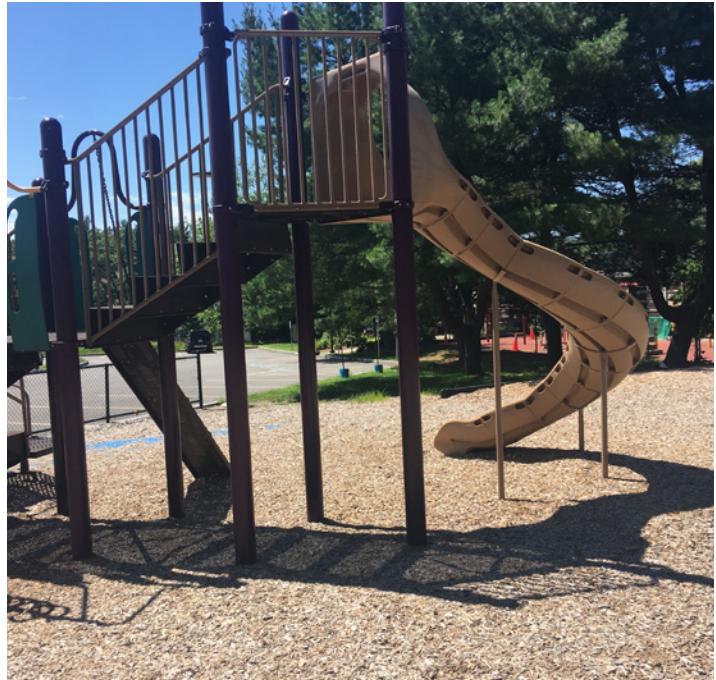
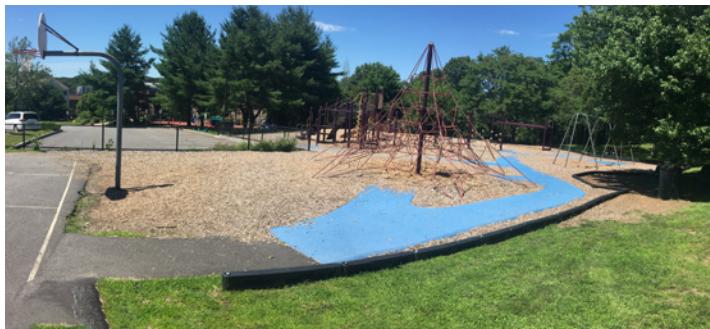
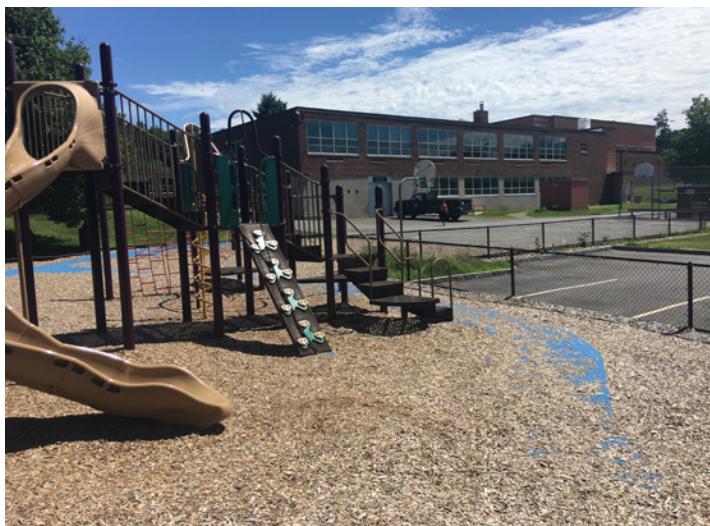
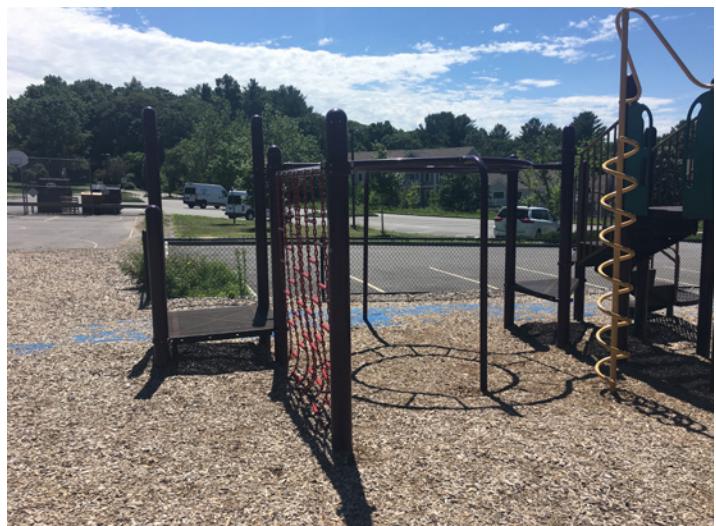
PHOTOS:

Play equipment is in fair condition, some paint has chipped, showing wear and tear.

Benches and picnic tables are in good condition but not accessible.

Fencing between property lines is rusted with vines growing through, poor condition.

Large trees around playground do not provide shade - play equipment is in full sunlight.

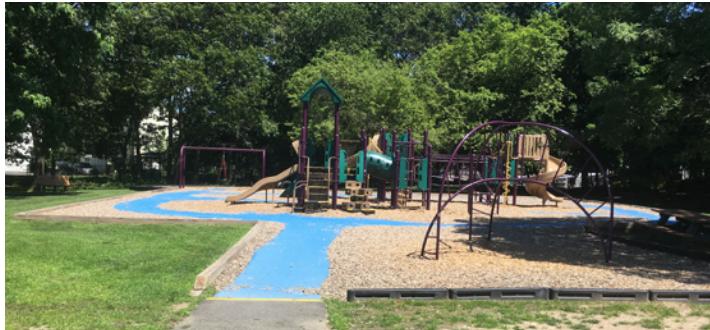
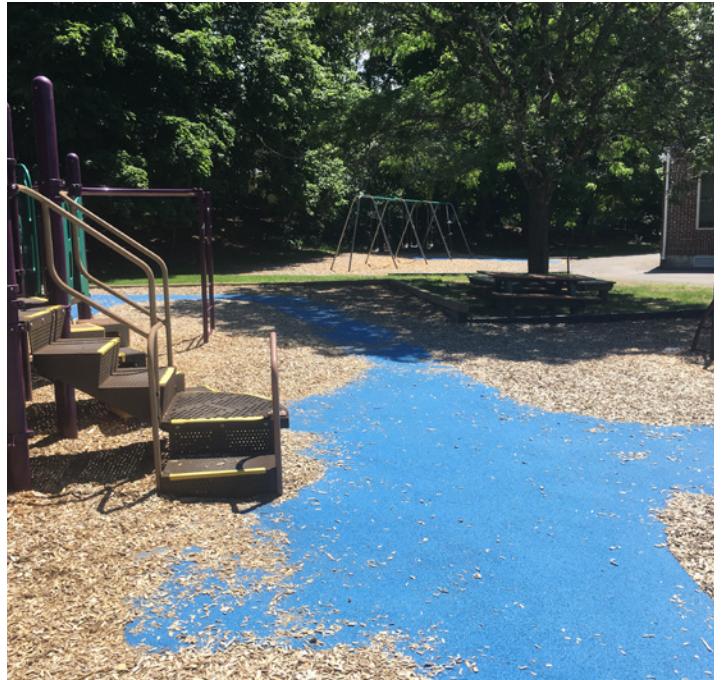
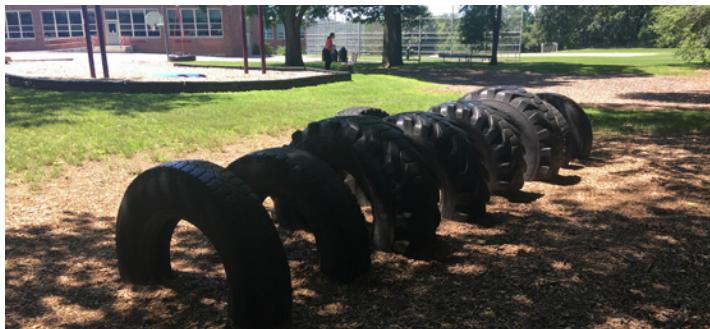
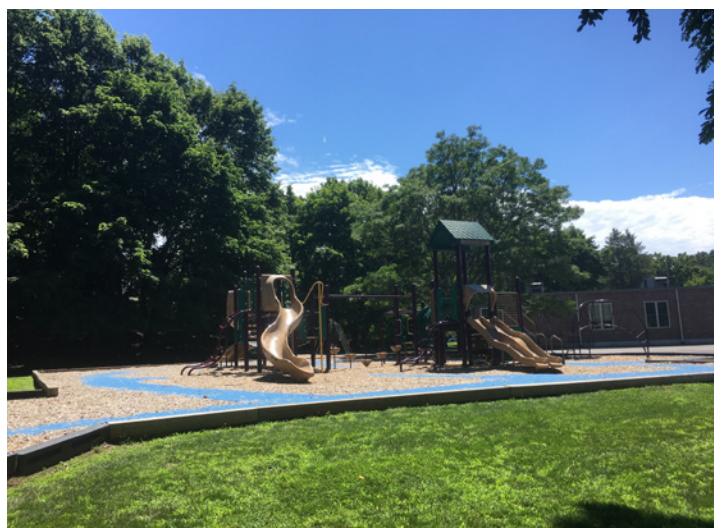
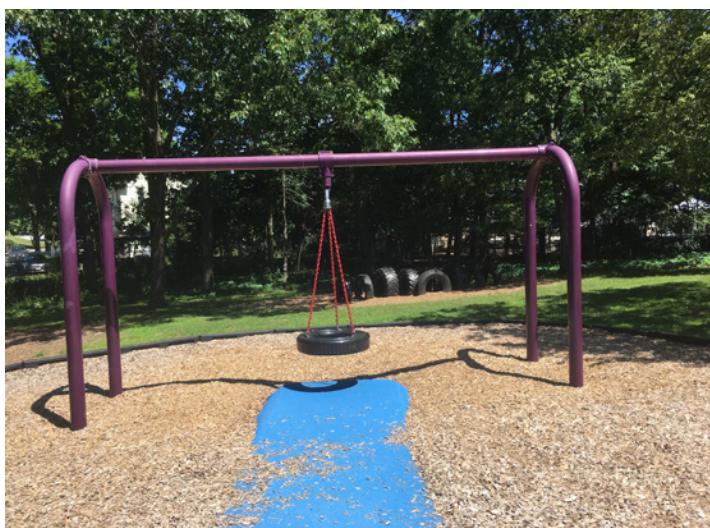
PHOTOS:

One (1) bench on concrete pad - good condition, two

Play equipment is in good condition. There is rubber safety surfacing pathways going to most elements.

Large trees around playground do not provide shade - play equipment is in full sunlight.

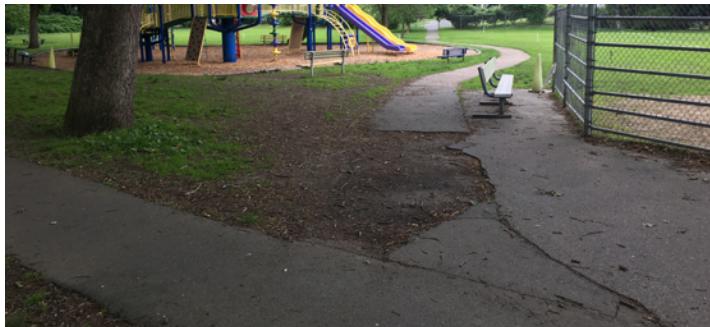
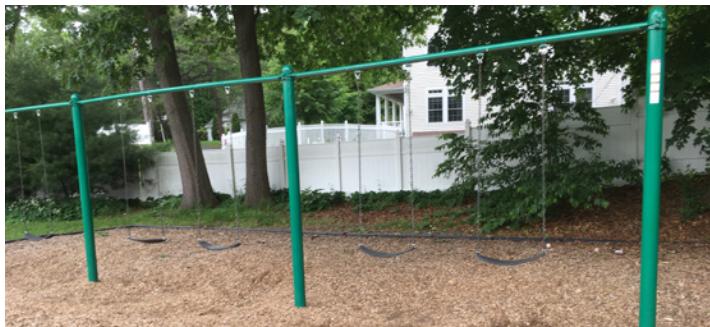
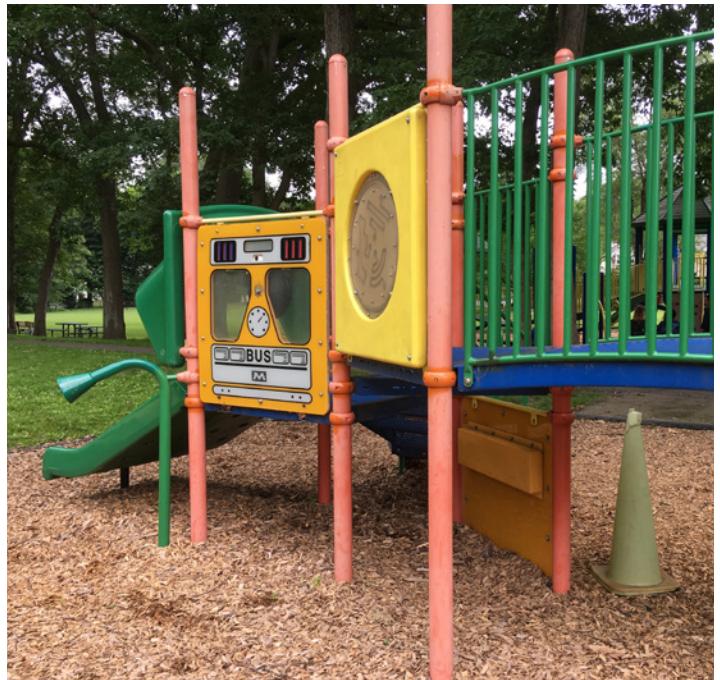
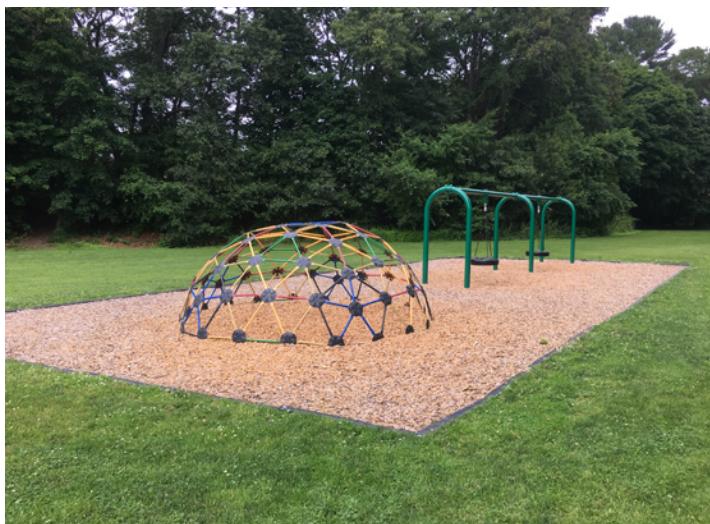
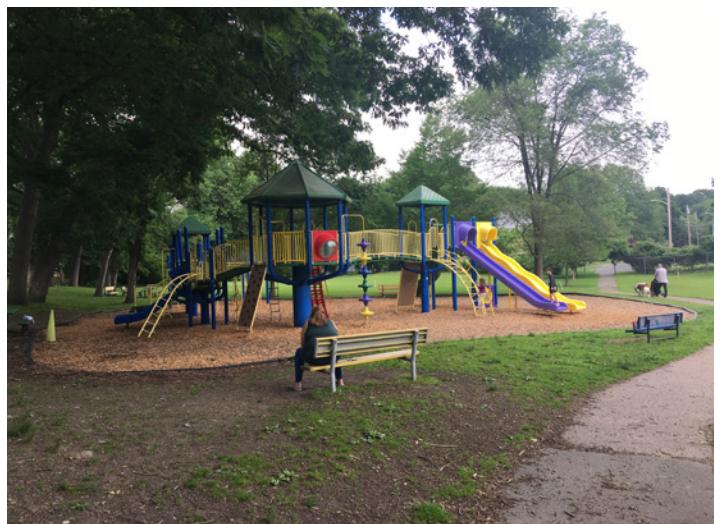
PHOTOS:

Large trees along pathway leading to playspace. Some branches extending towards playstructures safety zones.
