TOWN OF WELLESLEY

WELLESLEY DEPARTMENT OF PUBLIC WORKS

Weston & SampsonSM

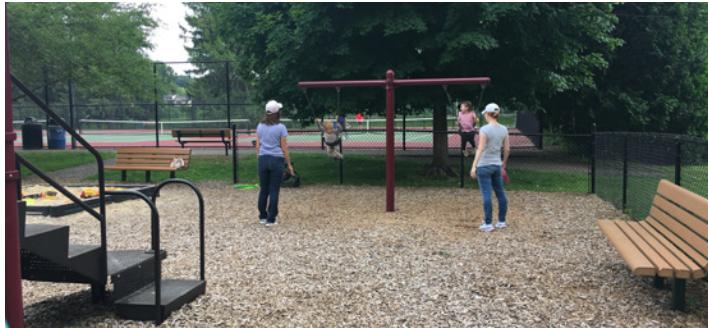
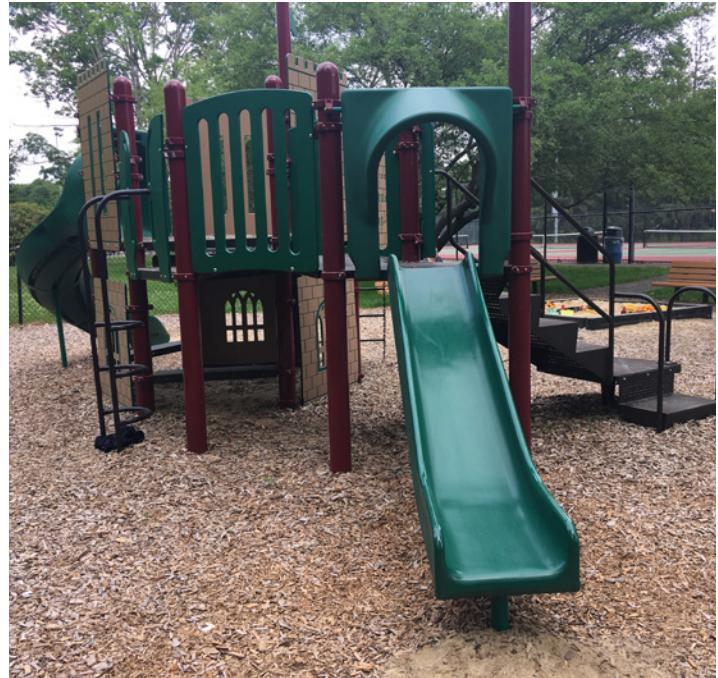
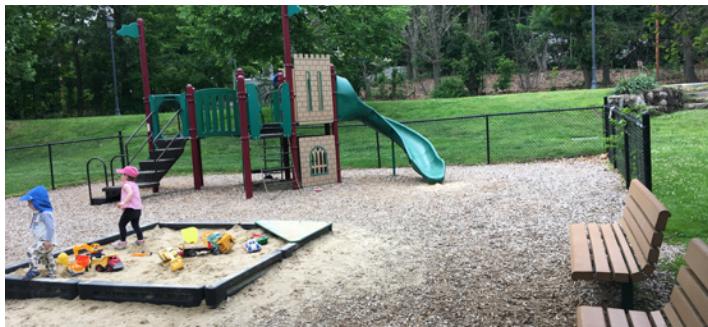
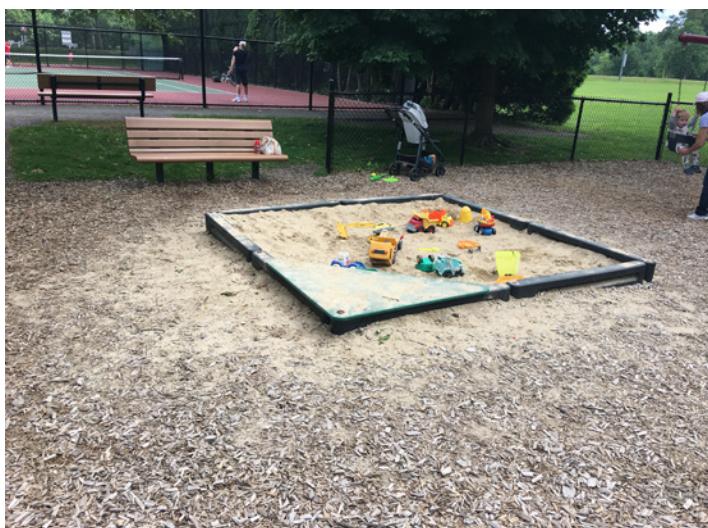
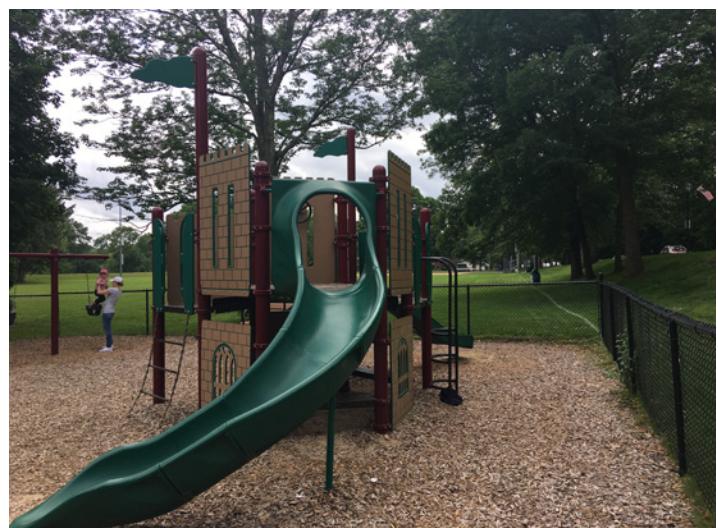
PHOTOS:

Trees within playspace provide some shade for benches. Some trees with over reaching branches.

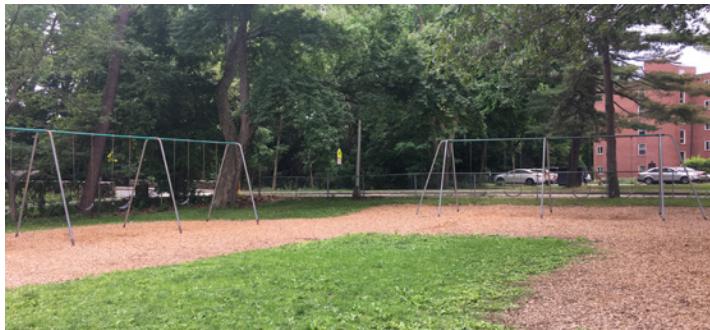
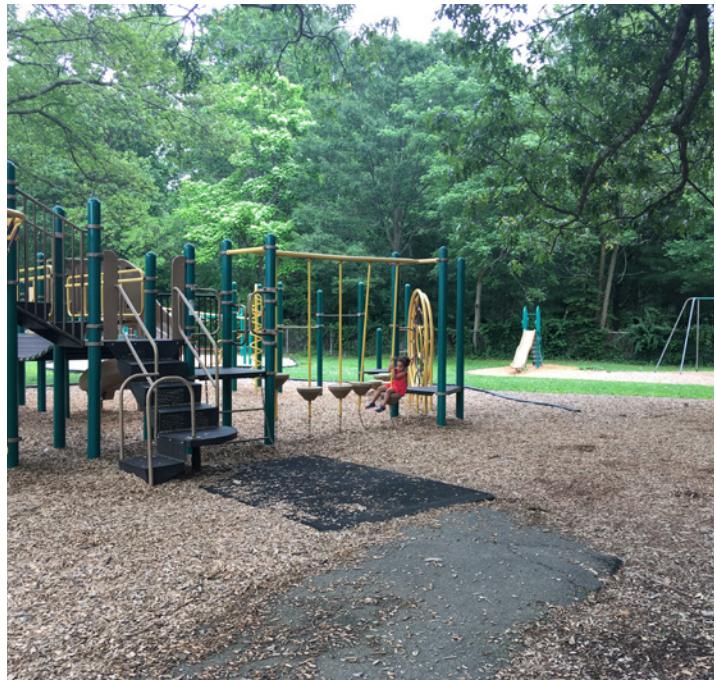
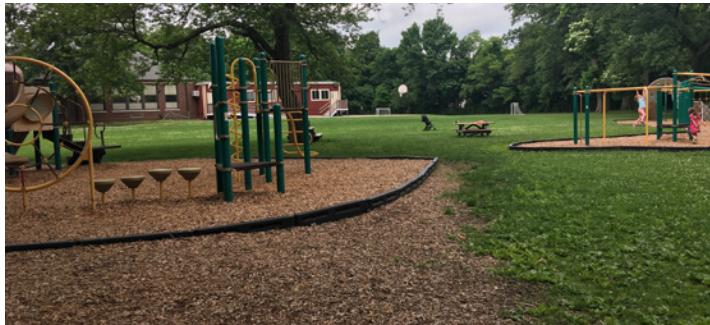
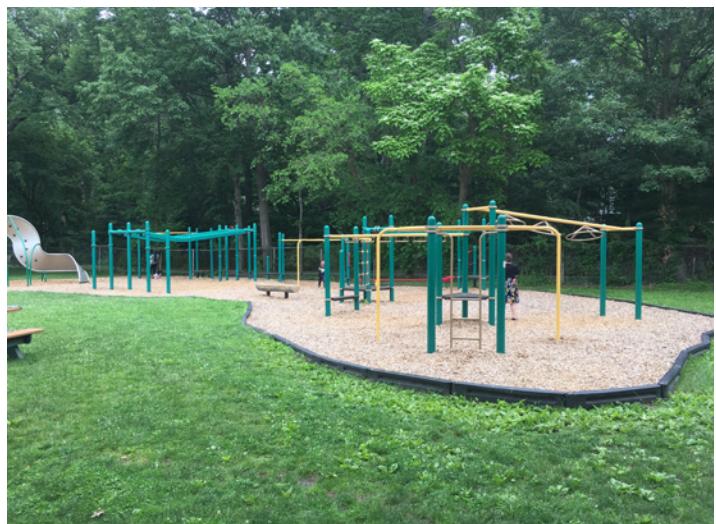
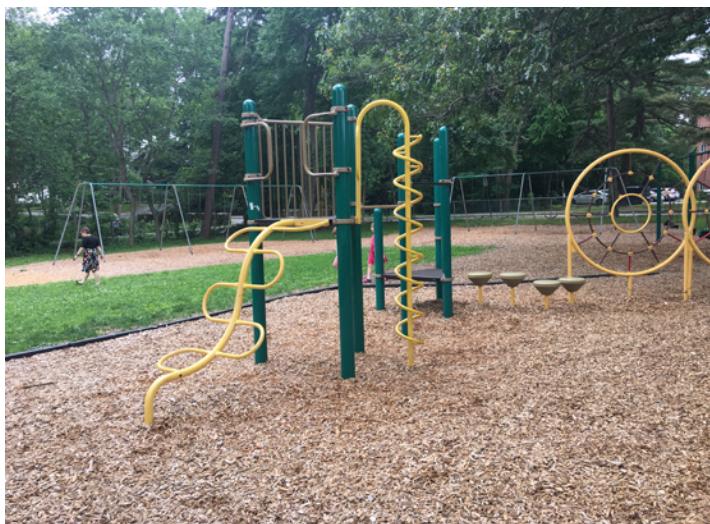
PHOTOS:

Play equipment is showing age, with some repairs having been carried out to ropes.

Swings are in fair condition.

Accessible path from buildings and car park to
5-12 year old main structures transfer platform via
safety rubber surfacing. Some repair is needed to
this surfacing.

Large trees among and around playarea - some branches extending towards playstructure safety zones.

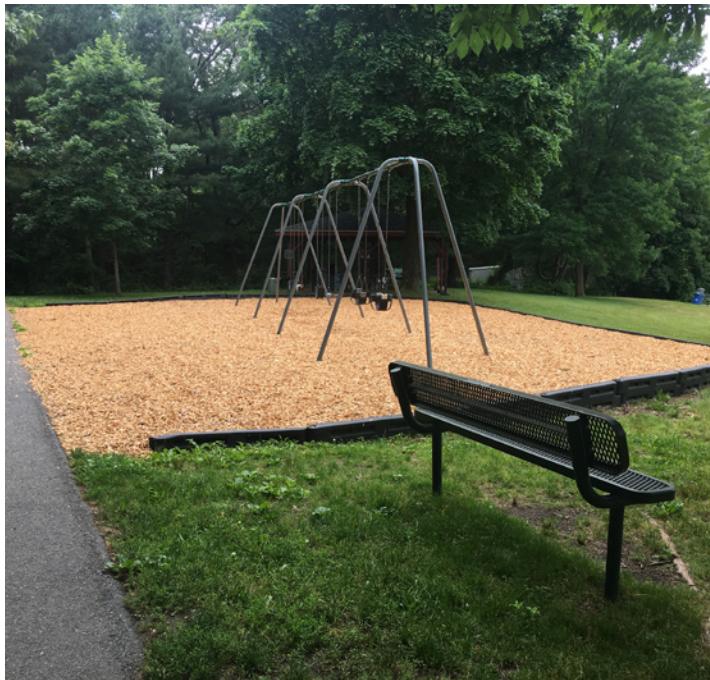
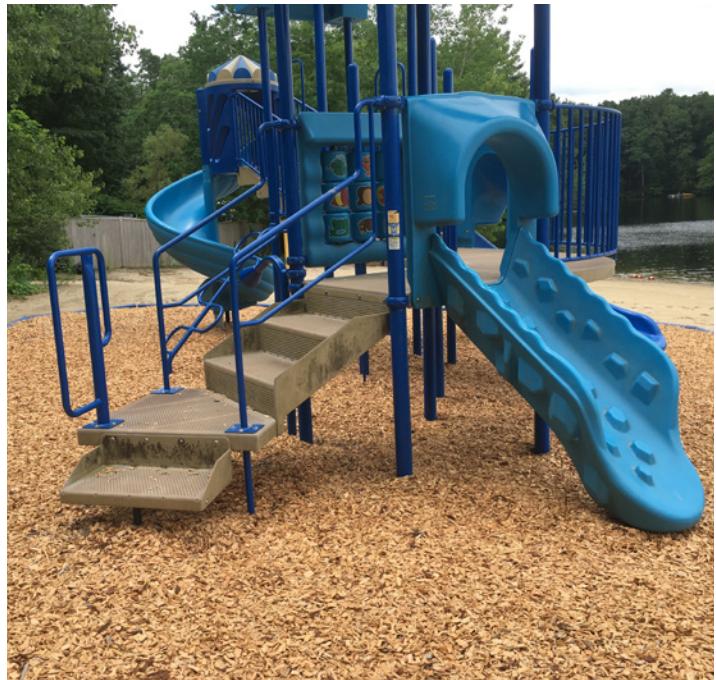
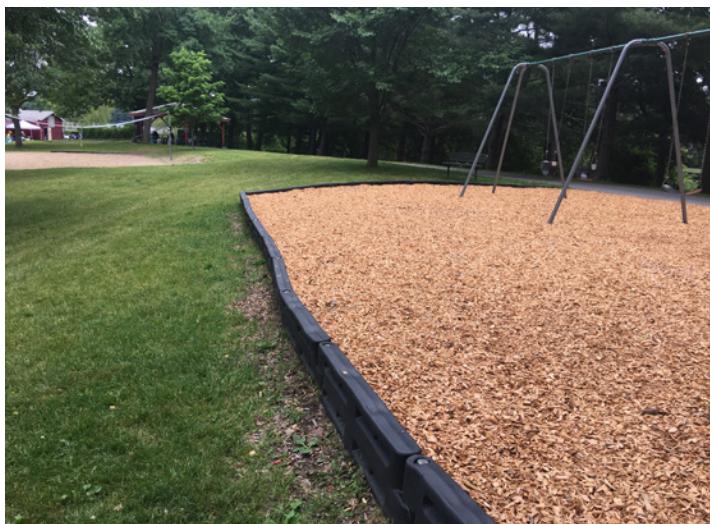
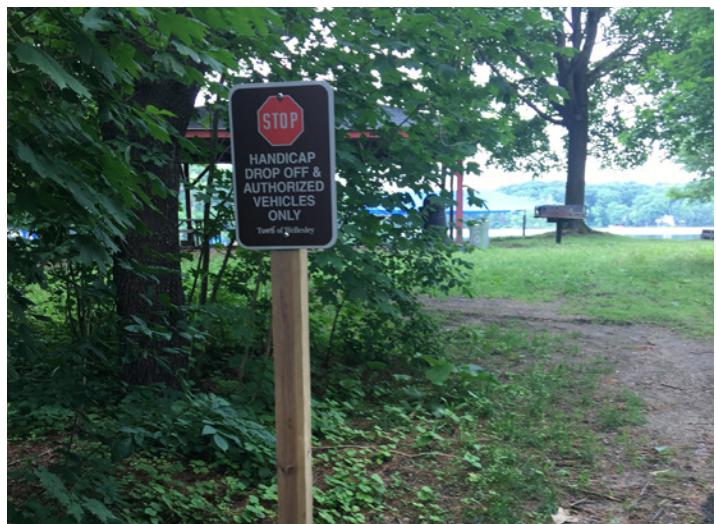
PHOTOS:

Structure is in fair condition - slightly weathered but structurally sound. Plastic curbing around wood fiber mulch is a tripping hazard.

Densely wooded area provides screening between beach and train tracks.

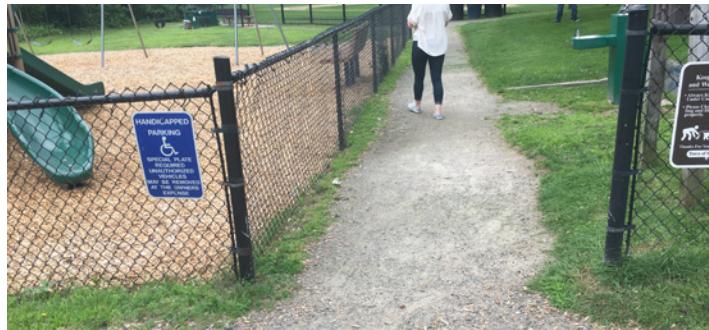
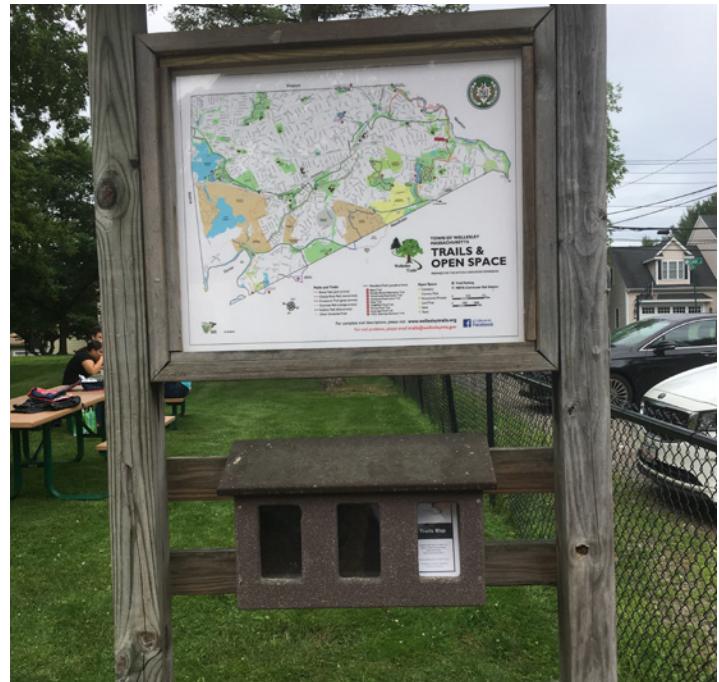
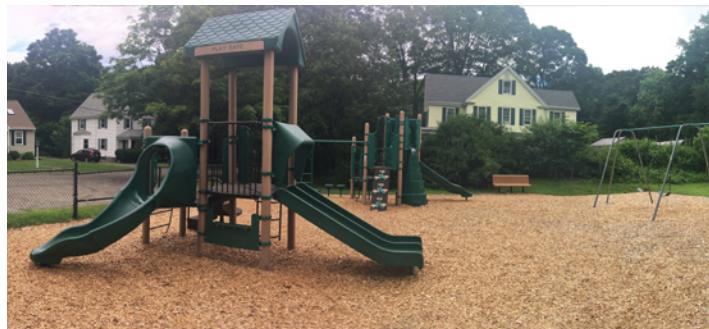
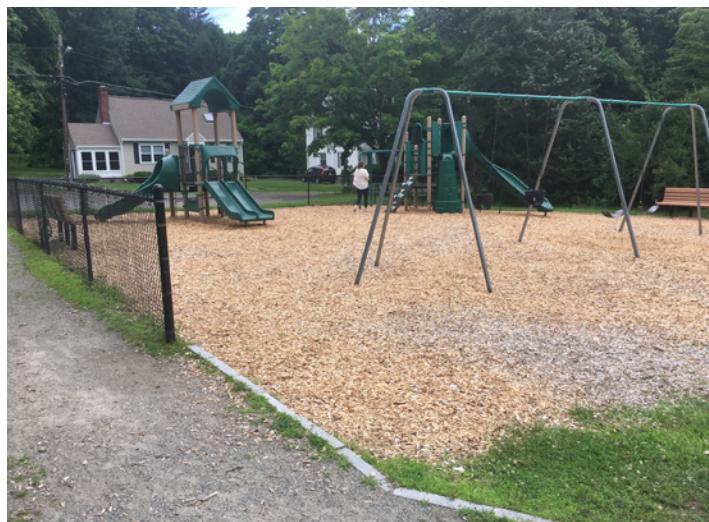
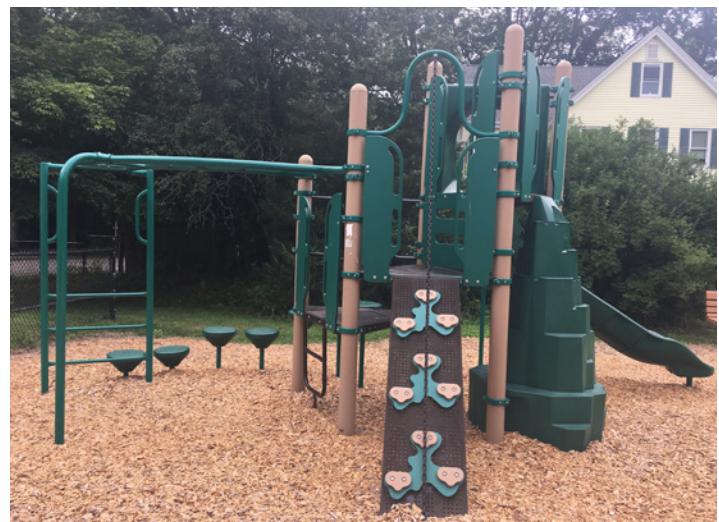
PHOTOS:

Playstructures are in good condition, swings are in fair condition.

ADA parking spot leads to stone dust pathway in fair condition.

Parking lot and access road are stone dust/bituminous concrete in fair to poor condition, are in need of repair.

Shrubs act as visual buffer to neighboring properties. Some shade trees within park, are not near playground.

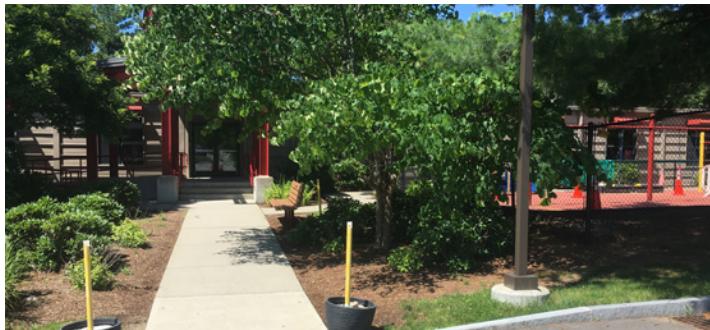
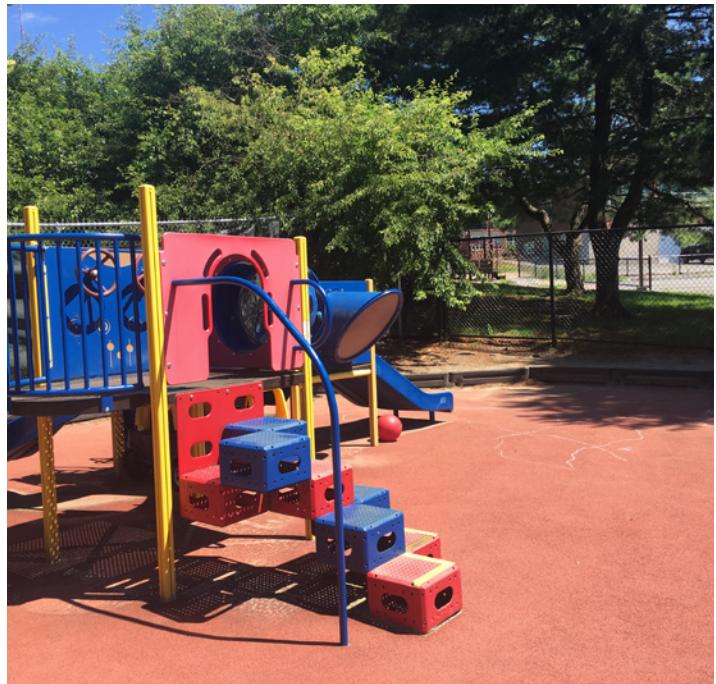
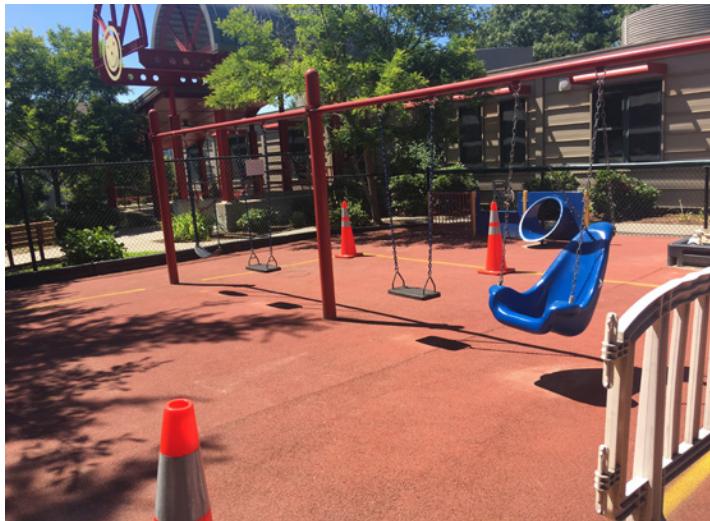
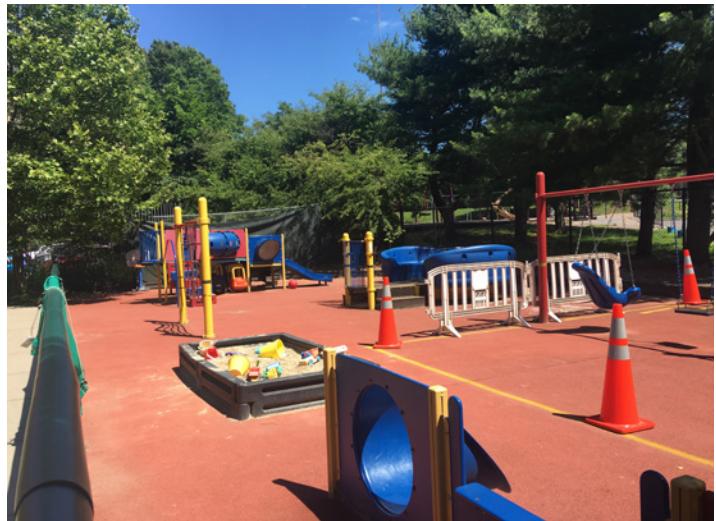
PHOTOS:

Play equipment is in fair condition. Rubber safety surfacing is uneven, with bulging mounds/air bubbles, can become a tripping hazard.

Plastic curb around rubber safety surfacing may have contributed to poor surfacing condition.

Some tree branches are encroaching on play equipment safety zones.

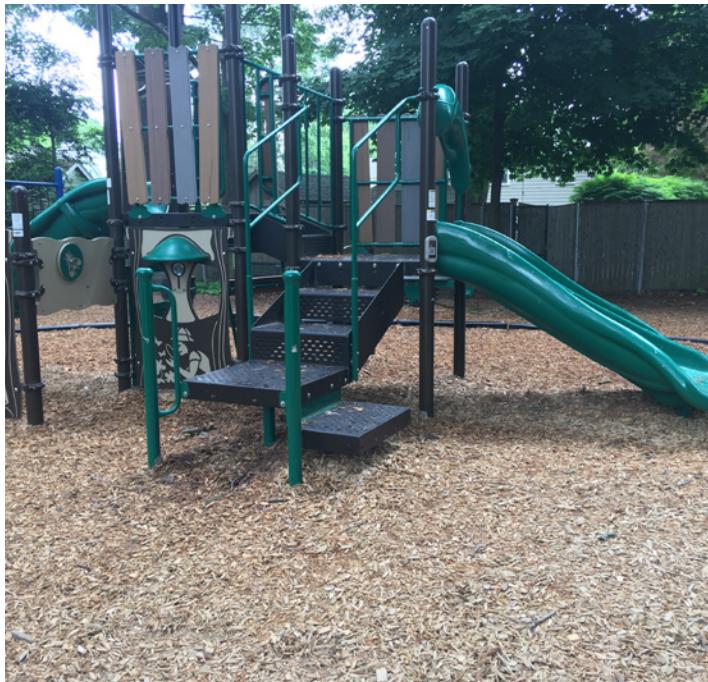
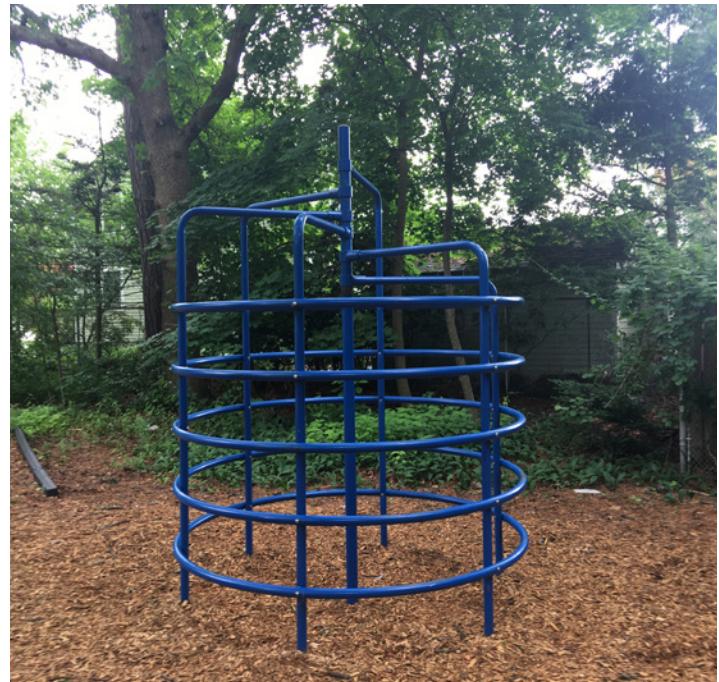
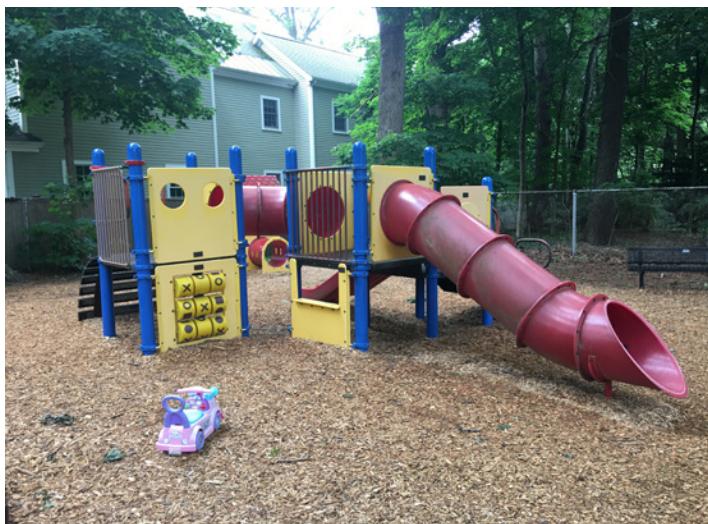
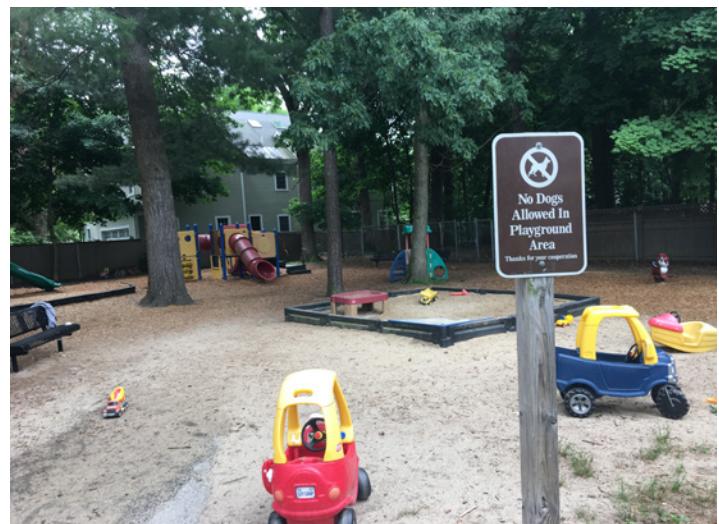
PHOTOS:

Ultiplay and Landscape Structures elements are aging and showing rust.

Wood fiber mulch is in fair condition. No clear edges.

Large trees within playarea require pruning or/and are within safety zones of play equipment - some trees branches encroaching on playequipment safety zones.

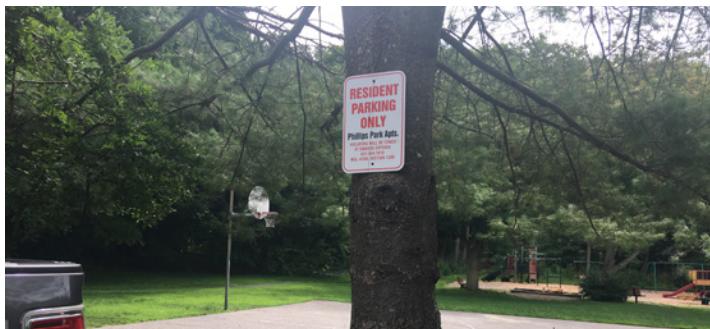
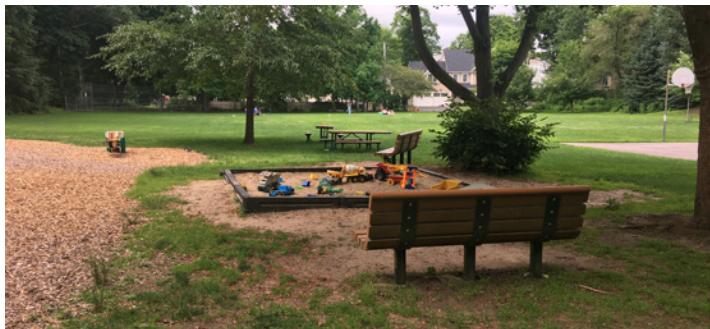
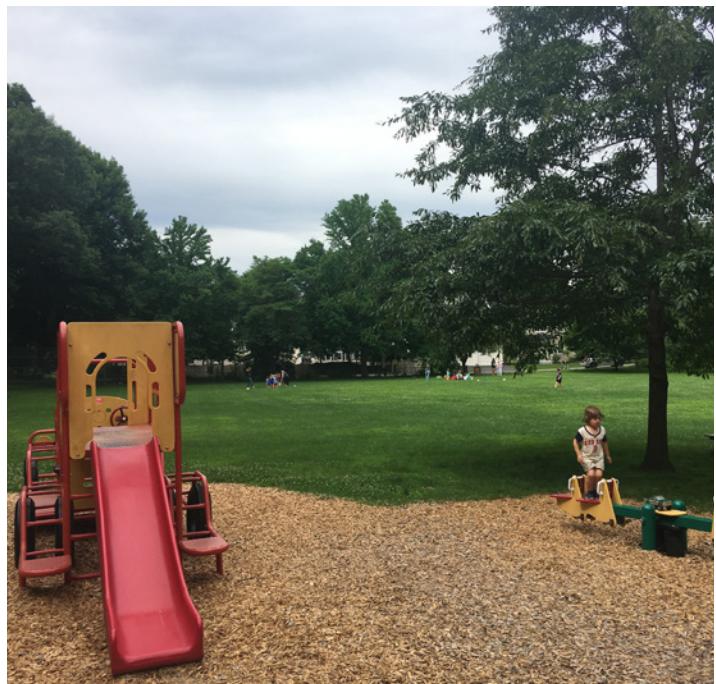
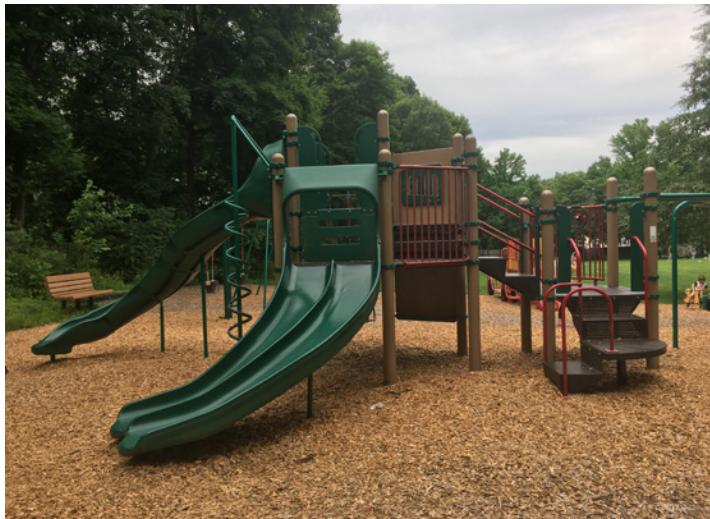
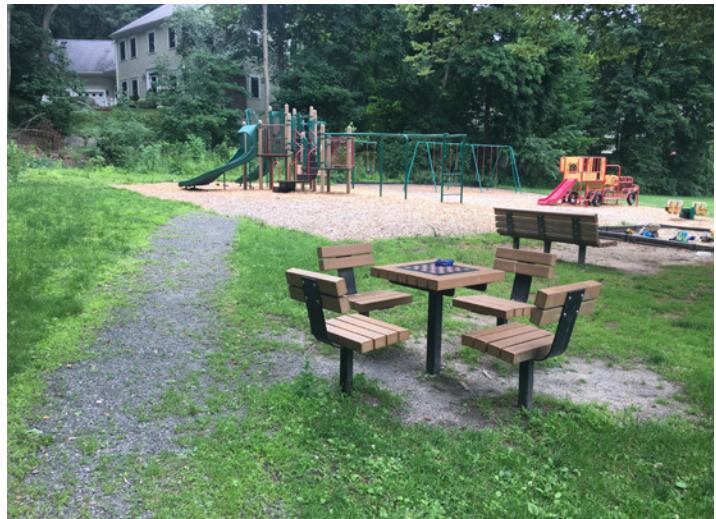
PHOTOS:

Large trees surrounding the playground, with two set in close proximity to sand box providing shade to that area.

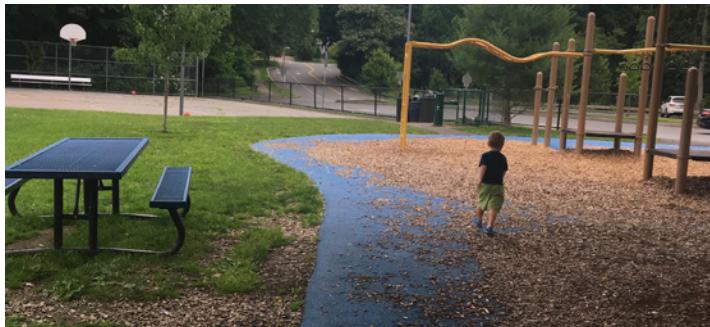
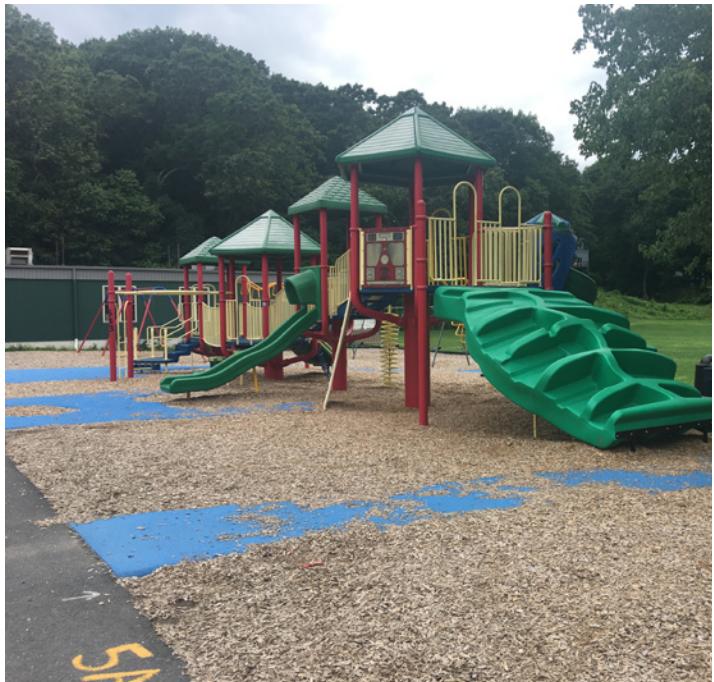
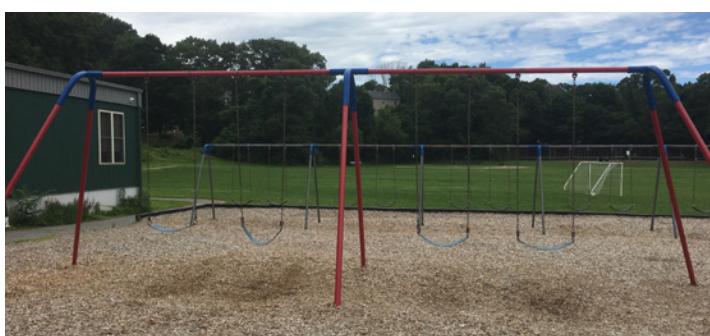
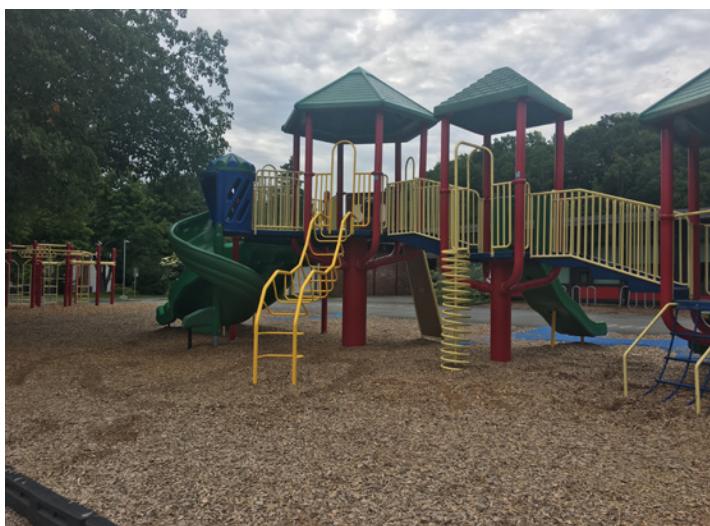
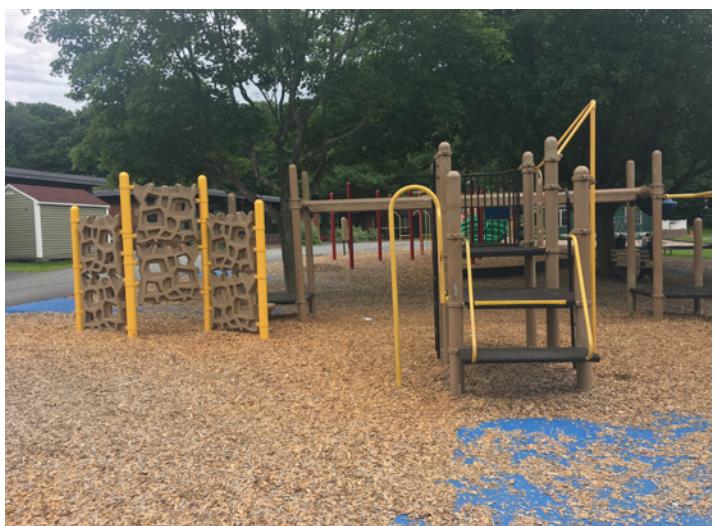
PHOTOS:

Four large trees within playspace, provide shade - non are within safety zones, however trimming of branches is recommended to prevent any future safety concerns.

Trees provide shade to structures.

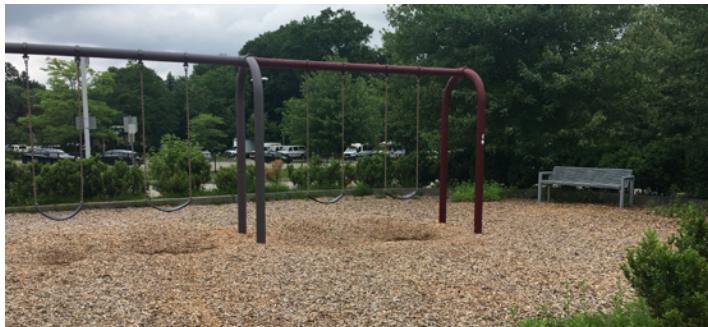
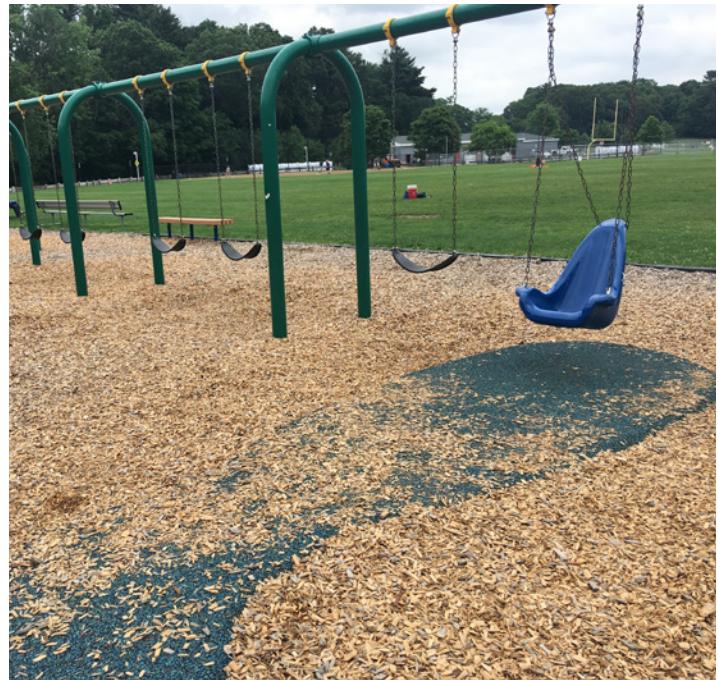
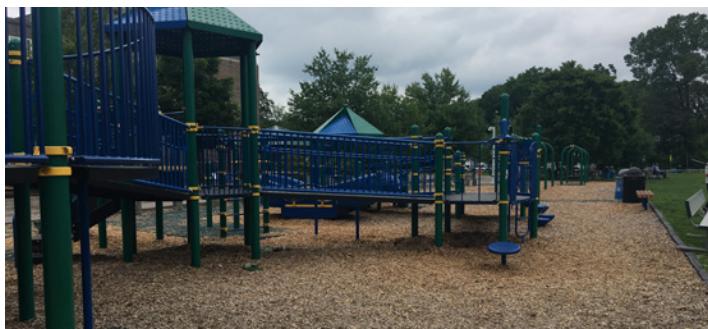
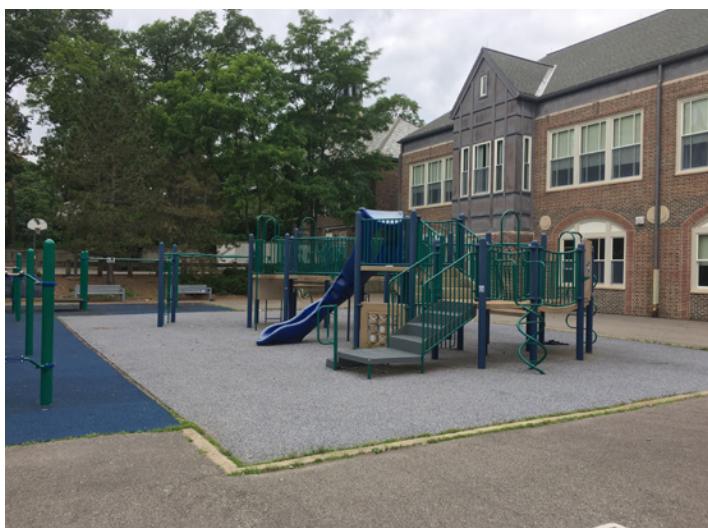
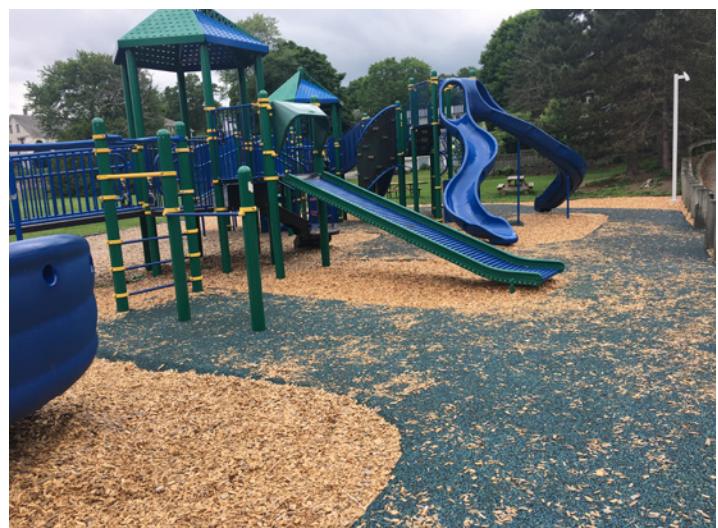
PHOTOS:

Shrubs, trees and fencing screen playspaces from parking lot.

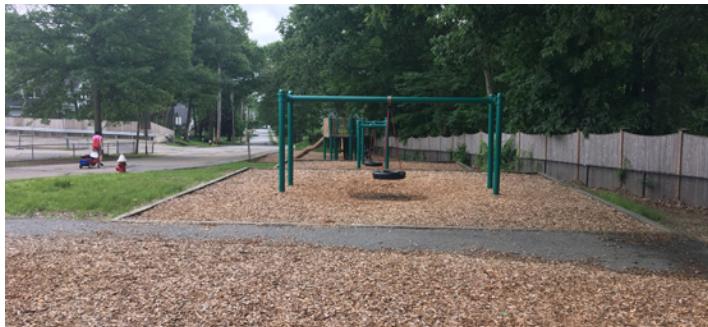
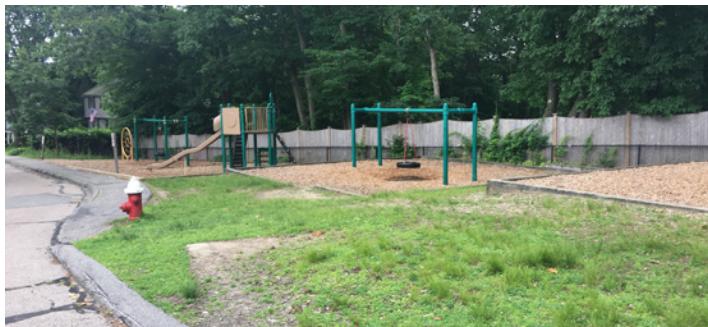
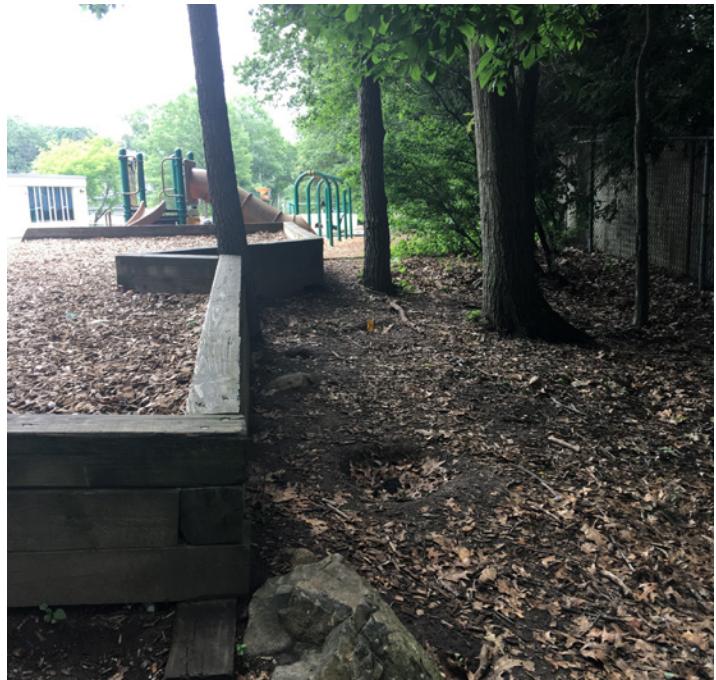
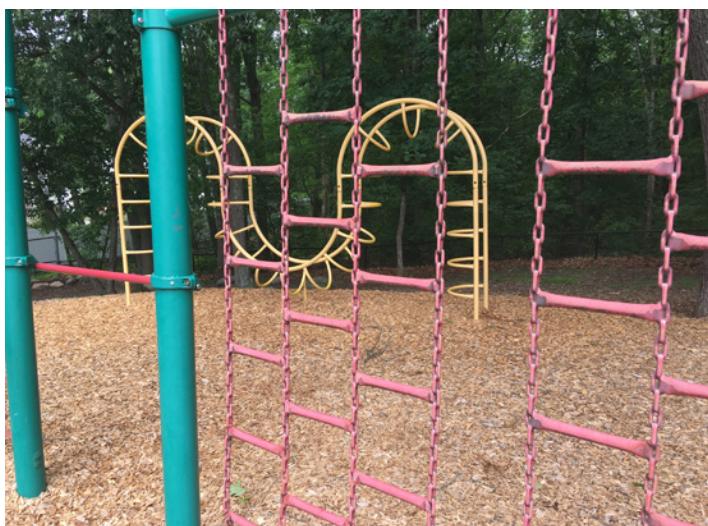
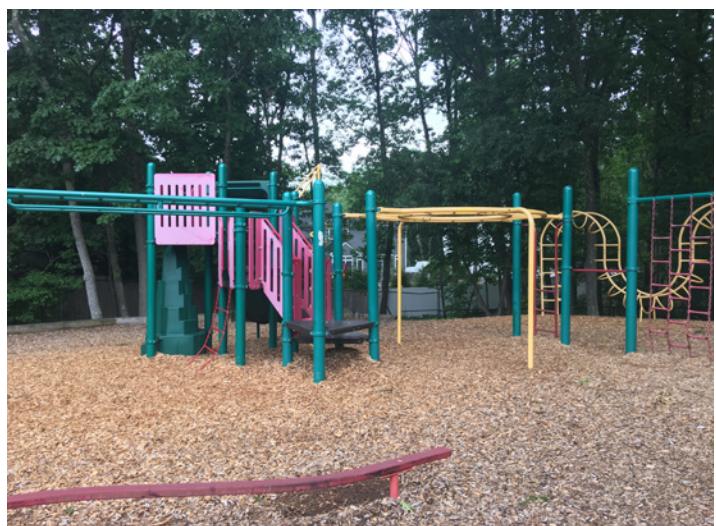
PHOTOS:

Densely vegetated area to the north of the school. Large trees surrounding the main play equipment provide shade.

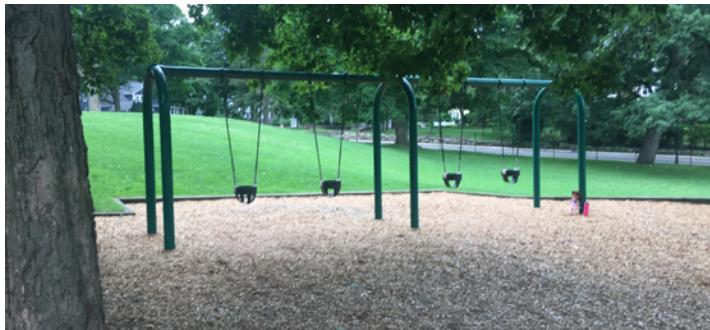
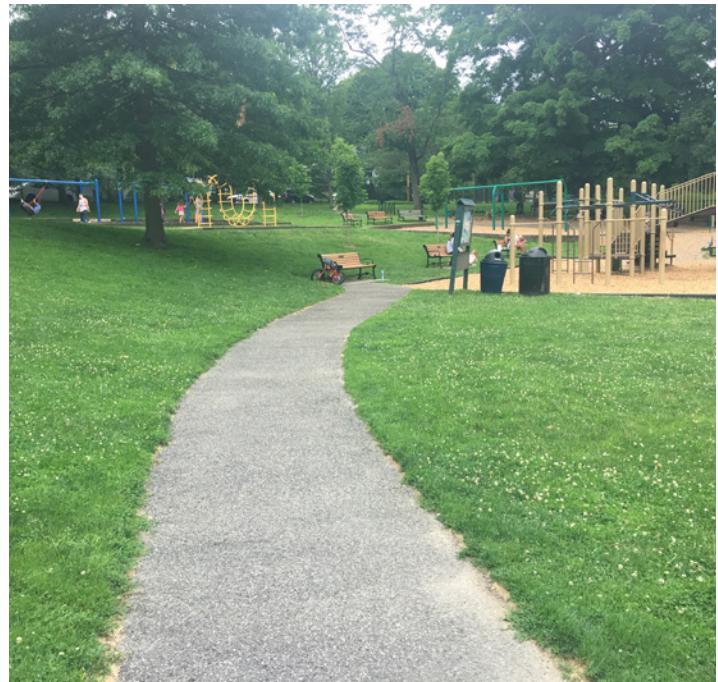
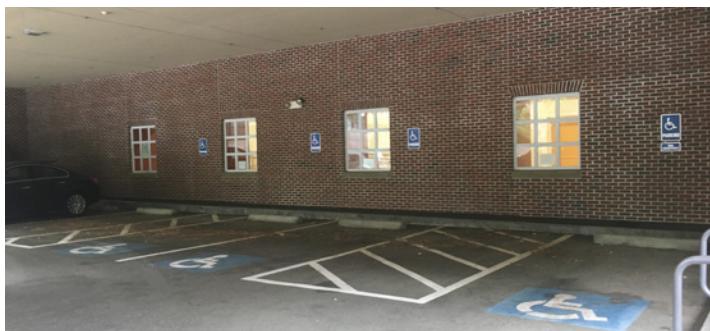
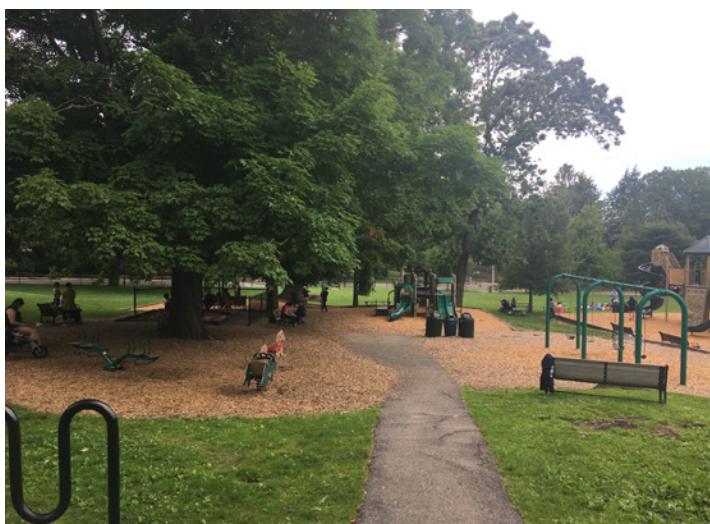
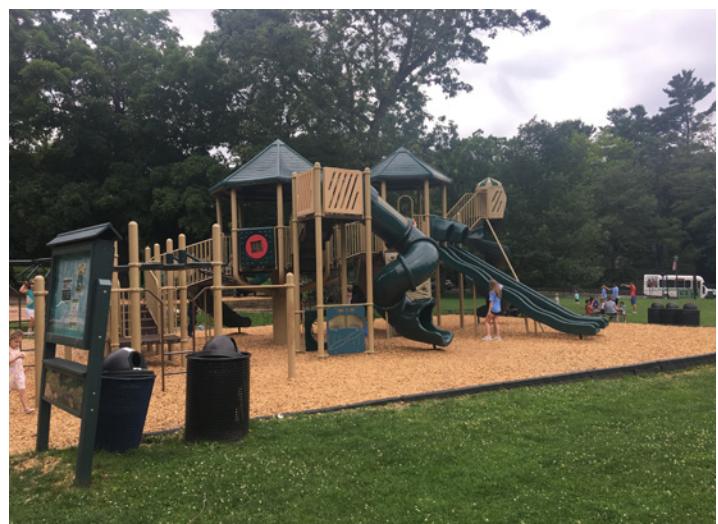
PHOTOS:

Large trees and shrubs provide shade to playground and surrounding benches. Some trees are close to encroaching on safety zones of multiple equipment especially the smaller structure.
