# MORSES POND ANNUAL REPORT: 2020

**PREPARED FOR THE TOWN OF WELLESLEY**

**BY WATER RESOURCE SERVICES, INC.**

**DECEMBER 2020**

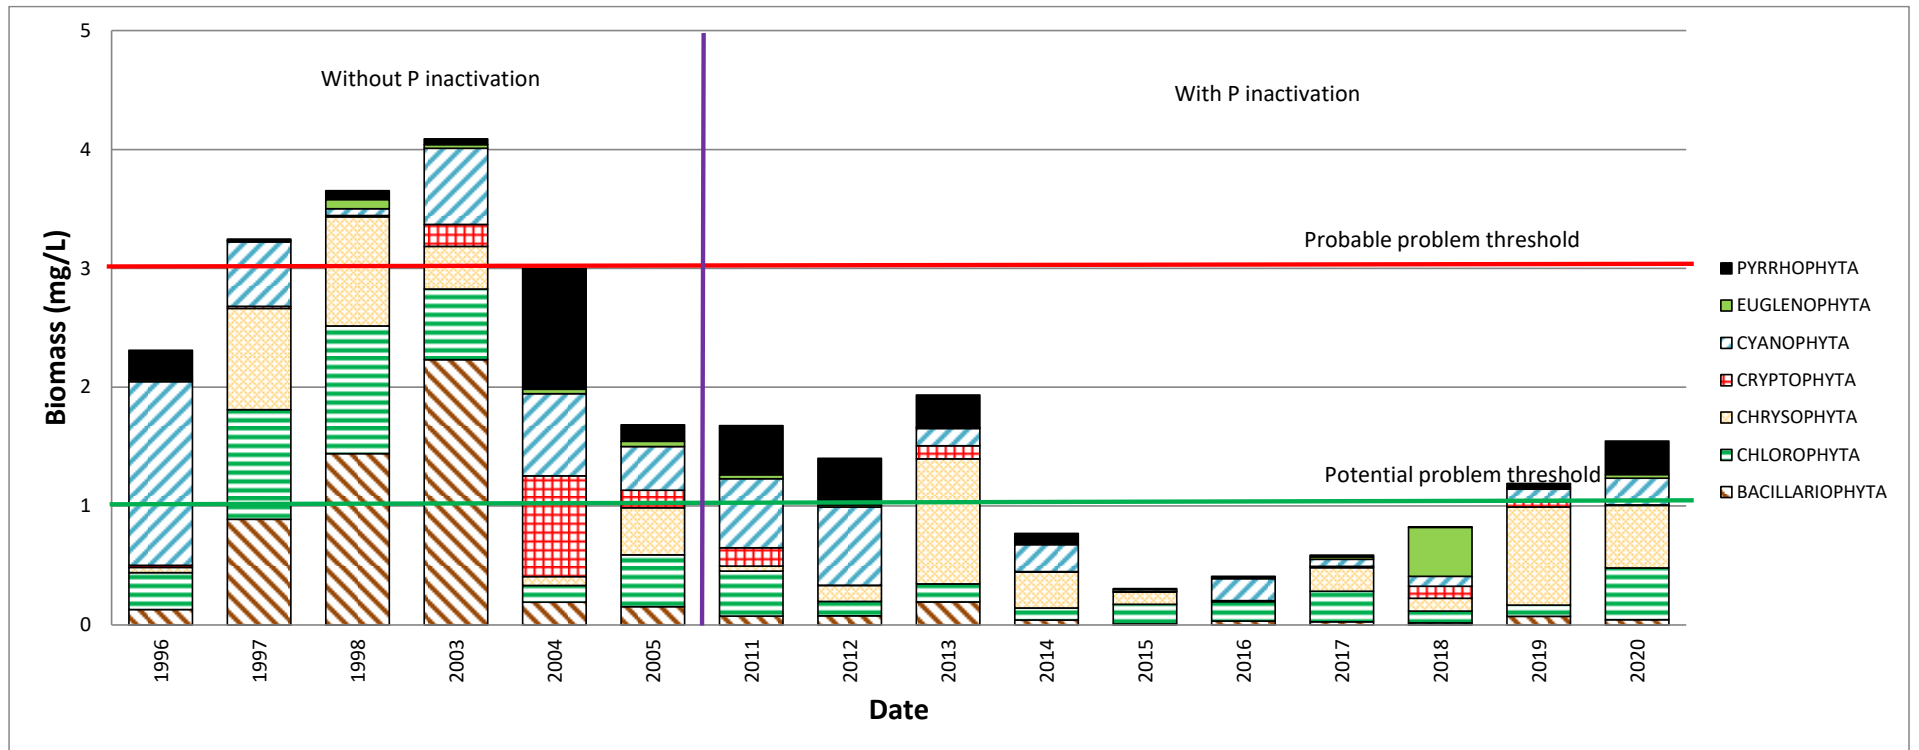
Figure 4. Summer average algae biomass divided into major algae groups for 1996-2020.

Algal data for 1996-2020 illustrate processes in Morses Pond over the summer (Figure 4). Algae biomass and composition can be very variable, depending on combinations of nutrient levels, light, temperature and flushing. Morses Pond phytoplankton biomass was frequently elevated prior to spring phosphorus inactivation, but since then biomass values have not exceeded the general threshold of 3 mg/L that signals low clarity (note that there is no official threshold for algae, but the red line in Figure 4 is a useful guide). Phytoplankton biomass as an annual spring/summer average has been below the 1 mg/L threshold indicative of low biomass since the system adjustments of 2014 and cyanobacteria have represented only a small amount of biomass each year. There have been small peaks in biomass at times, but no blooms that would prompt beach closure or other recreational impairment since improved operation of the phosphorus inactivation system in 2014. In September of 2018 and 2019 some cyanobacteria of the problem genus *Aphanizomenon* were present, but no surface blooms developed.

In 2020 cyanobacteria were present as early as June and peaked in late August and early September but were still not a dominant component of the phytoplankton assemblage. Alert beach staff and residents noted small accumulations of cyanobacteria on several occasions, usually along shore but never in the swim area, and additional investigation by WRS revealed these to be species known to grow at the sediment-water interface then develop gas pockets in cells that make them buoyant. Once at the surface, the wind can concentrate them along shore. Concentrations in open water and the swim area were not high enough to constitute a human or ecological health threat, but there were more cyanobacteria and more algae in general than in any summer since 2013 and 2014 respectively. Better treatment in the May-June period is needed to minimize summer issues but is partly dependent on an uncontrollable weather pattern.

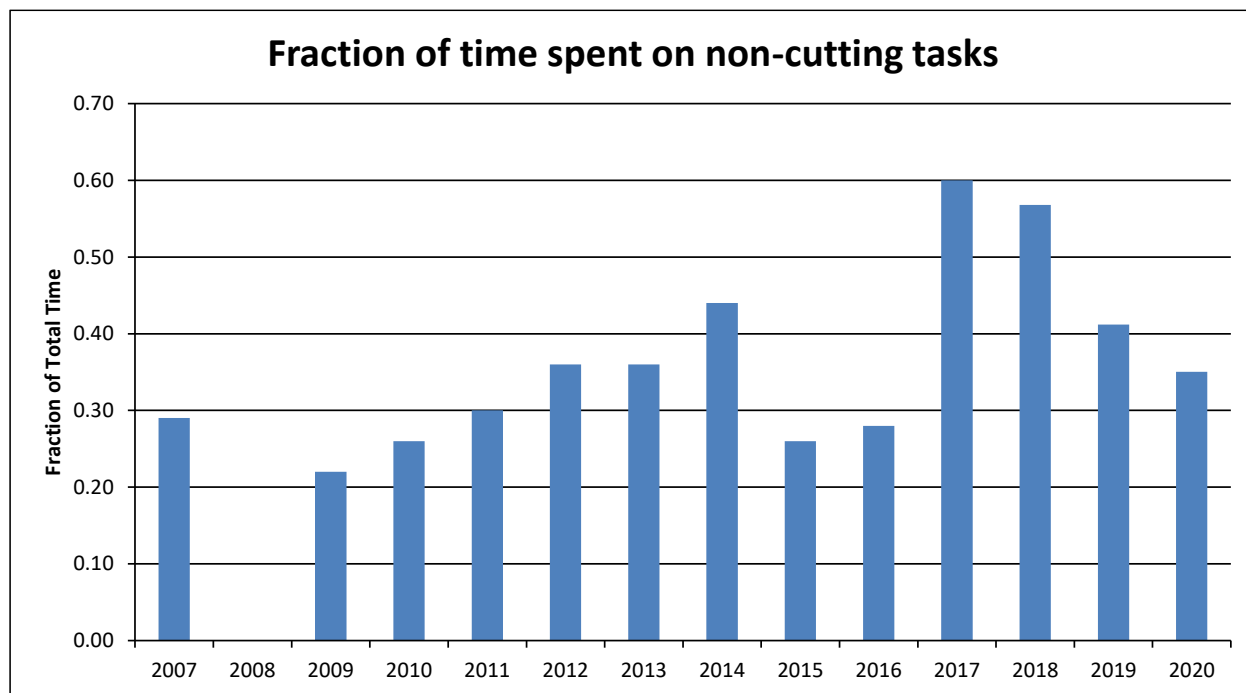
**Figure 8. Non-cutting hours associated with the harvesting program.**

An increasing number of non-cutting hours was observed from 2009 until 2015 (Figure 8) and appeared related to increases in time for maintenance and travel. From 2014 through 2017, records were kept for non-cutting hours in categories including transport time on the water, transport time on land, and maintenance. With a renewed emphasis on efficiency, the 2015 record indicates that non-cutting time was roughly cut in half. Non-cutting time increased very slightly in 2016 but was still far less than in 2014. Non-cutting time increased markedly in 2017, as the large harvester was working but not properly, resulting in low efficiency and an eventual breakdown. Note that this harvester experienced considerable downtime in 2016, but time not in use awaiting parts is not counted in the harvesting program. Non-cutting time was reduced steadily in successive years since 2017 and in 2020 it was about the same as back in 2012 and 2013 but was still over one third of all time devoted to the harvesting program.

Efficiency is therefore an issue. The need to maximize cutting time conflicts with lower manageable load limits and more frequent trips back to the offloading location next to the outlet at the south end of the pond. Past efforts to establish other offloading points have met with resistance by shorefront residents and a renewed inquiry along those lines in 2020 raised similar concerns of truck traffic, noise, and odor. A new large harvester could solve much of the problem, but continued staff attention to efficiency is needed.

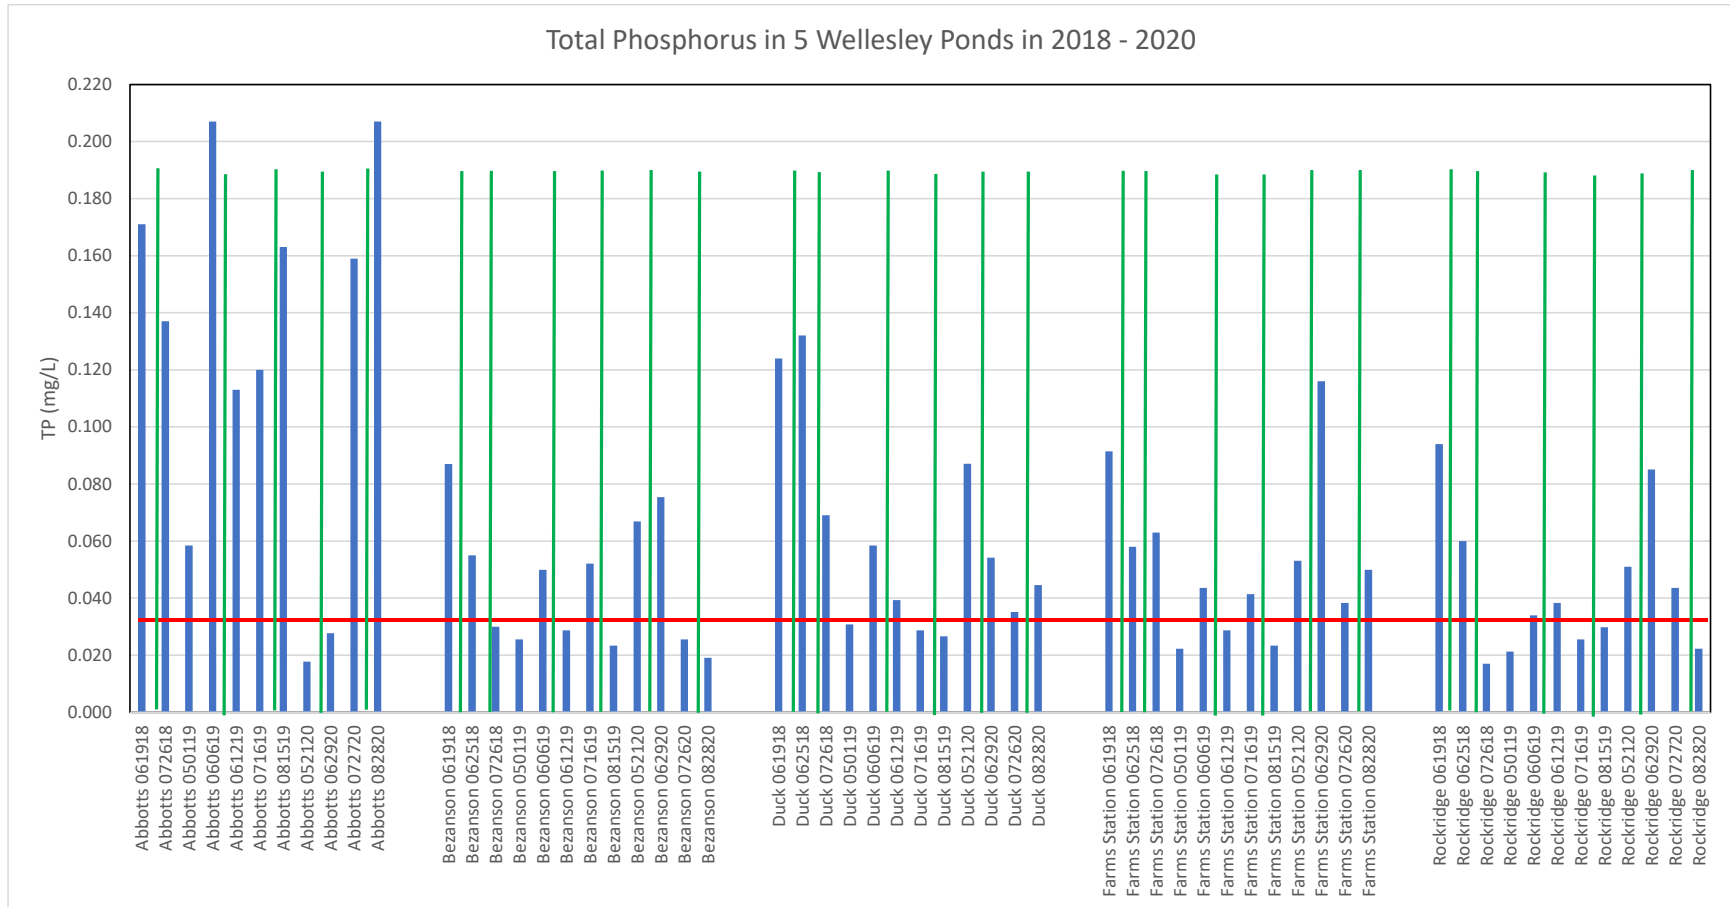
Figure 11. Phosphorus before and after aluminum treatments of five Wellesley Ponds

Treatment was repeated on June 10 and July 22 in 2019, with about 417 gallons of polyaluminum chloride spread over 5 ponds in each application (Abbotts @ 80 gal, Bezanson @ 40 gal, Duck @ 22 gal, Farms Station @ 112 gal, and Rockridge @ 163 gal). Phosphorus concentration and general pond condition was assessed before and after each treatment. This process was repeated in 2020 on June 22<sup>nd</sup> and August 17<sup>th</sup> of 2020 for the same ponds at the same doses.

Green vertical lines indicate treatment dates, red horizontal line indicates target P concentration

In 2019 the treatment appeared to provide clear water, but phosphorus concentrations were not far above the desirable threshold even before treatment. There was some filamentous green algae, but not as much as in years prior to treatment, and there were no other problems species of algae detected. However, rooted plant growths were dense in the pond in May and June of 2019 and harvesting should probably have occurred earlier. The rooted plants may have limited algae as much as treatment did. Phosphorus was higher in 2020 after the first treatment but the second treatment reduced it to the target level and algae were not a problem in 2020. Rooted plants were selectively harvested in July and that activity may have increased phosphorus by bottom disturbance. Treatment with aluminum should follow harvesting to achieve best results, but harvesting is not typically conducted until sometime in July and algae can be a problem in Rockridge Pond before that time.

The phosphorus inactivation program for these smaller ponds showed promise in 2018 through 2020. Bezanson and Farms Station Ponds exhibited markedly better conditions in 2019 and 2020 than in past years and this may be all that is needed to keep those ponds in a condition appropriate for their intended uses. It would be best if use at Rockridge Pond followed harvesting, which should occur earlier in the summer if possible, but if harvesting has to wait until July the paired treatment approach can be continued. Duck Pond does not require much aluminum, but conditions in this pond would be much enhanced by dredging and clearing the water under current conditions provides only slight benefit for a short period. Treatment of Abbotts Pond will probably necessitate launching a boat and spraying from the pond surface to get adequate coverage, as the results from 2018 through 2020 were not acceptable.
