# MORSES POND ANNUAL REPORT: 2021

**PREPARED FOR THE TOWN OF WELLESLEY**

**BY WATER RESOURCE SERVICES, INC.**

**NOVEMBER 2021**

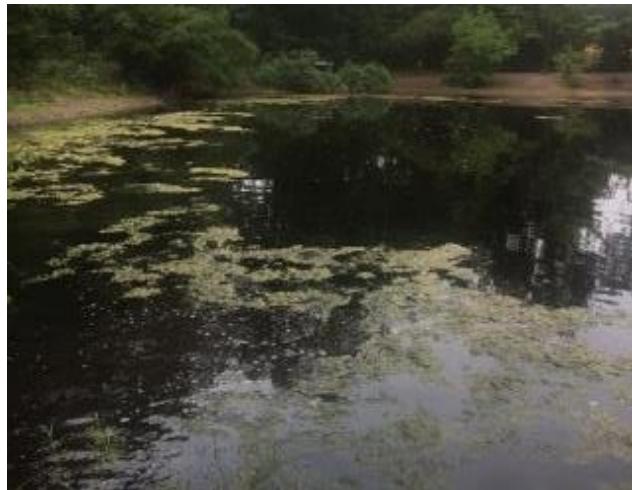
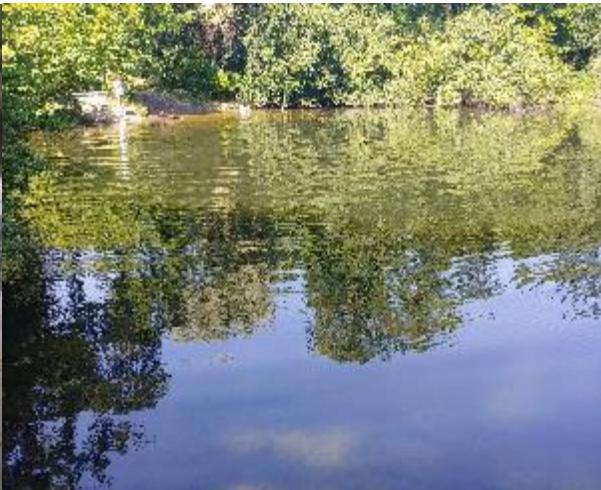
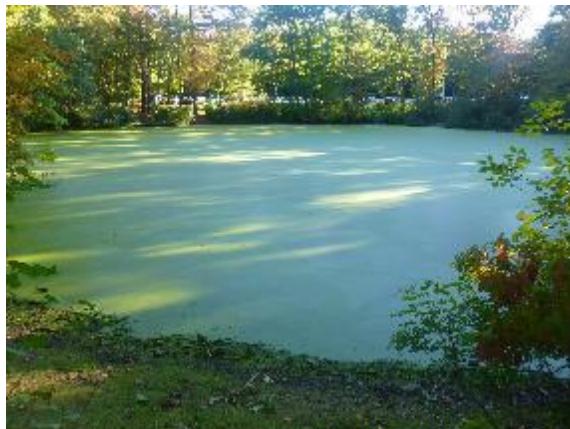
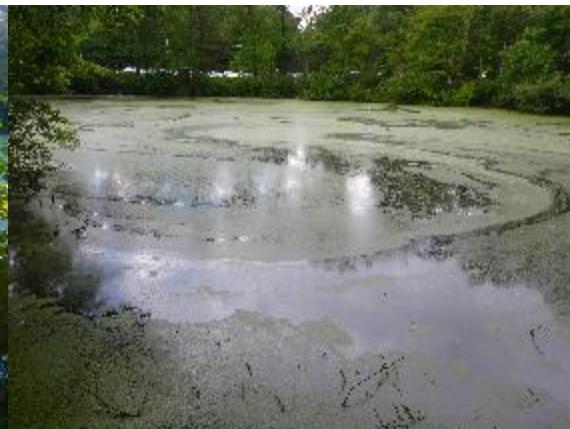
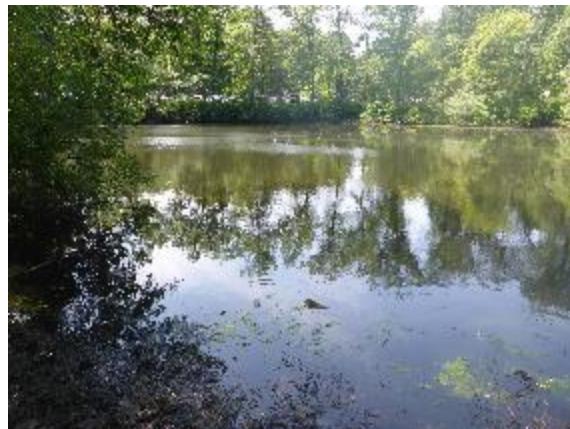
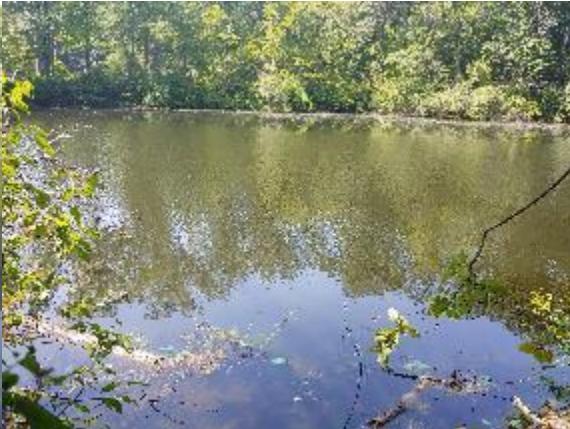
**Figure 15. Photographic documentation of improvement in two Wellesley Ponds**

nutrition from the water column instead of the sediment via roots. The treatment appears to have solved both algae and vascular plant problems in this pond (Figure 15), making it far better in its role as a dog swimming pool. Bezanson Pond did not develop algae or macrophyte problems in 2021 but the water was murkier, a likely result of so much storm runoff input, and there was some floating coontail, probably dislodged by high inflows.

The phosphorus inactivation program for these smaller ponds showed promise in 2018 through 2020. Bezanson and Farms Station Ponds exhibited markedly better conditions in 2019 and 2020 than in past years and this may be all that is needed to keep those ponds in a condition appropriate for their intended uses. It would be best if treatment of Rockridge Pond followed harvesting, which should occur earlier in the summer, if possible, but if harvesting has to wait until July the paired treatment approach can be continued. Duck Pond does not require much aluminum, but conditions in this pond would be much enhanced by dredging and clearing the water under current conditions provides only slight benefit for a short period. Treatment of Abbotts Pond will probably necessitate launching a boat and spraying from the pond surface to get adequate coverage, as the results from 2018 through 2021 were not acceptable, and more intensive management may be needed in this shallow, highly eutrophic pond.
