MORSES POND ANNUAL REPORT: 2022

PREPARED FOR THE TOWN OF WELLESLEY

BY WATER RESOURCE SERVICES, INC.

FEBRUARY 2023

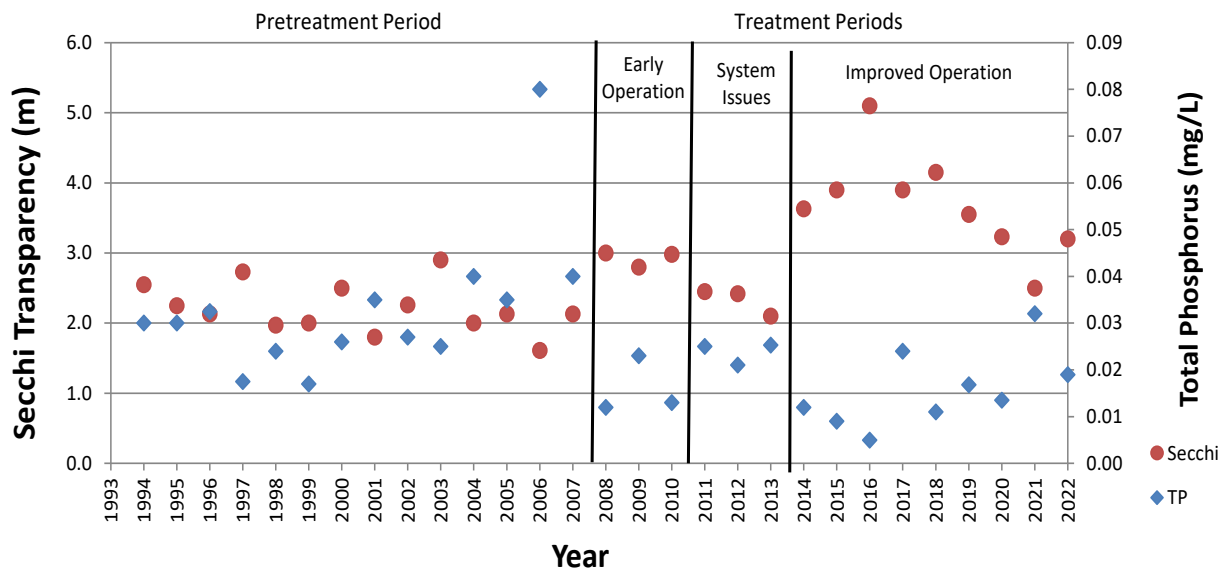
Figure 2. Average summer water clarity and total phosphorus in Morses Pond, 1994-2022.

Summer water clarity in 2022 was similar to that of past years since the inactivation system was enhanced (Figures 2 and 3), other than 2021, which had the lowest clarity by virtue of high stormwater inputs. Those inputs supported more algal growth but were also a source of non-algal solids and color, both of which reduce clarity. The dry weather in 2022 reduced stormwater inputs and treatment with aluminum further enhanced clarity, but the clarity was not higher than average, given fewer opportunities to treat incoming water and some issues with internal recycling with phosphorus. Clarity in 2021 stands in contrast to all other years of phosphorus inactivation and clarity in 2022 represented a return to the recent norm, which has supported contact recreation and other desirable uses of Morses Pond.

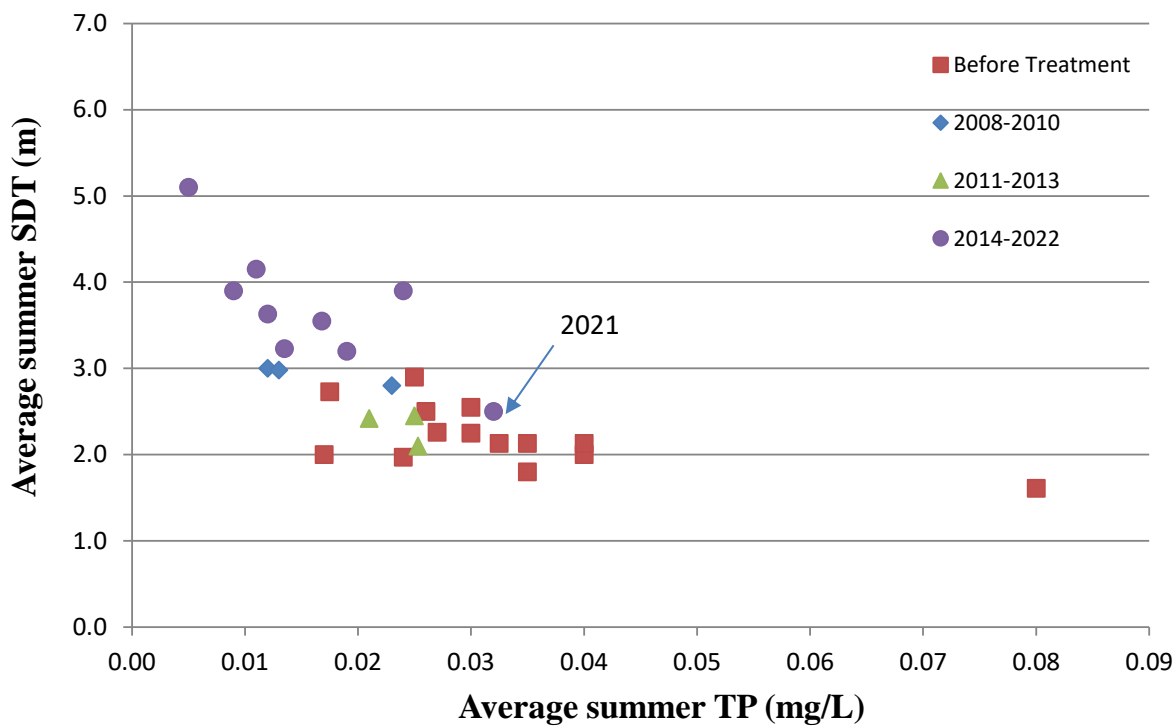
Figure 3. Relationship between summer water clarity and total phosphorus in Morses Pond.

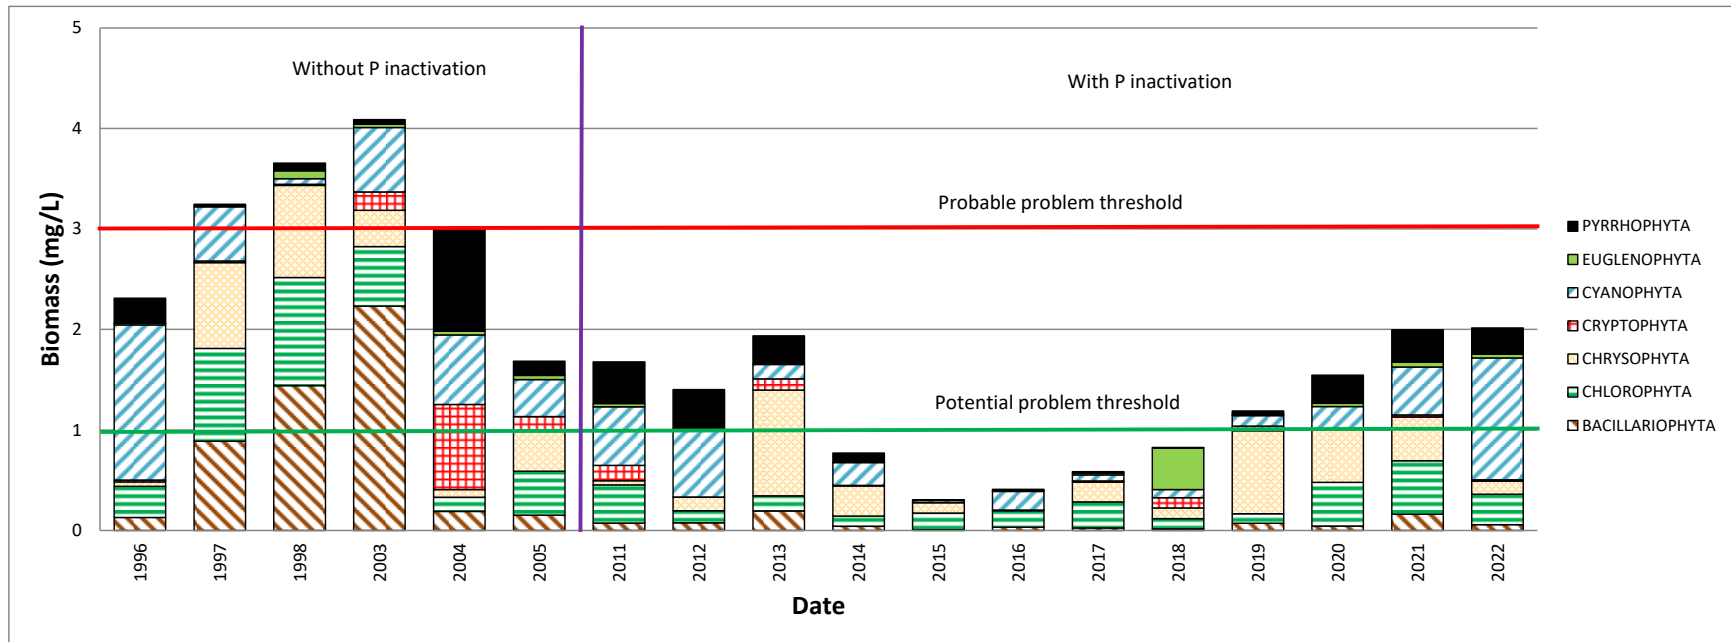
Figure 4. Summer average algae biomass divided into major algae groups for 1996-2022.

Algal data for 1996-2022 (Figure 4) indicate that algae biomass and composition can be very variable, depending on combinations of nutrient levels, light, temperature, and flushing. Morses Pond phytoplankton biomass was frequently elevated prior to spring phosphorus inactivation, but since then biomass values have not exceeded the general threshold of 3 mg/L that signals low clarity (note that there is no official threshold for algae, but the red line in Figure 4 is a useful guide). Phytoplankton biomass as an annual spring/summer average was below the 1 mg/L threshold indicative of low biomass after the system adjustments of 2014 until 2019 and cyanobacteria have represented only a small amount of biomass each year until 2022. In 2019 the 1 mg/L threshold was just slightly exceeded, but the average algal biomass increased further in 2020 and 2021. There have been small peaks in biomass at times, but no blooms that would prompt beach closure or other recreational impairment since improved operation of the phosphorus inactivation system in 2014.

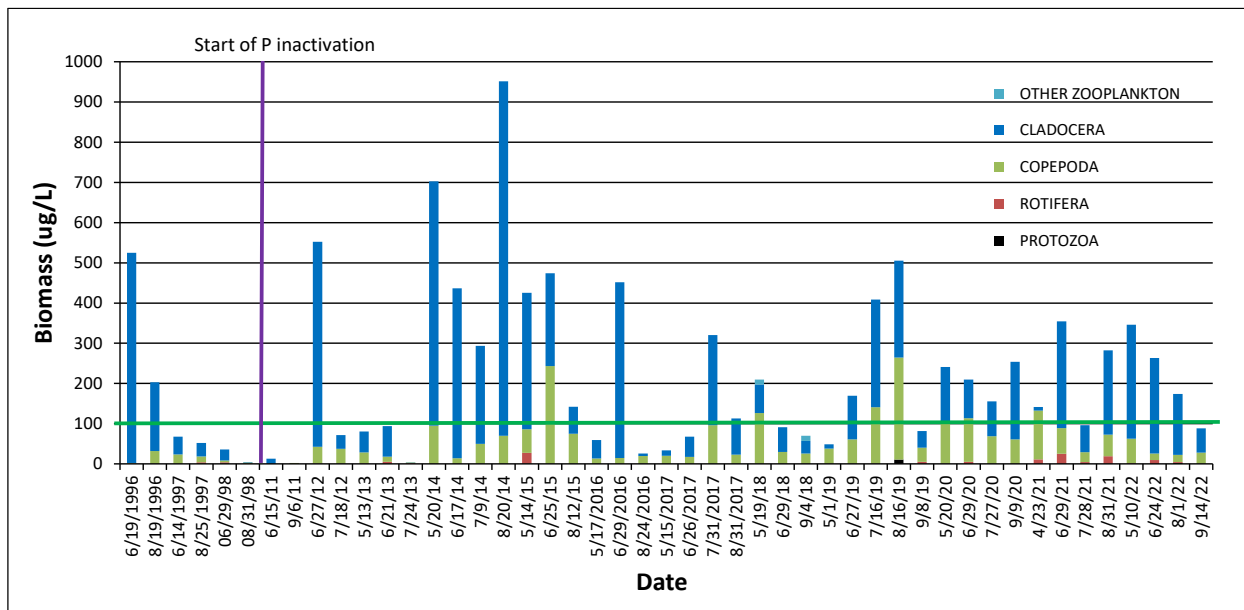
Figure 5. Zooplankton abundance for 1996-2022.

Zooplankton have also been sampled, and while not as tightly linked to nutrients as algae, provide important information on the link between algae and fish (Figures 5 and 6). Zooplankton biomass varies strongly between and within years. Values $<25 \mu\text{g/L}$ are minimal, and values higher than $100 \mu\text{g/L}$ are preferred as rough thresholds, with high values desired for both algae grazing and fish food. Morses Pond values span that range and more. Values in later summer are expected to be lower than in late spring or early summer, as fish predation by young-of-the-year fish (those hatching that year) reduces populations of zooplankters. Spring levels will depend on water quality, predation by adult fish, and available algae, which are food for zooplankton. The dominant zooplankton groups are cladocerans and copepods, both groups of micro-crustaceans. *Daphnia*, among the larger cladocerans, filter the water to accumulate algae as food, and can increase water clarity markedly.

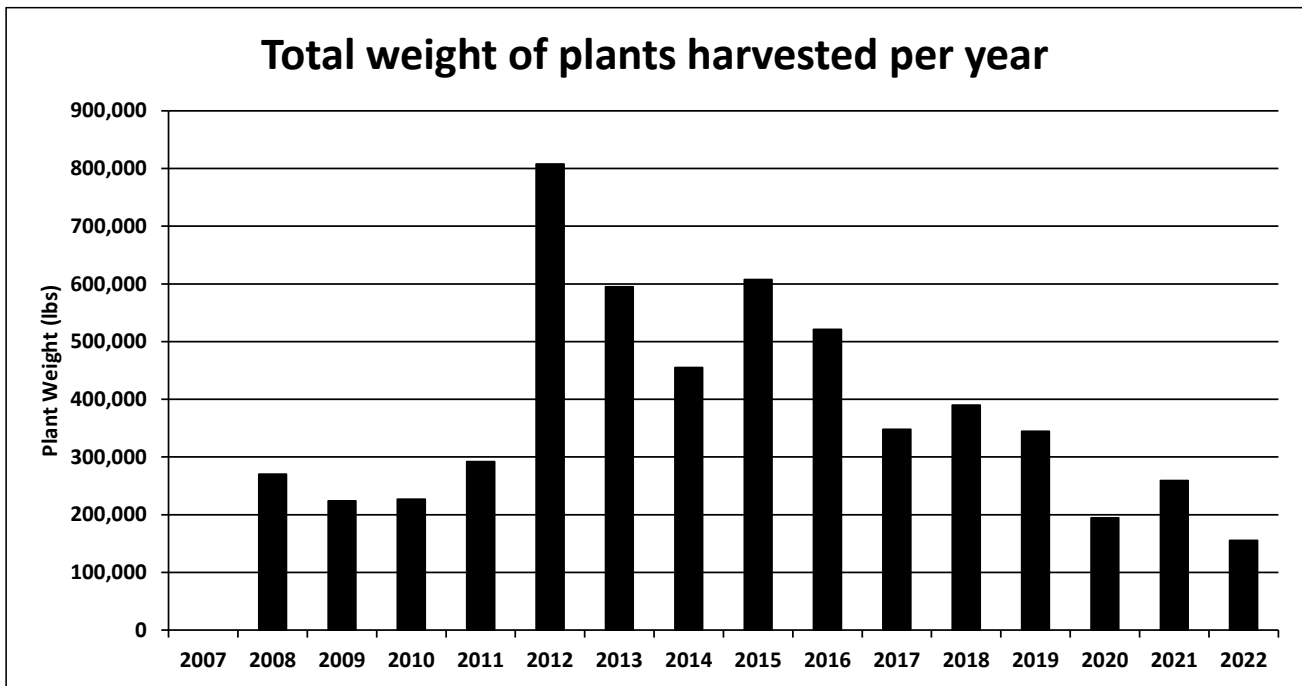
Figure 9. Total mass of plants removed by the harvesting program.

Total weight of plants harvested, as measured upon entry to the composting facility (so there is some draining of water, but values are still wet weight) has ranged from 156,000 to 808,000 lbs. The 2022 biomass total was the lowest recorded. A few load weights may not have been recorded, but the total mass removed was still likely the least in program history, owing mainly to smaller loads. Weight per load has declined in recent years because at full capacity it is hard to empty the older, larger harvester; the aging conveyor cannot push a full load out of the barge, mainly due to friction and reduced power. Additionally, the larger harvester is out of service for repairs several weeks per harvesting season and the smaller harvester holds less biomass per load. The results are illustrated in Figures 8-10. The larger, older harvester has become the primary limit to program success. A new harvester has been ordered and is expected in 2023, although possibly not by the start of the harvesting season.

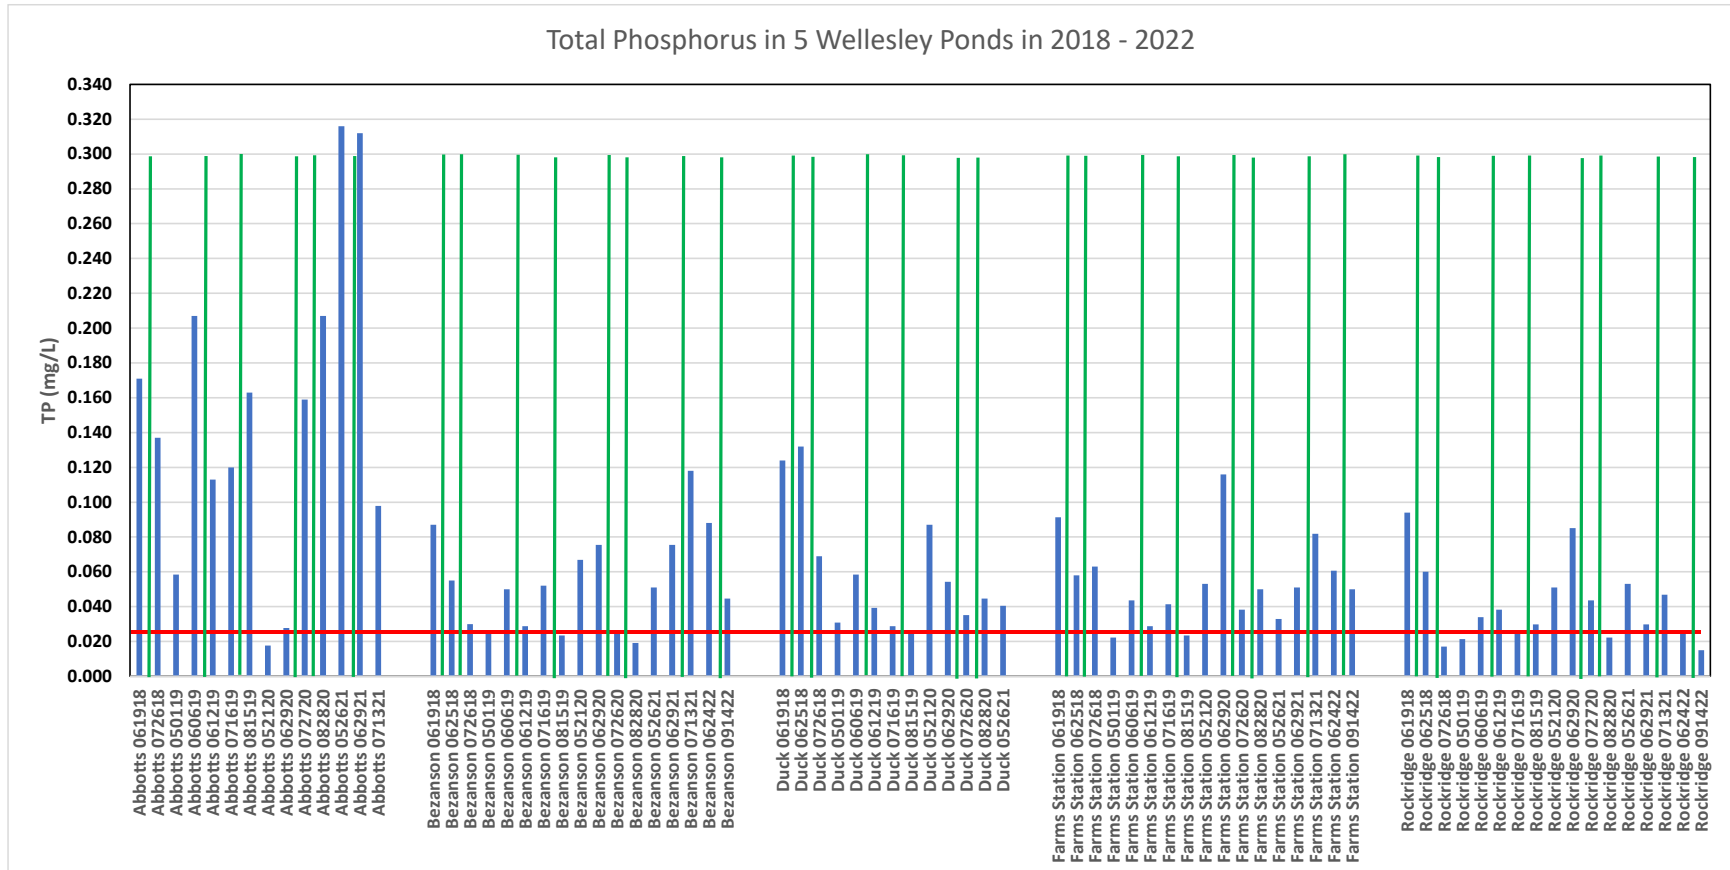
Figure 13. Phosphorus before and after aluminum treatments of five Wellesley Ponds
 Green vertical lines indicate treatment dates, red horizontal line indicates target P concentration

Bezanson Pond exhibited a desirable response to all treatments, showing declines in phosphorus (Figure 13) and algae to near desirable thresholds. No filamentous green algae mats formed in the years with
