Roofing and Envelope Feasibility Study

Wellesley Police Station
Wellesley, MA
2 October 2015

SGH Project 150841

Project 150841 – Roofing and Envelope Feasibility Study (#WFMD-RFP-FY16-001),
Wellesley Police Station, 485 Washington St., Wellesley, MA

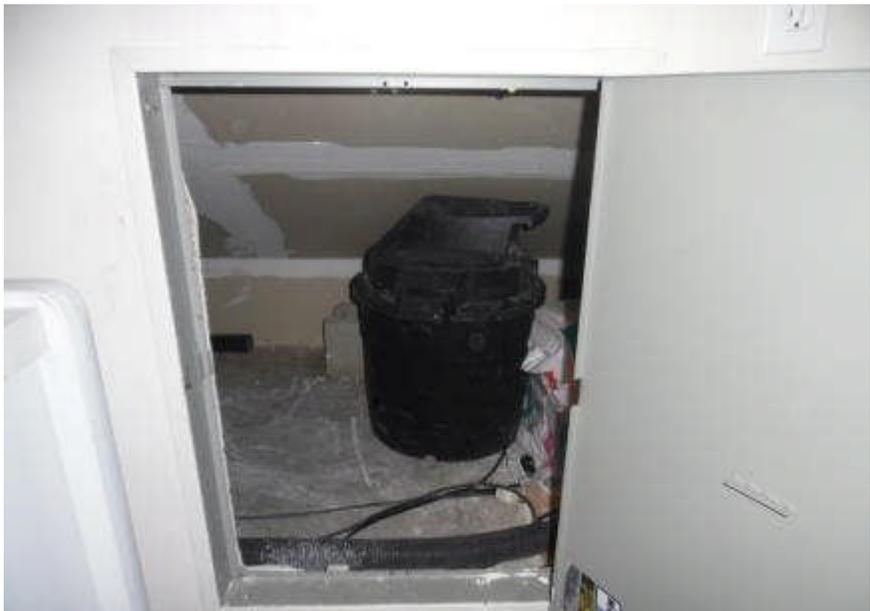
Photo 3

- The attic and second-floor crawl spaces have a wet pipe sprinkler system (Photos 3 and 4). Access doors were installed to the crawl spaces in December 1999. In approximately 2005, a sprinkler pipe in a crawl space froze and broke causing interior water damage. Following that break, electric heat was added to these crawl spaces. The addition of the electric heat appeared to increase the ice dam formation on the roofs. Large icicles form and hang from the eaves during the winter.

Access door to second floor crawl space over the garage (sally port west eave).

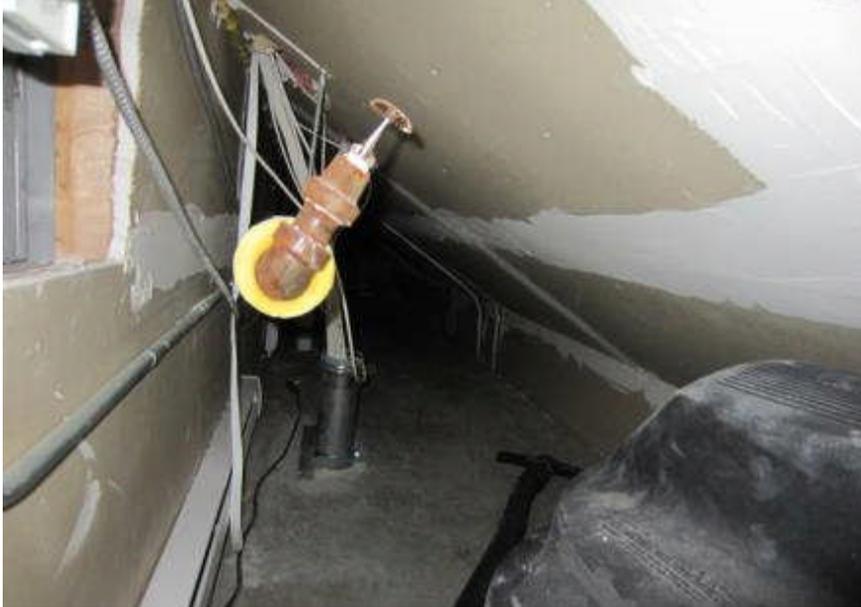
Photo 4

Sprinkler pipe and base board heating in crawl space over the garage (sally port west eave).

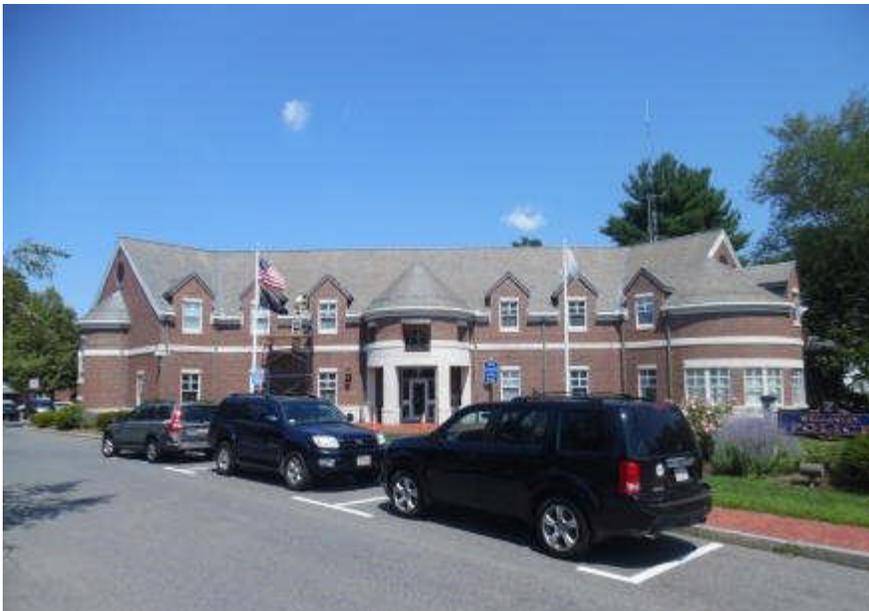
Photo 12

South elevation of the WPS.

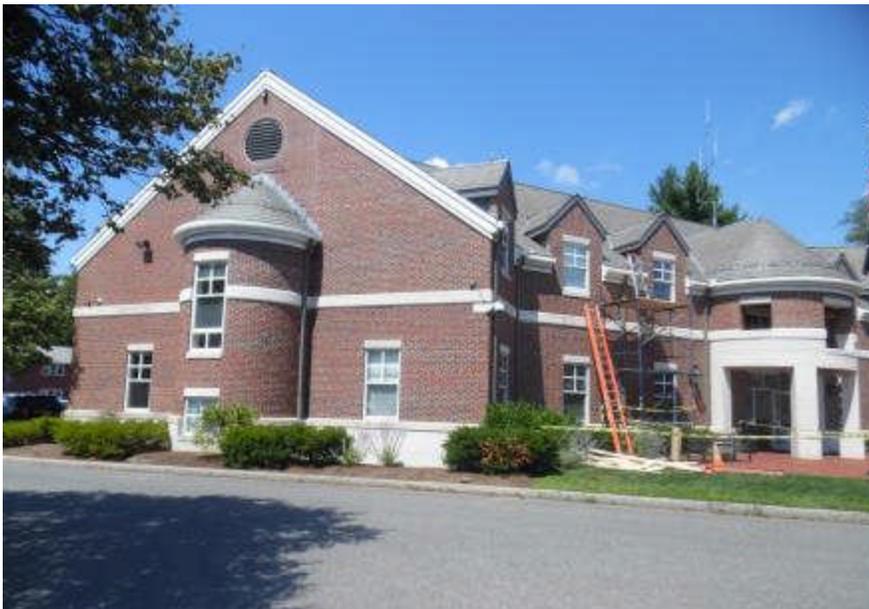
Photo 13

Southwest elevation of the WPS.

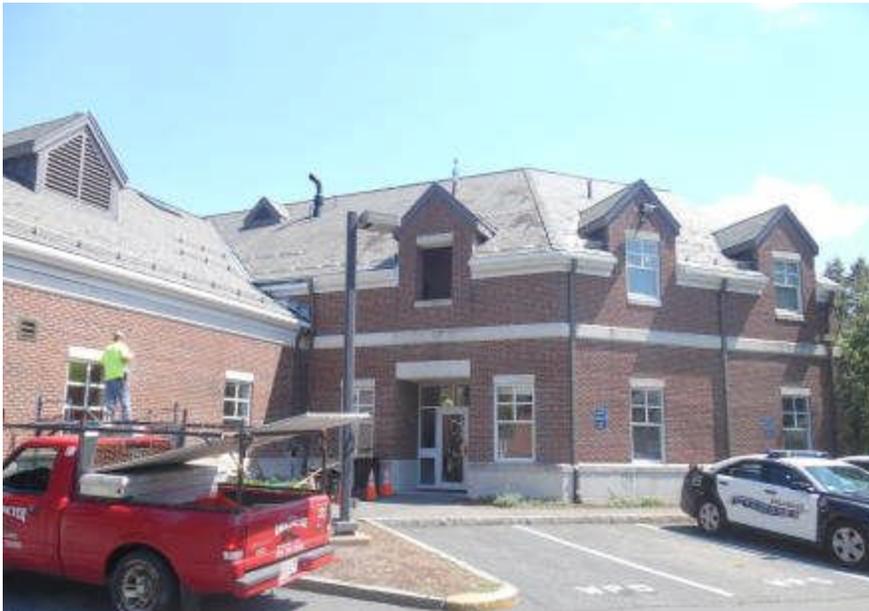
Photo 14

Partial north elevation of the WPS. The main building is on the right and the sally port is on the left.

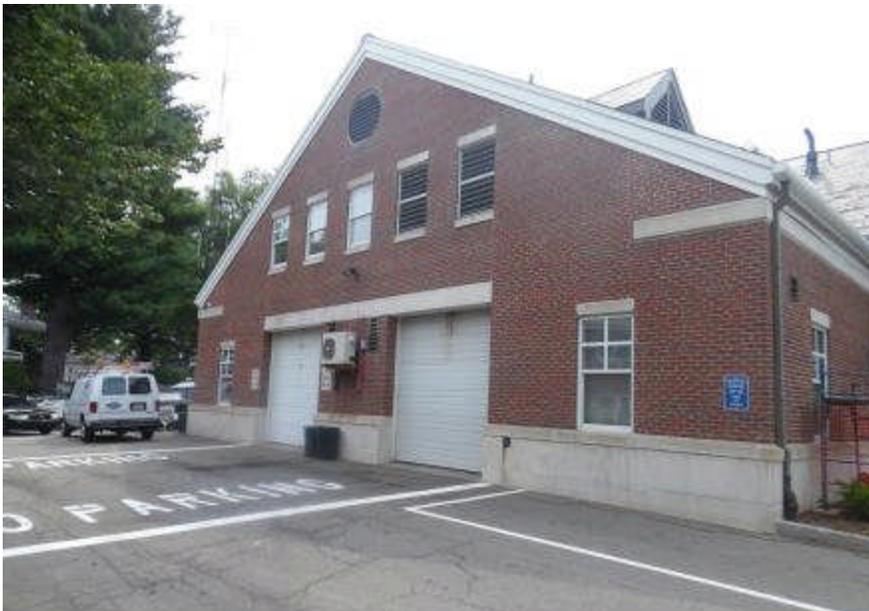
Photo 15

Partial north elevation of WPS ("sally port").

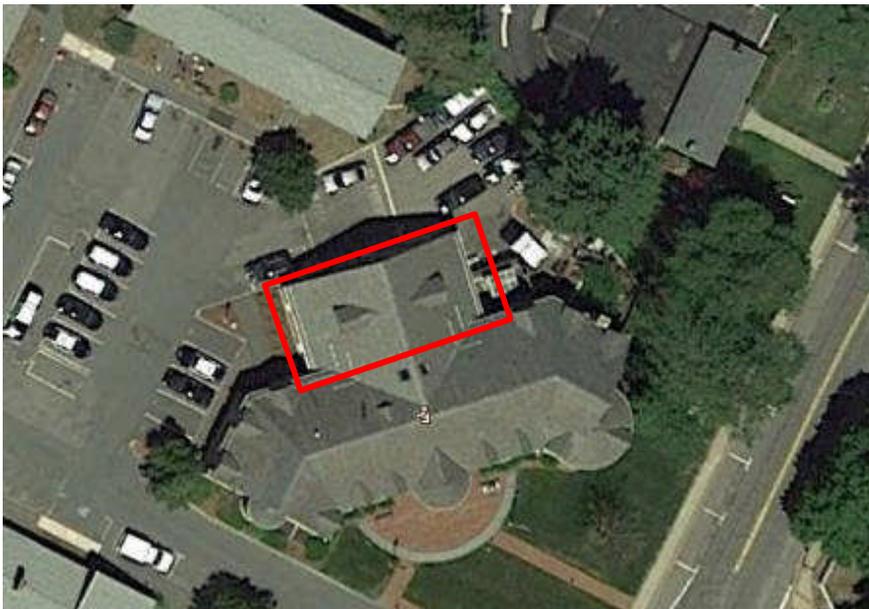
Photo 16

Satellite image of the WPS roof. The boxed area is the sally port.

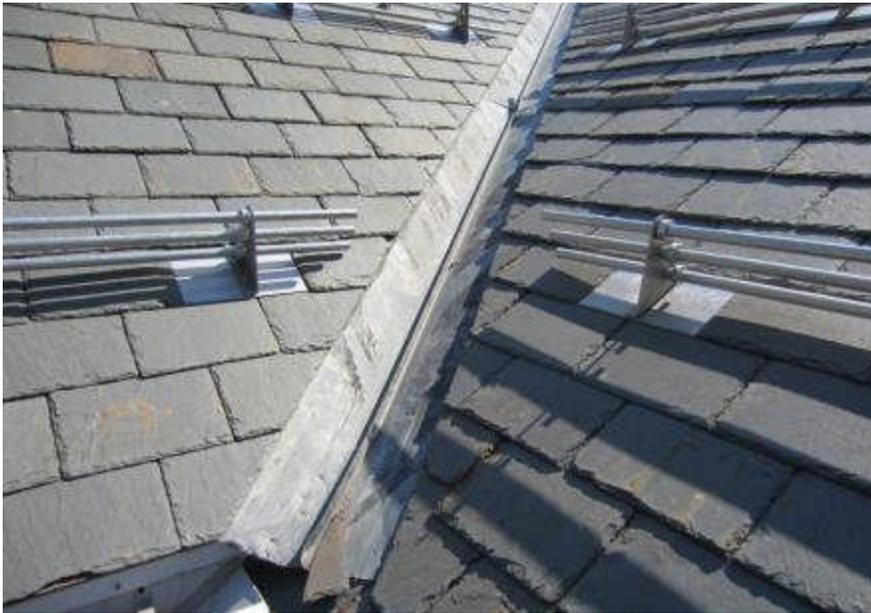
Photo 23

Natural roof slate with lead-coated copper valley pans and flashings.

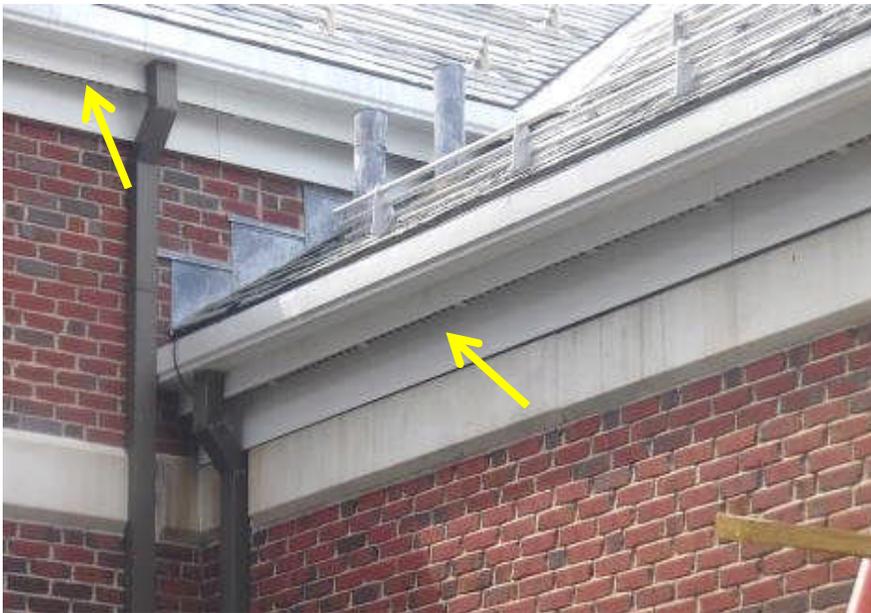
Photo 24

- Natural roof slate with lead-coated copper valley pans and flashings (Photo 23). The slate has a typical dimension of approximately 18 in. x 12 in.
- Soffit and ridge vents (Photos 24 – 28). The soffit vent is 2 in. wide, but mostly blocked by metal frieze and fascia trim cladding. The ridge vent has 3/8 in. dia. holes at approximately 2-1/4 in. o.c. The dormers have perforated soffits, but no ridge vents.

Soffit vents.

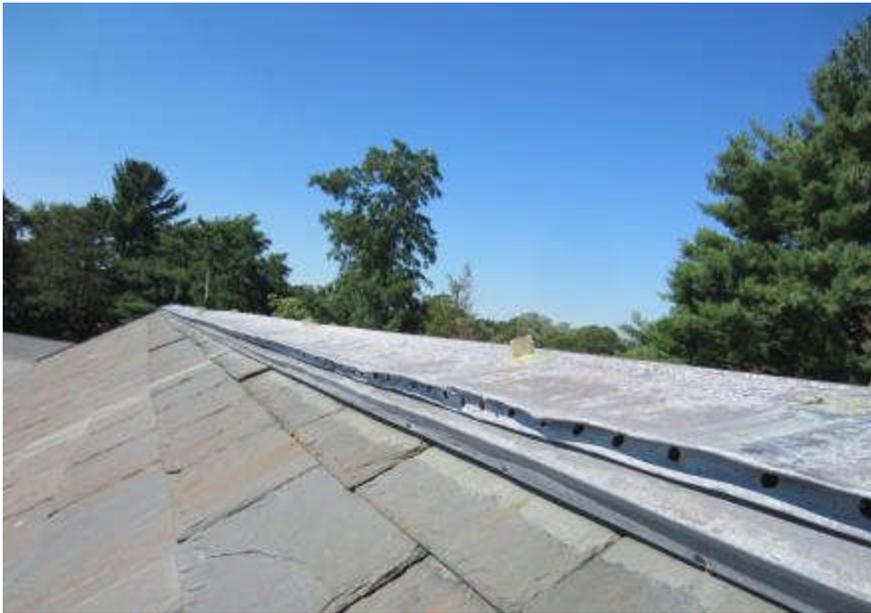
Photo 26

The ridge vent has 3/8 in. diameter holes at 2 1/4 in. O.C.

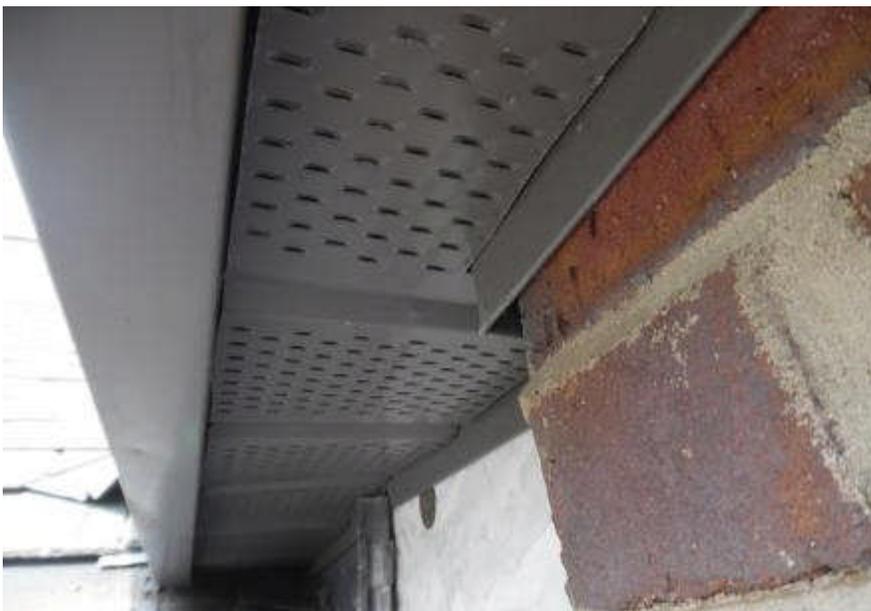
Photo 28

The dormers have perforated soffit vents.

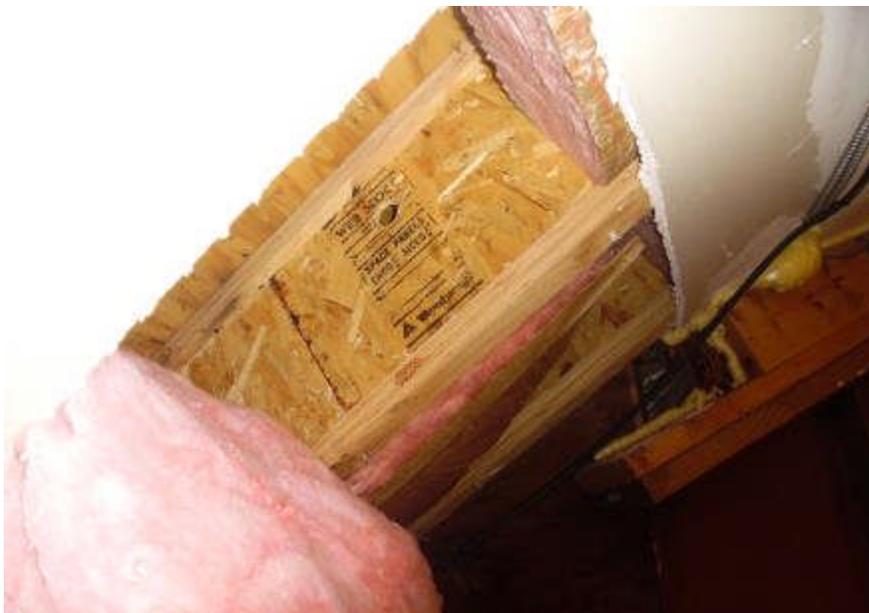
Photo 30

- Engineered wood I-joist roof rafters typically at 16 in. o.c. (Photo 30); we documented the spacing and dimensions in the sally port only. The rafters in the sally port are 14 in. deep, with an 11 in. oriented strand board (OSB) web and 2-1/2 in. x 1-1/2 in. flanges, and supplemented with laminated veneer lumber at dormers and skylights.

Engineered wood I-joint roof rafters typically at 16 in. o.c.

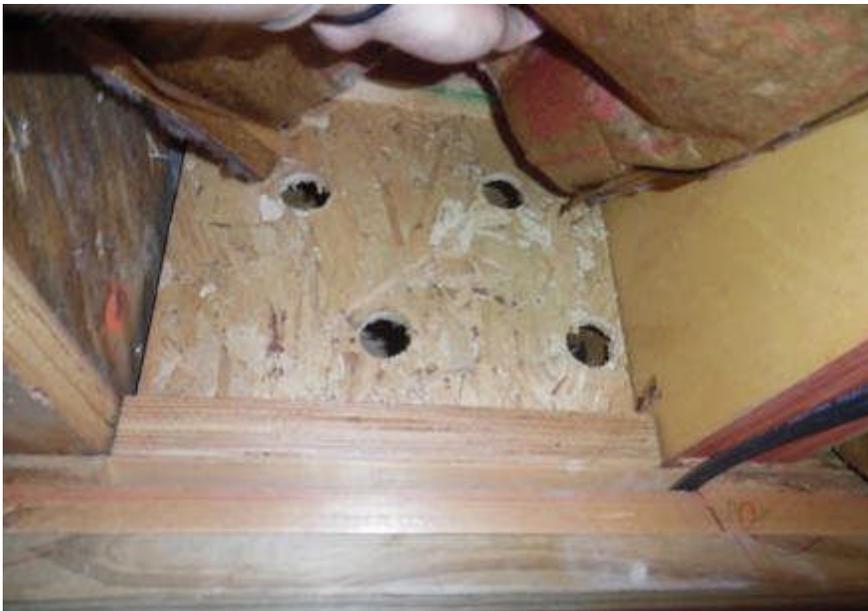
Photo 33

Wood blocking installed between the joists has approximately 1-1/2 in. diameter holes (visual estimate) that are located below the vent space between the insulation and roof sheathing.

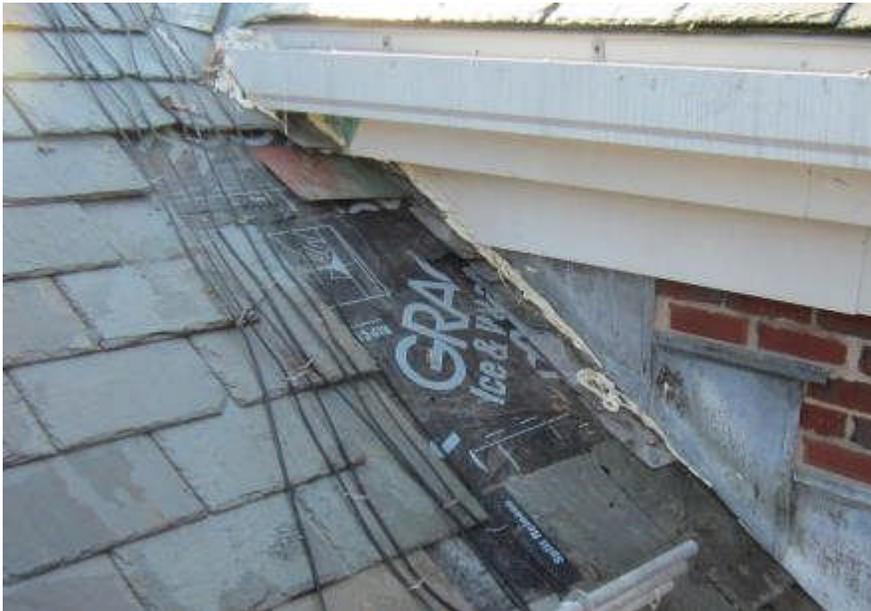
Photo 35

- Lead-coated copper step and base flashing forms the transition between the slate roofing and the brick masonry (Photos 35 and 36). Individual step flashing pieces are 8 in. by 12 in., folded along the long axis, and lap the downslope step flashing 3 in. The step flashing is counterflashed by base flashing that engages a reglet-terminated or through-wall flashing.

Lead-coated copper step flashing, counterflashing, and reglet-set or through-wall flashing.

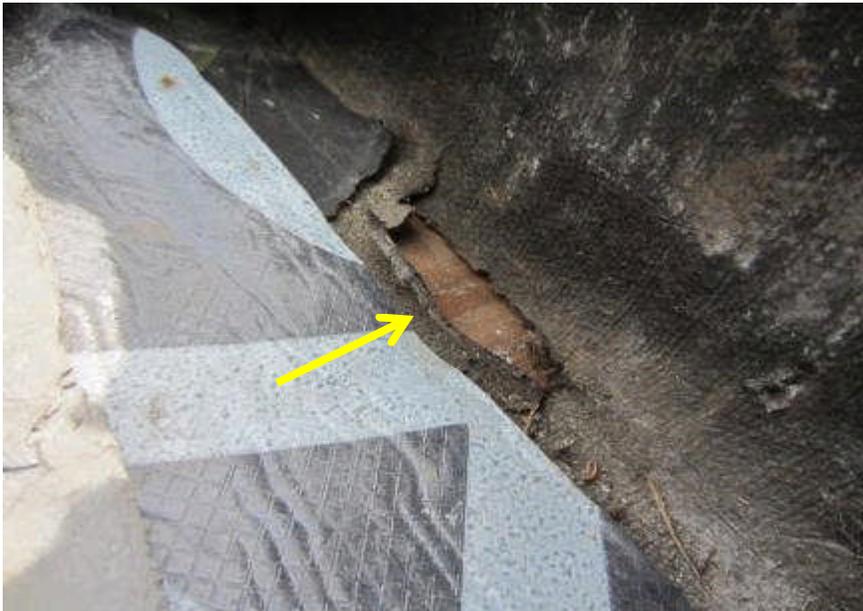
Photo 38

- The roofing underlayments (felt and membrane) terminate at the fascia and under the soffit where the eave is terminated against the roof at the base of the valley (Photos 37 and 38). We observed holes in the underlayment, through which water can leak, at several locations along the base of the sidewall. A large volume of sealant filled the void between the end of the gutter and roofing at this location (Photo 39); we assume this was an attempt to mitigate water leakage.

Hole in the roofing underlayment.

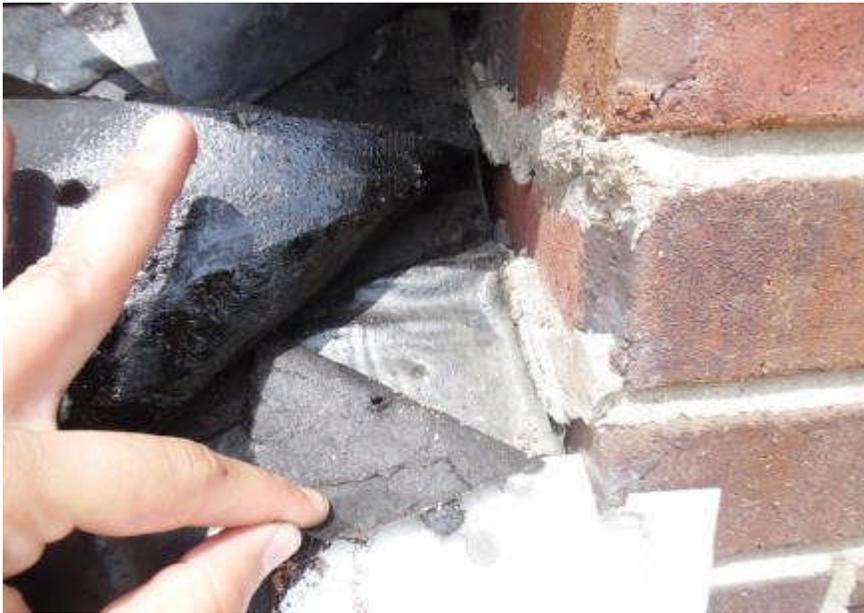
Photo 44

- The roofing underlayment turns up the dormer sidewall and is adhered to DuPont Tyvek water-resistant barrier (WRB) installed on the sidewall, with tunnels through the underlayment laps (Photos 42 – 44). The underlayment does not turn up the end of the brick masonry on the front face of the dormer.
- Lead-coated copper step flashing is counterflashed by standing seam lead coated copper wall panels (Photo 45). The step flashing is 8 in. by 12 in., folded along the long axis, and laps the downslope step flashing 3 in.
- The roofing underlayment terminates at the fascia and under the soffit where the dormer eave terminates against the main roof at the base of the valley, similar to Photo 38). We observed holes in the underlayment through which water can leak.

The underlayment does not turn up the end of the brick masonry on the front face of the dormer.

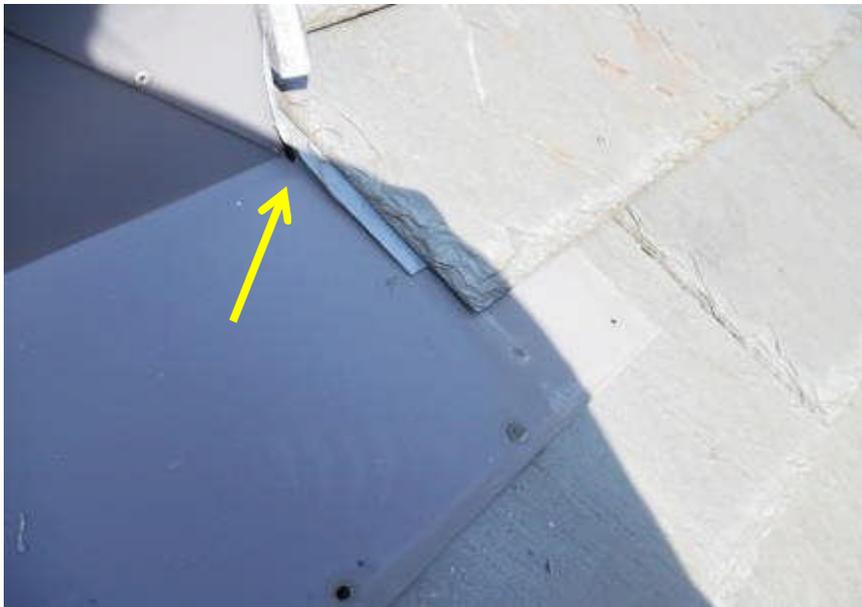
Photo 48

- We observed holes at the ends of the painted metal base flashing between the louver sill and roofing through which water can leak to the roofing underlayment (Photo 48).

Hole at the end of the painted metal base flashing between the louver sill and roofing. See Photo 46 for a further back view.

- The louver perimeter must be flashed and the plenum must be modified to be watertight and drained to stop water leakage; other modifications may also be appropriate.

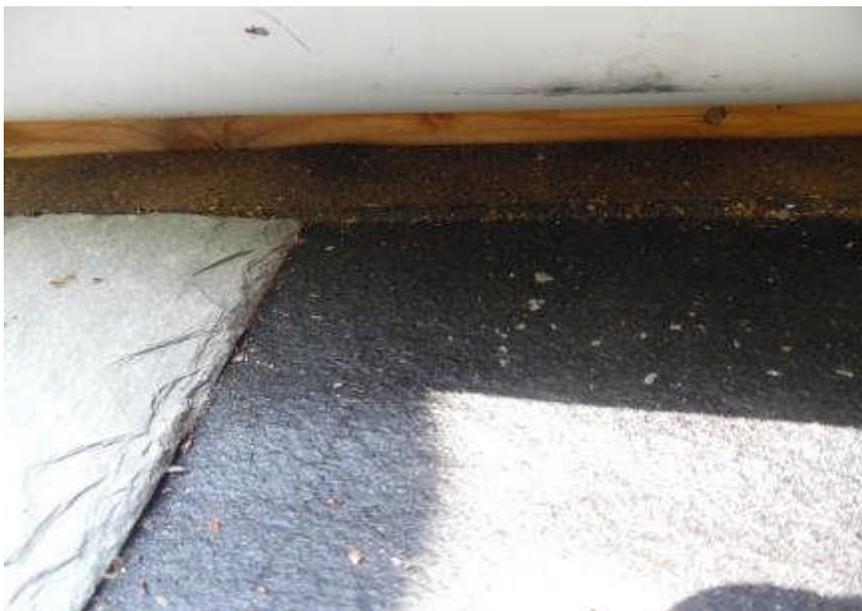
Photo 49

The asphalt-saturated felt roofing underlayment does not turn up the dormer wall below the louver sill (looking underneath the metal base flashing, see Photo 46).

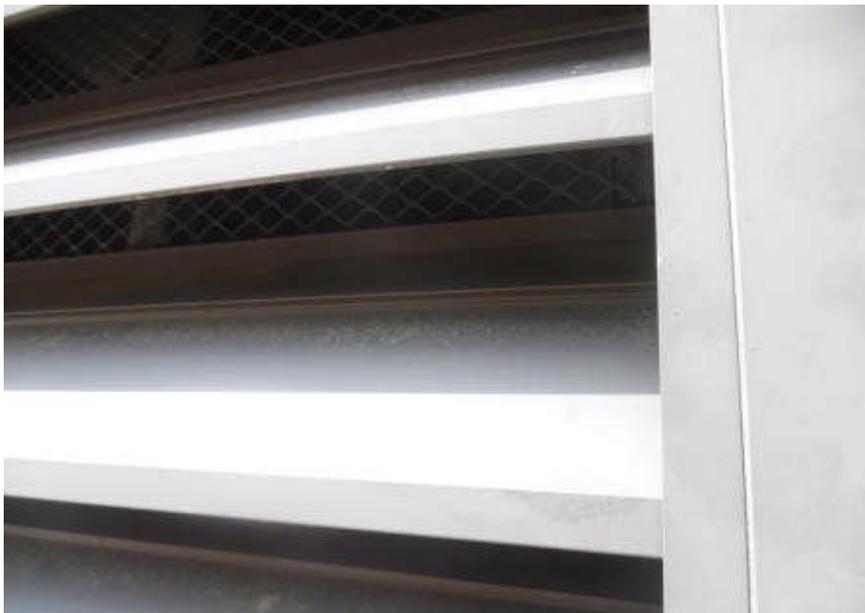
Photo 50

The vertical rise of the louver fins is approximately 5-1/2 in. with 1/2 in. overlaps. The louver screen has approximately 1/2 in. square holes.

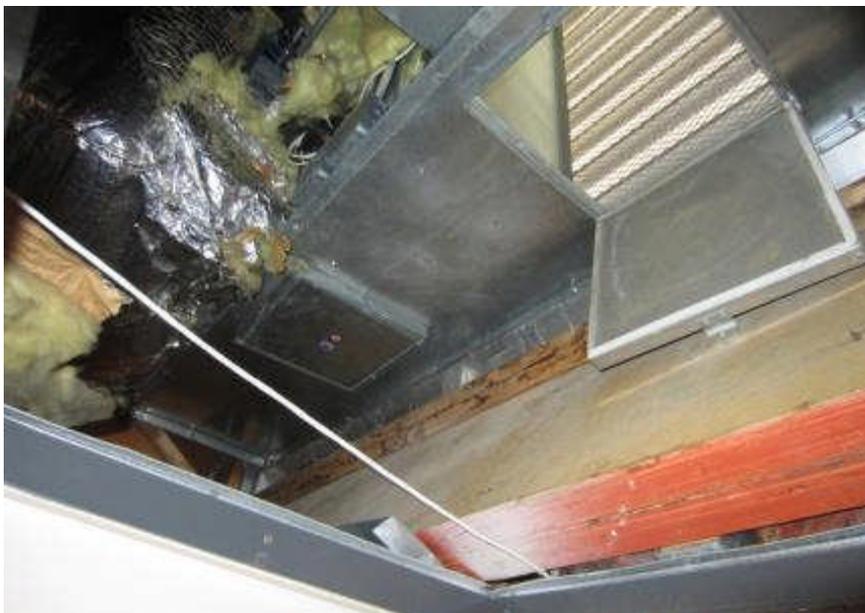
Photo 51

- The roof lacks effective ventilation, and its geometry concentrates water and snow runoff along dormer side walls, resulting in water leaks.
- The roof lacks an effective ice barrier, and has defective waterproofing detailing at rising walls, resulting in water leaks.
- A new roof with properly designed and installed flashings and ventilation is required to stop water leakage.
- The louvers lack effective perimeter flashing, and the louver plenum is not waterproofed and drained, resulting in water leaks.

The plenum behind the louver is not watertight and has approximately 12 in. square access hatches in the bottom.

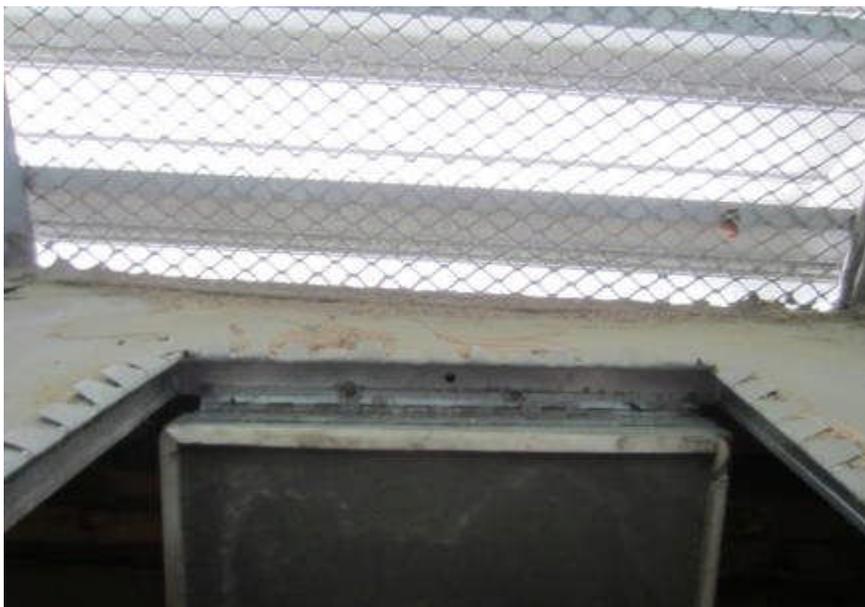
Photo 52

View of the louver fins and screen from within the plenum.

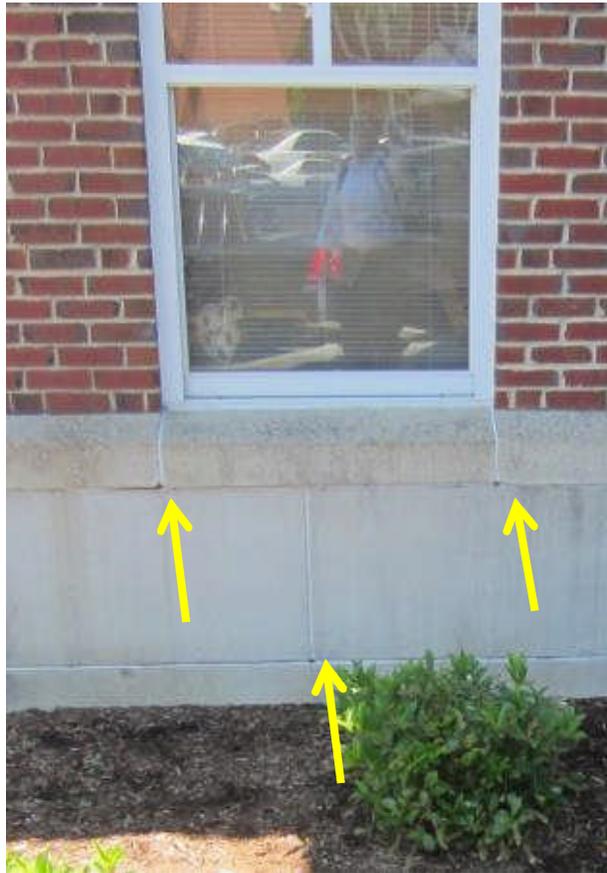
Photo 53

Weeps in the precast bed joints at the base of the walls (commonly at the bottom of head joints) and below precast window sills on the first floor.

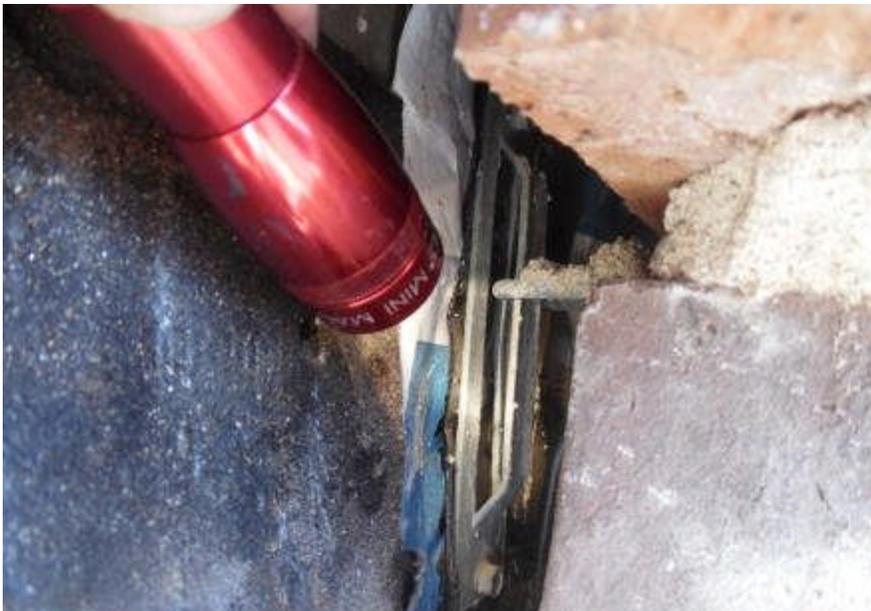
Photo 56

The brick masonry is anchored to the backup wall with vertically adjustable wire ties with a sheet metal plate.

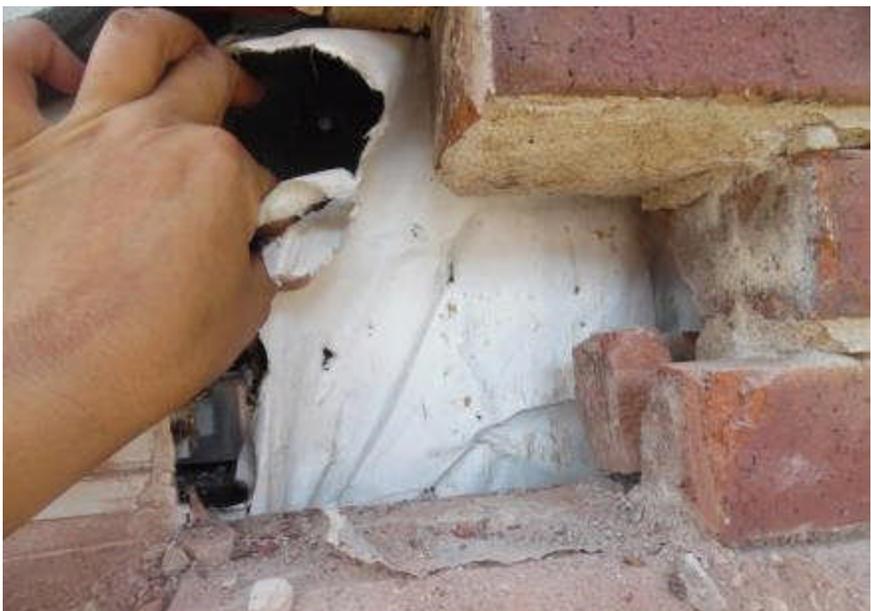
Photo 57

DuPont Tyvek over 1/2 in. thick brown paper-faced gypsum sheathing.

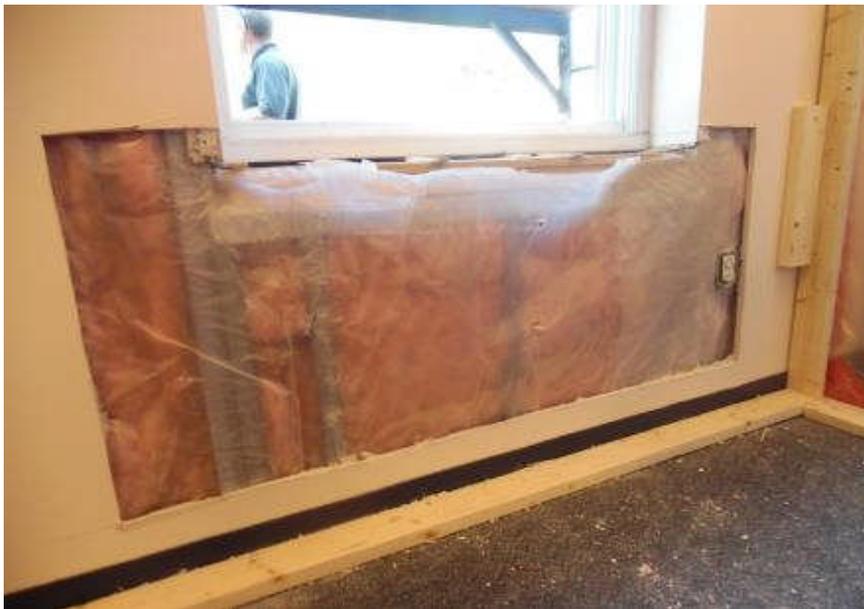
Photo 58

6 in. deep steel studs with unfaced fiberglass batt insulation between the studs, plastic sheeting vapor retarder, and painted interior gypsum wallboard.

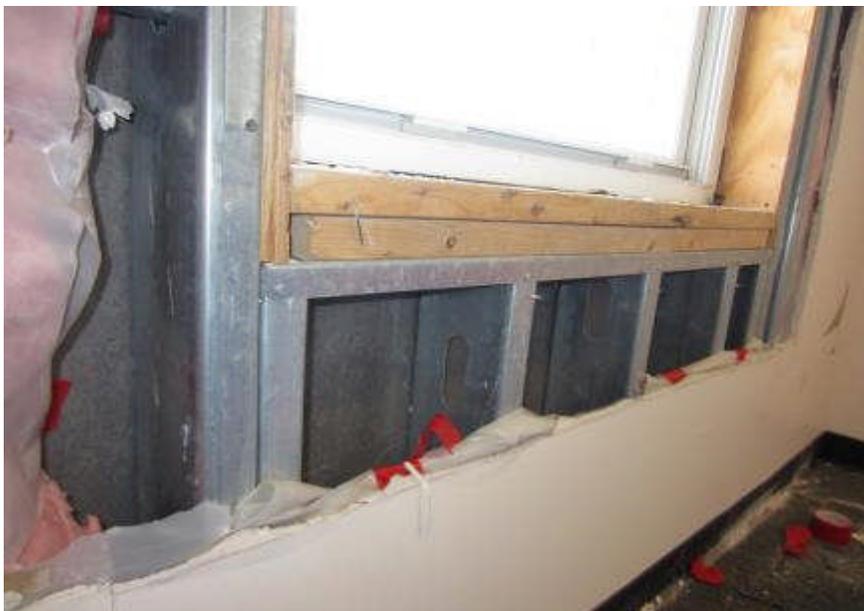
Photo 59

Wood blocking in the window rough opening. Wall assembly similar to Test Location 2. Note that batt insulation and vapor barrier was removed prior to the photo.

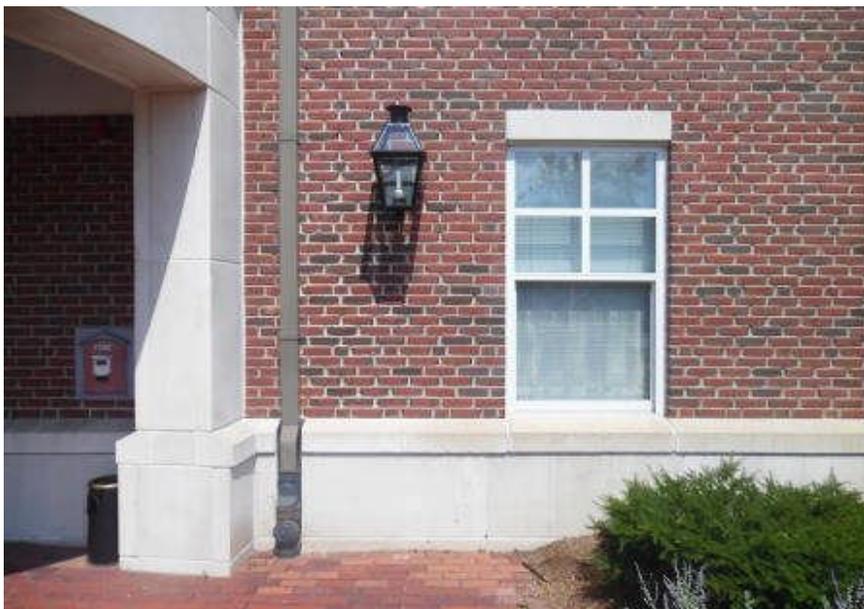
Photo 60

Windows are aluminum-framed and single-hung.

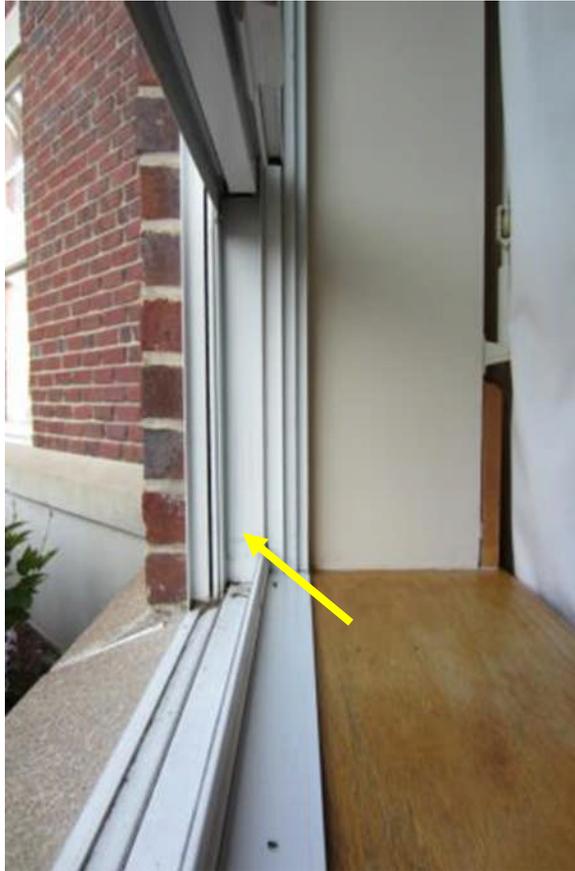
Photo 61

The aluminum sashes are thermally broken, and the aluminum frame has a thermal break in line with the fixed upper sash (arrow).

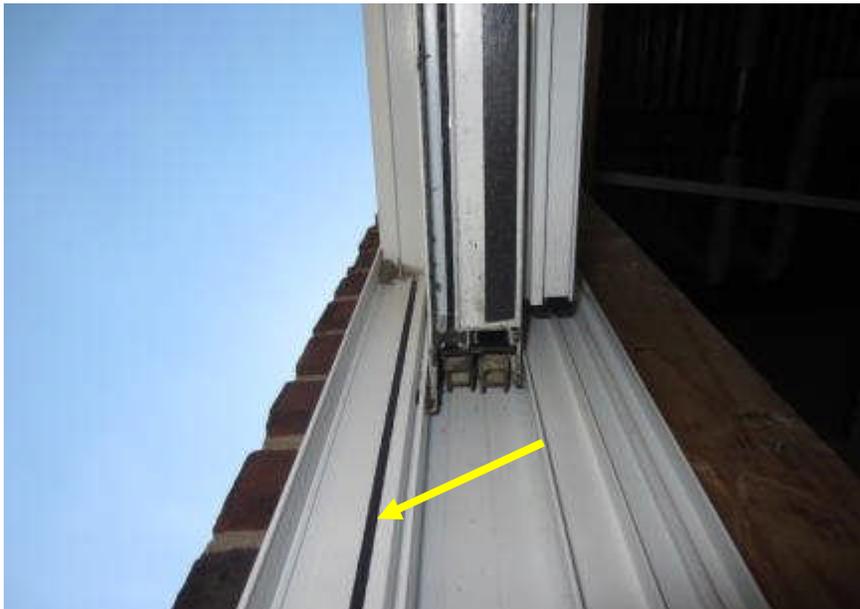
Photo 62

The aluminum sashes are thermally broken, and the aluminum frame has a thermal break in line with the fixed upper sash (arrow).

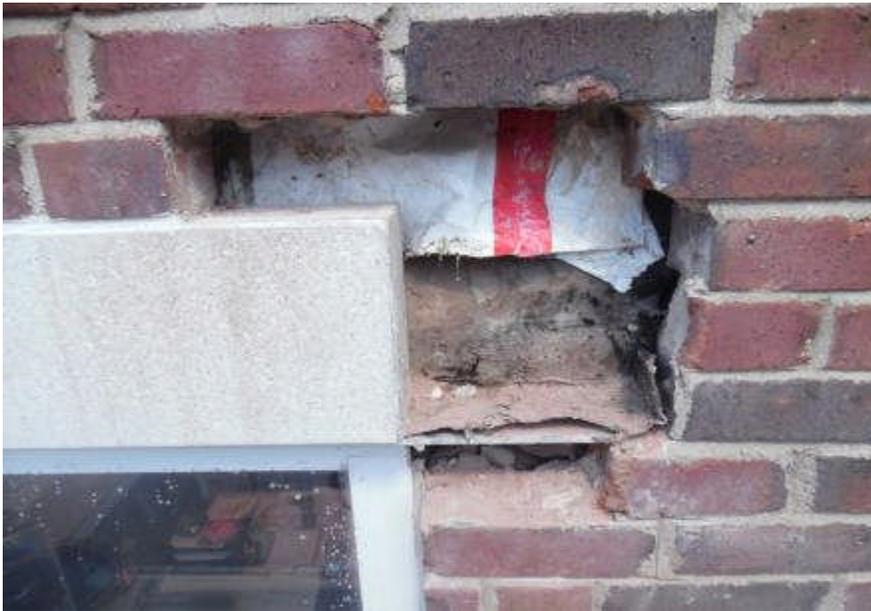
Photo 63

Asphalt-coated flexible copper flashing is installed over a steel lintel that supports the precast window head and masonry above.

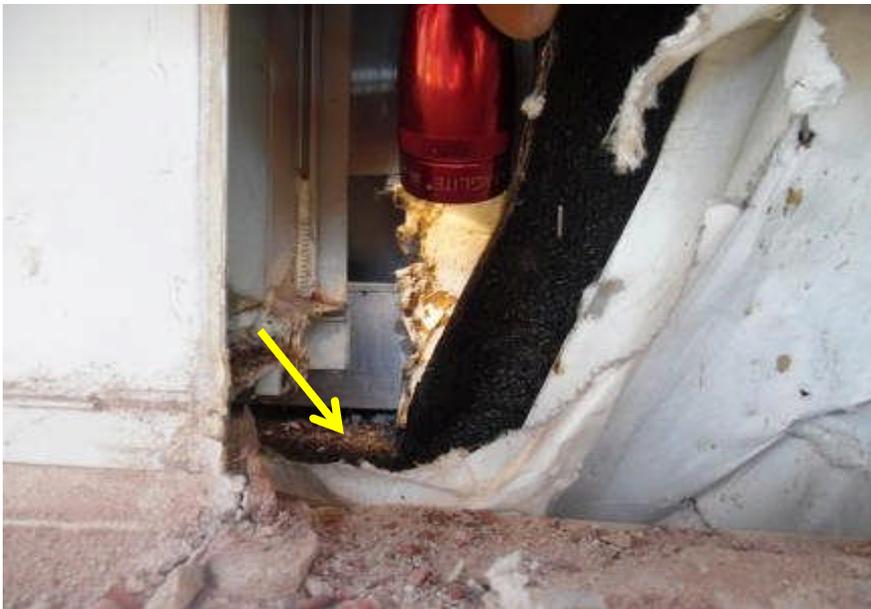
Photo 64

We observed no flashing tie-in between the window frame and DuPont Tyvek, or the sill flashing, and the window frame.

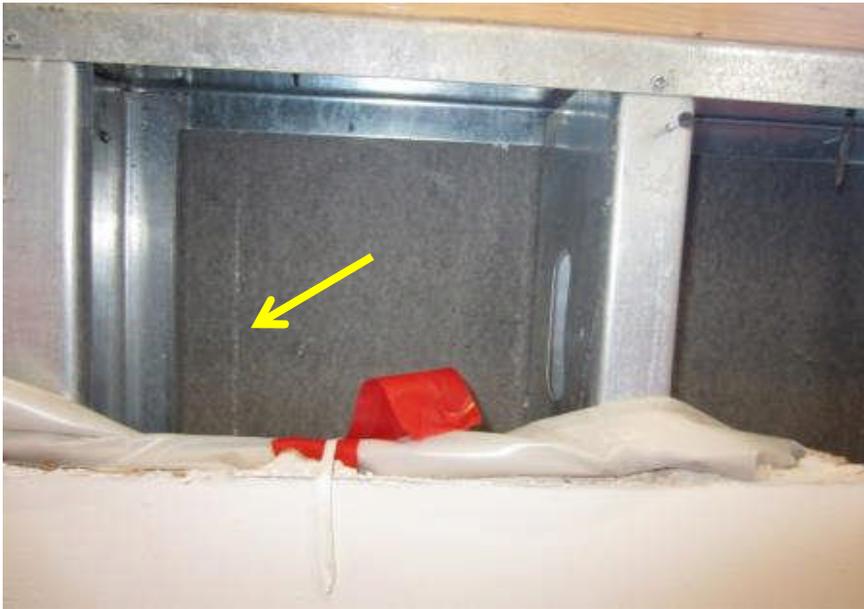
Photo 66

At the interior openings around the windows in the Patrol Supervisors Office and Lieutenants Office we observed apparent water streaks on the cavity side of the exterior gypsum sheathing below windows (Photos 66). We observed no damage to the exterior gypsum sheathing, apparent mold growth, or rusted steel framing.

Apparent water stains on the wood blocking in the window rough opening.

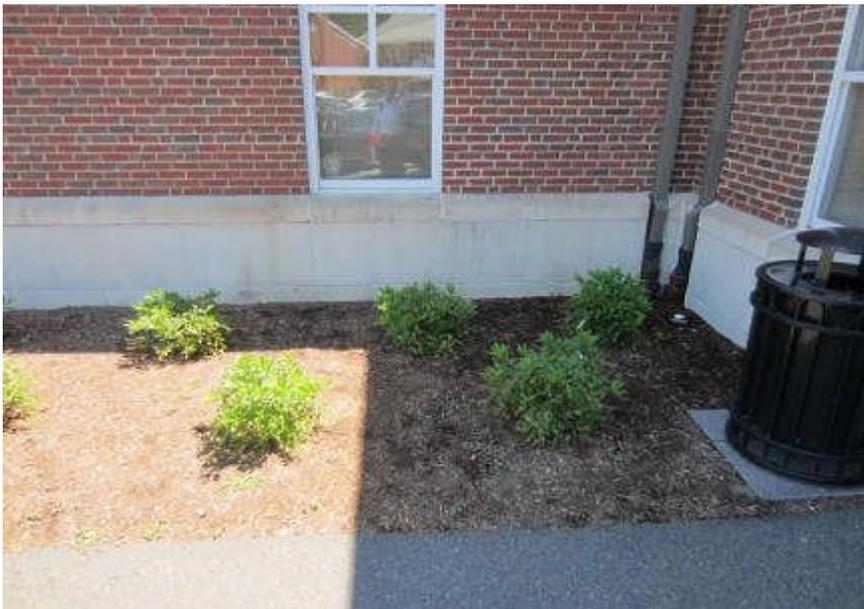
Photo 68

Overall view of precast concrete panels before removal.

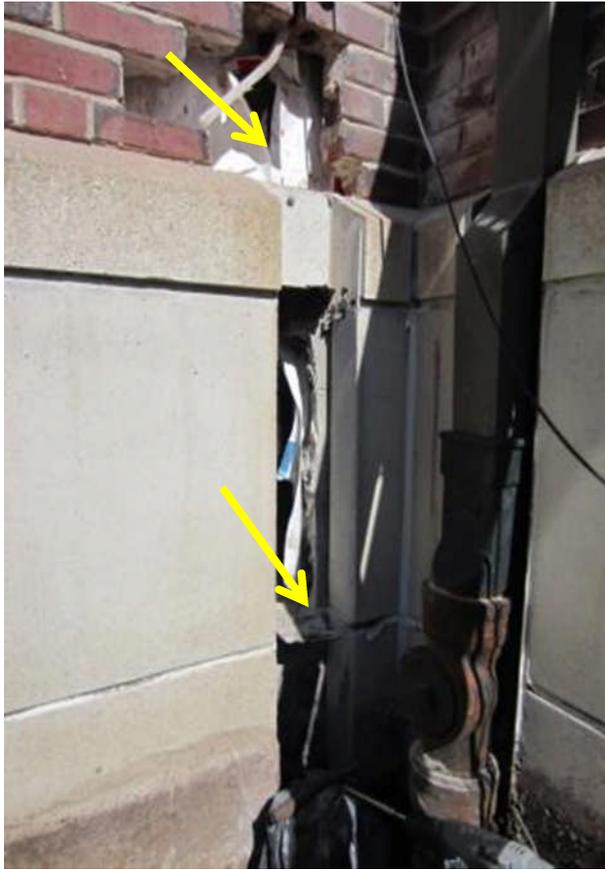
Photo 69

Asphalt-coated copper flashing through-wall flashing is installed underneath the precast concrete panel (lower arrow).

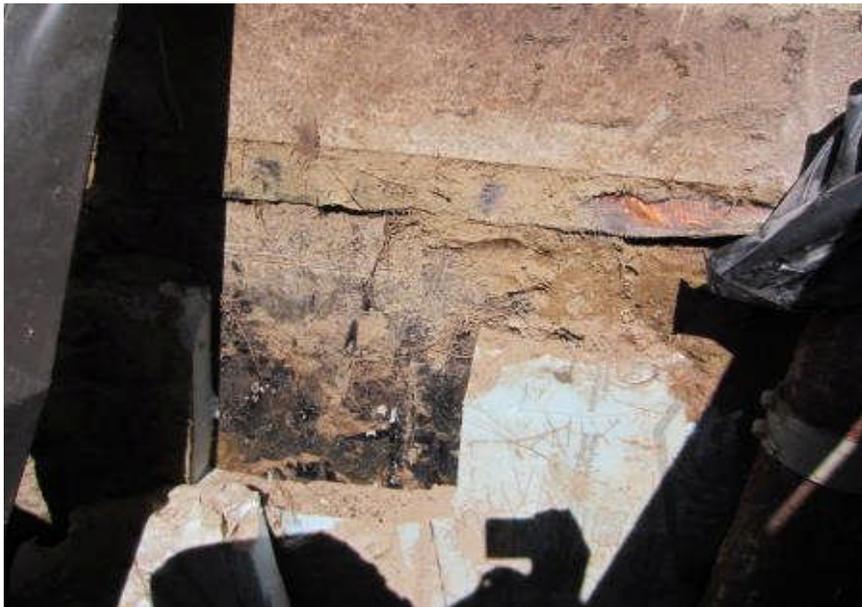
Photo 70

A thin fluid-applied dampproofing is applied to the concrete foundation and covered with 2 in. thick extruded polystyrene insulation.

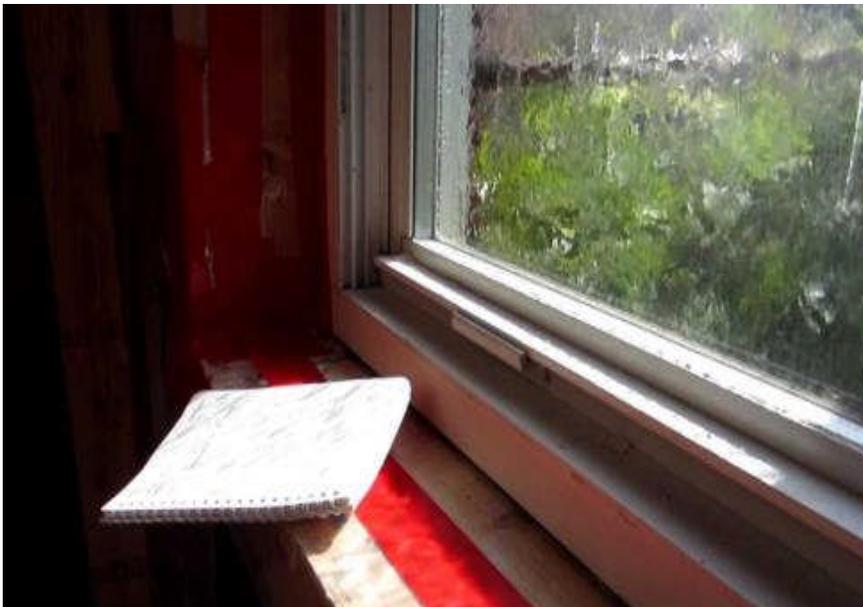
Photo 75

During our test at Location No. 2 the flowing air blew a 0.2 lb field book off the rough opening sill.

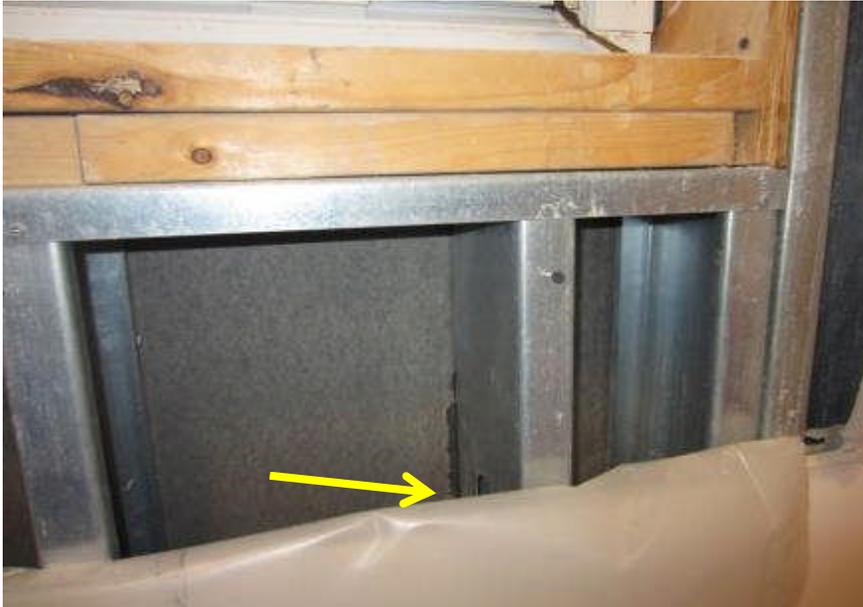
Photo 80

Water flowing down the cavity side of the exterior gypsum sheathing along a metal stud and into the stud track below the window.

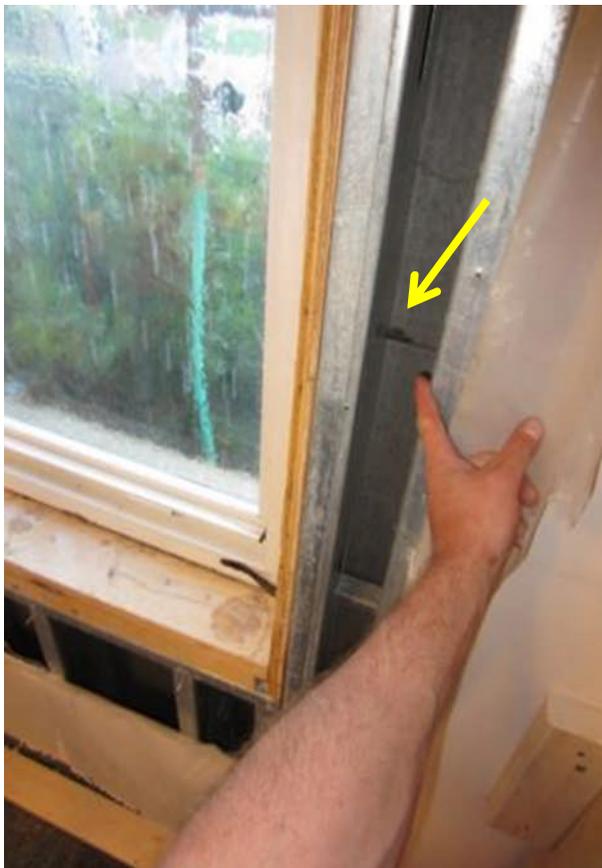
Photo 81

Wet spot at a horizontal joint in the exterior gypsum sheathing at the window jamb. We saw a similar spot at the other jamb.

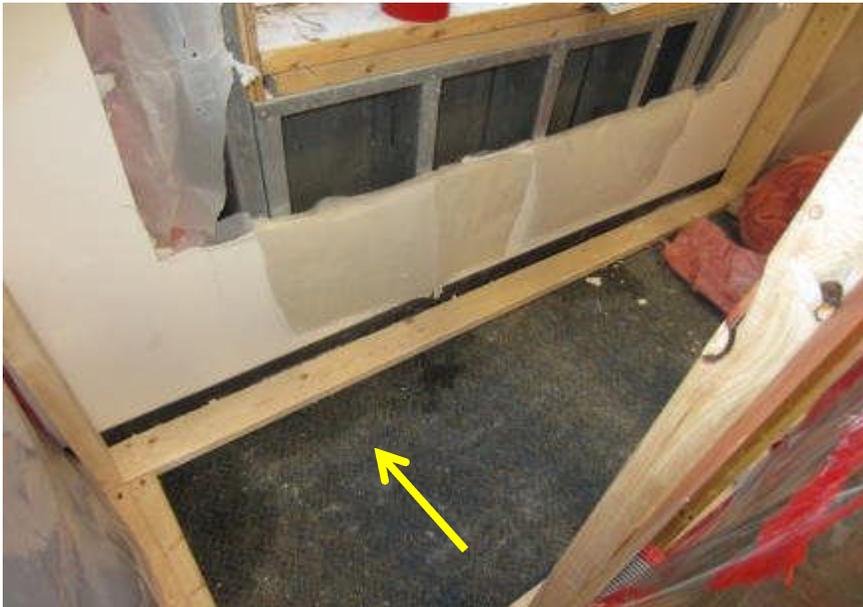
Photo 82

Wet carpet below the window.
