Roofing and Envelope Feasibility Study

Wellesley Police Station
Wellesley, MA
2 October 2015

SGH Project 150841

Project 150841 – Roofing and Envelope Feasibility Study (#WFMD-RFP-FY16-001),
Wellesley Police Station, 485 Washington St., Wellesley, MA

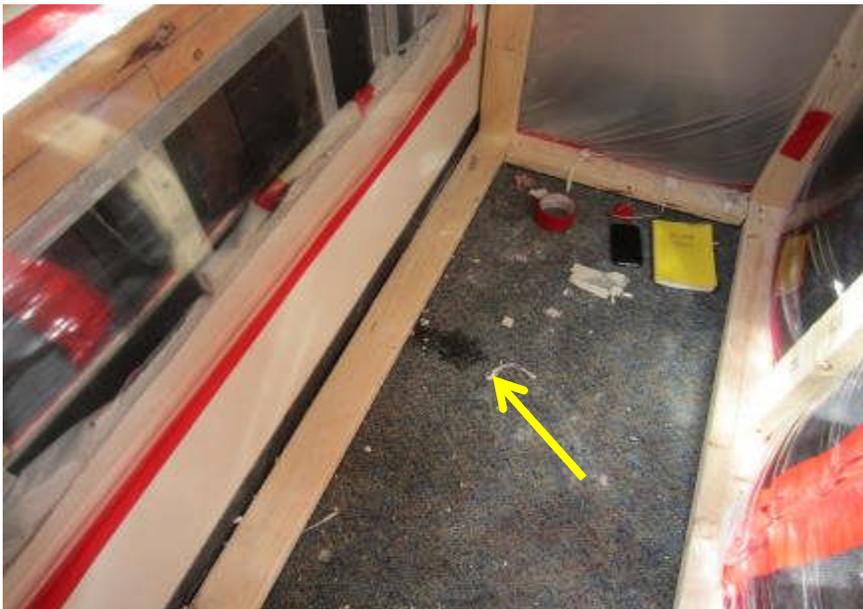
Photo 84

Water wetting the carpet
below the window.

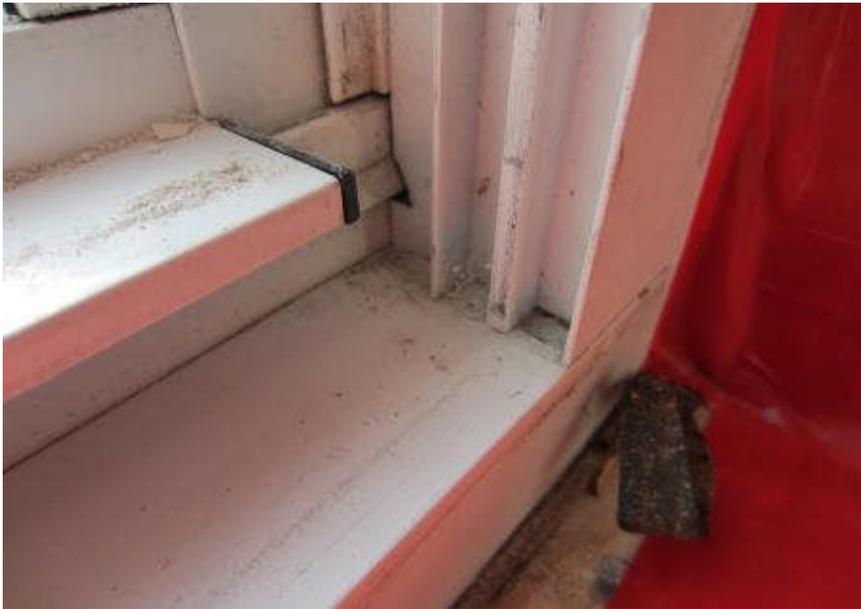
Photo 85

Water leaking
(spitting/bubbling) from the
right sill/jamb window frame
joint.

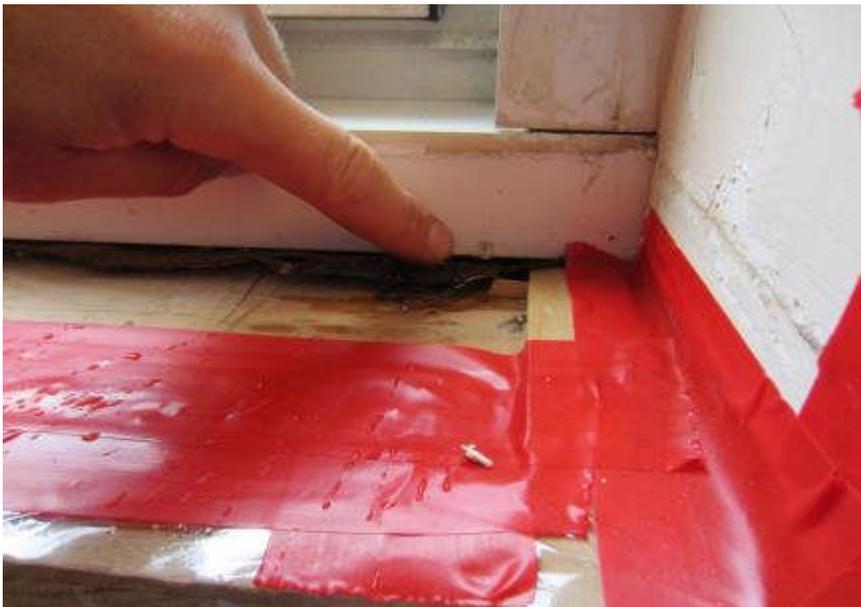
Photo 87

Water leaking (spitting) at the
joint between the window sill
and wood blocking on the
rough opening sill.

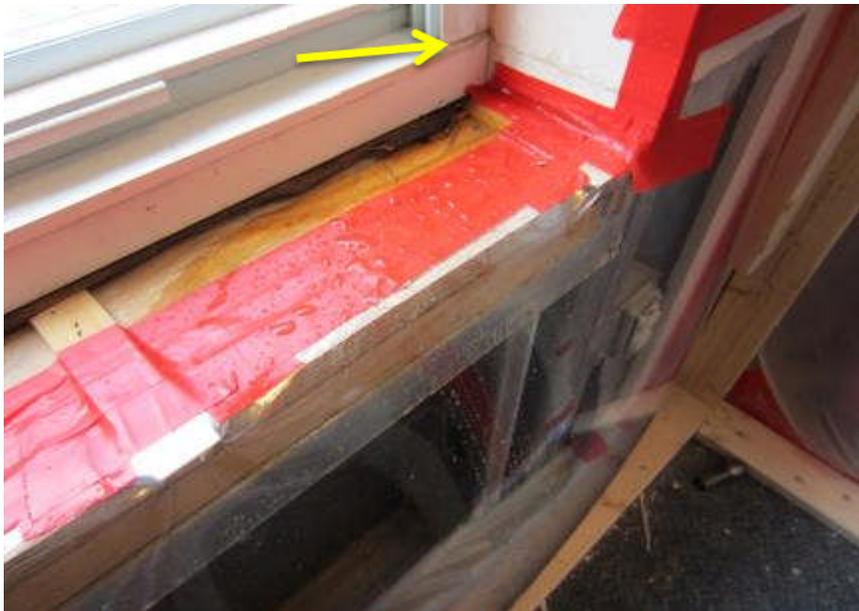
Photo 88

<p data-bbox="204 695 626 751"><u>Test Location No.2 (3 August 2015)</u> Lieutenants Office Room 101</p> <p data-bbox="204 787 800 968">Setup D: Spray rack over the window (Photo 86) Test Type: Static Test Duration: 7 min. without pressure differential, immediately followed by 15 min. with pressure differential Applied Air Pressure Differential (ΔP): 6.4 psf</p>	<p data-bbox="836 695 1414 814">1 min. after applying pressure differential – Water started leaking (spitting) at the joint between the window sill and wood blocking on the rough opening sill (Photo 87).</p> <p data-bbox="836 850 1414 968">2-3 min. after applying pressure differential – Water started leaking (spitting) from the right sill/jamb window frame joint (interior view, Photo 88).</p>

Water leaking (spitting) from the right sill/jamb window frame joint.
