July 21, 2025
Updated October 13, 2025

Re: Engineering and Cost Estimating Services
Wights Pond, Hundreds Road, Wellesley, MA

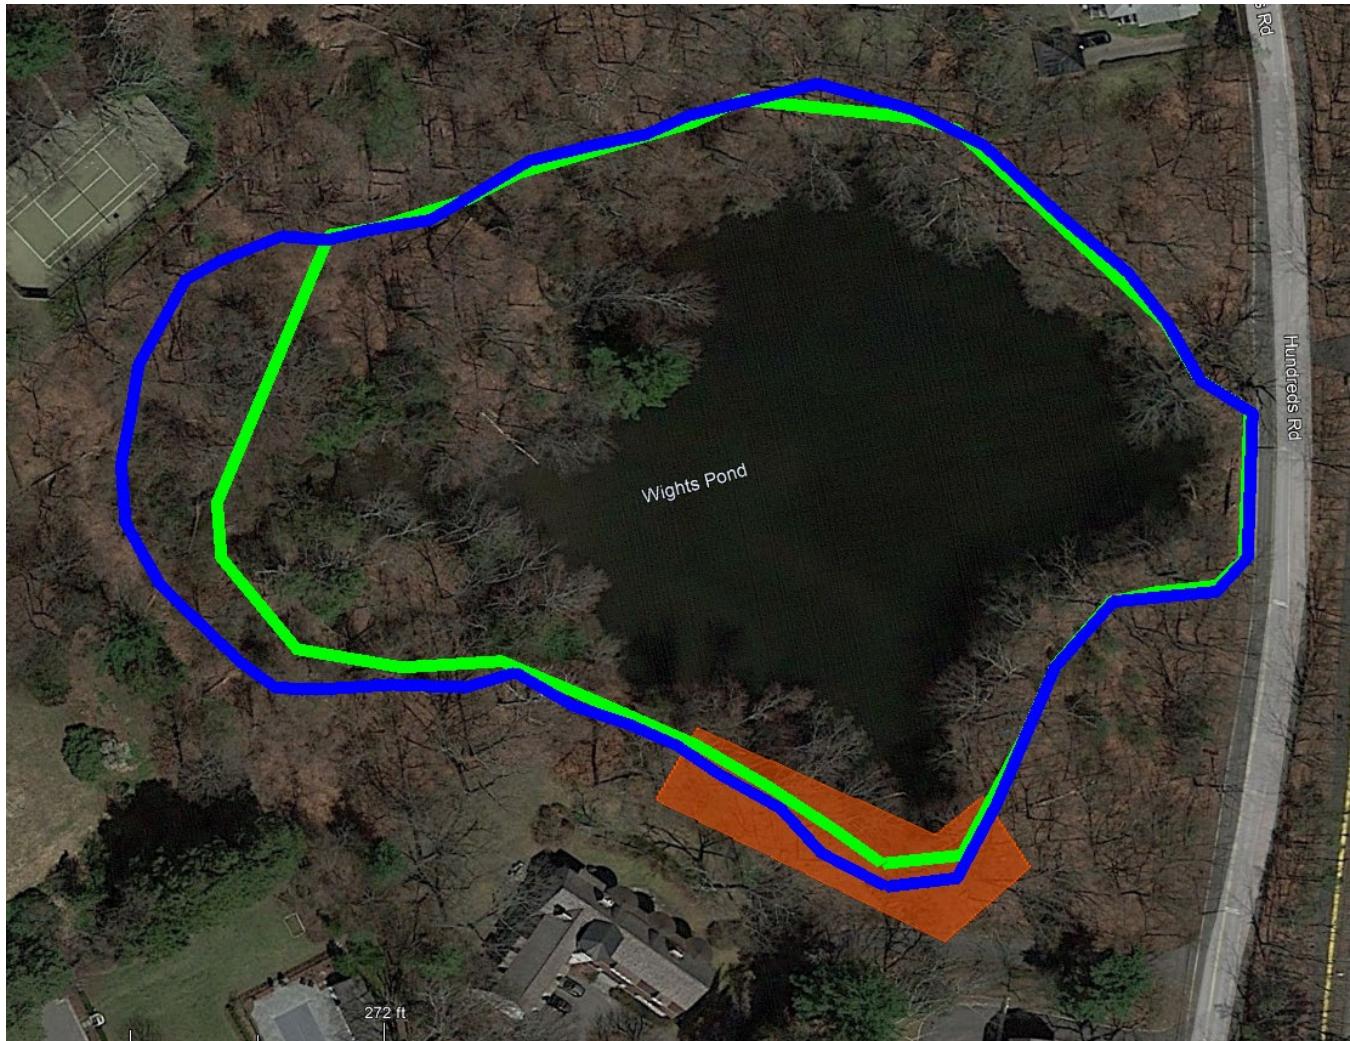
Figure 1- Schematic Representation of Potential Walkways, with the orange zone of dense growth that was inaccessible.

- The lower pathway, with less elevation change, would likely require multiple pedestrian bridges or pile supported elevated decking walkways to cross either wet areas, the streams, or branches of the pond.
- The higher pathway would require fewer pedestrian bridges, however, given the existing slopes on site, would require significant cutting and regrading in order to achieve an ADA accessible pathway.
- The crossing over existing culvert/spillway on the eastern side of the pond would require a pedestrian crossing structure with handrails due to the drop-offs on either side.
- Any pathway would require permitting under the Wetlands Protection Act and Wellesley Wetlands Bylaw due to the wetland resources that exist on site.

- Walking pathways would require some clearing and in order to avoid erosion and other negative impacts, we would recommend reinforcing the pathway with a geotextile fabric and either a stone dust cover or heavy-duty vegetative planting.
- The Town may want to consider acquiring an easement from the neighboring property (29 Hundreds Road) to the south to allow for easier access around the Pond.
- There isn't dedicated parking, possibly two spots along the western side of Hundreds Road, so the Town should be cognizant of that limitation.
