# Morses Pond Erosion Study Wellesley, MA

FINAL - October 2016

**Prepared by:**  
Horsley Witten Group, Inc.

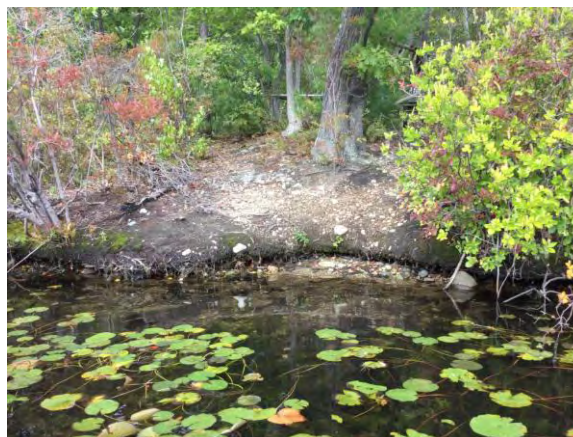
Boat and foot access point to island near Wellesley/Natick town line. Evidence of human activity on island (picnic table, compacted ground). If access to island is to be discouraged, stabilize exposed ground with coir fabric and plant native shrub species such as highbush blueberry. If access is to be permitted, install permanent or semi-permanent steps to minimize future soil erosion. In both scenarios, install coir logs to minimize future bank undercutting.

Boat and foot access point to island near Wellesley/Natick town line.

**Cause of Erosion or Deposition:** Launching boats/foot traffic

**Other Observed Impacts:** Unmanaged access, picnic area, boat launch

**Description:** Island has this one primary access through brush, so management of foot traffic is recommended. Install coir logs to control bank undercutting and plant native shrub plant species. If foot traffic is permitted, install rock or wood steps to reduce future impacts from foot traffic.

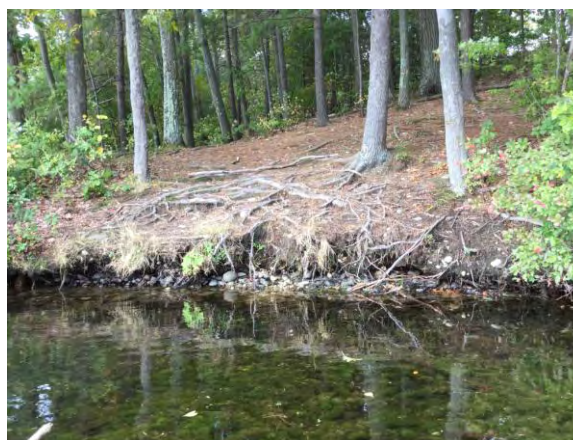
Popular pond access point through Natick DPW on western shore of pond. Evidence of common use of the area (exposed roots and compacted soil). Bank undercutting at this location likely exacerbated by long fetch and prevailing wind direction. Manage foot access at this location, stabilize slopes, and restore undercut banks.

Access point along pond's western shore near Natick DPW.

**Cause of Erosion or Deposition:** Foot traffic, wave erosion

**Other Observed Impacts:** Unmanaged access

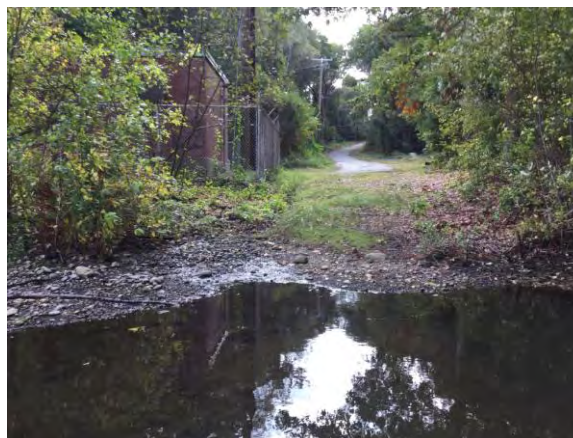
Pond access point from end of road at Natick Maintenance Facility. Evidence of little active use, potentially due to private property and shallow depths of pond at this location. Evidence of stormwater flows and erosion from end of road reaching pond. Stormwater management and reestablishment of the shoreline buffer are potential restoration scenarios.

Shoreline from end of utility access road.

**Cause of Erosion or Deposition:** Roadway

**Other Observed Impacts:** Unmanaged foot and road access

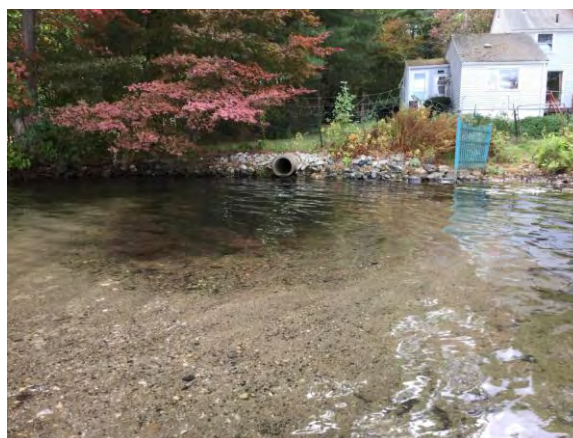
A 12" diameter concrete outfall drains into the pond at this location. The culvert was dry at the time of observation. Large deposit of sediment extends into pond from outfall. The outfall watershed is clearly a sediment source to pond during times of flow. Riprap around outfall appears stable. Water spurting from shore into pond about 30' west of outfall. Unknown source, and should be investigated.

Outfall and sediment deposit in pond.

**Cause of Erosion or Deposition:** Large sediment apron at mouth of outfall

**Other Observed Impacts:** Water source of unknown origin entering pond

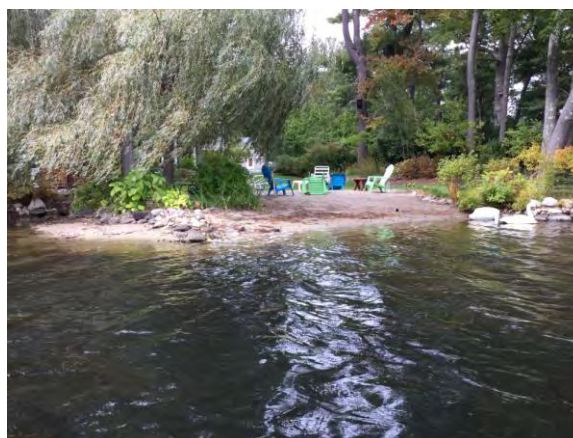
Private beach and shoreline for residence along College Road. Beach sand and rocky point appear vulnerable to erosion from wave action. 8" drain entering pond near this private beach did not appear to be conveying any drainage at the time of observation, nor was a sediment bar noted in the pond at the outfall. Explore replanting native vegetation where possible along the shoreline and reinforce the outfall with riprap. Inquire about lawn treatment due to proximity to pond.

**Cause of Erosion or Deposition:** Beach at residence

**Other Observed Impacts:** Beach, outfall stabilization, lawn runoff

Beach and waterfront.

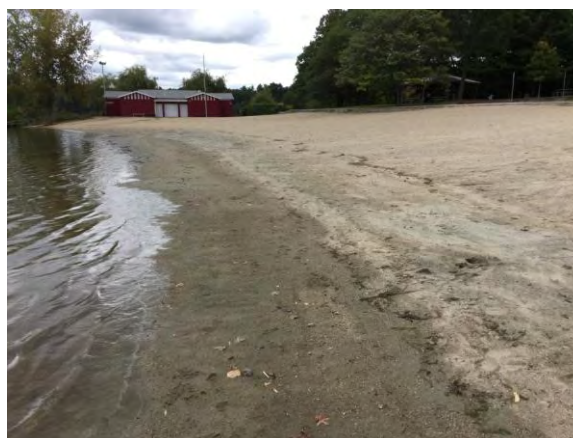
Wellesley Town Beach is an asset to the town, and appears to be maintained as such. It is also a contributor of sediment to the pond and is a good location to apply restoration practices, preferentially during the beach off-season. Because of the excellent public access, it is also an excellent candidate for educational programs on erosion and sediment control and how human influences impact water bodies.

Wellesley Town Beach

**Cause of Erosion or Deposition:** Beach

**Other Observed Impacts:** Beach erosion

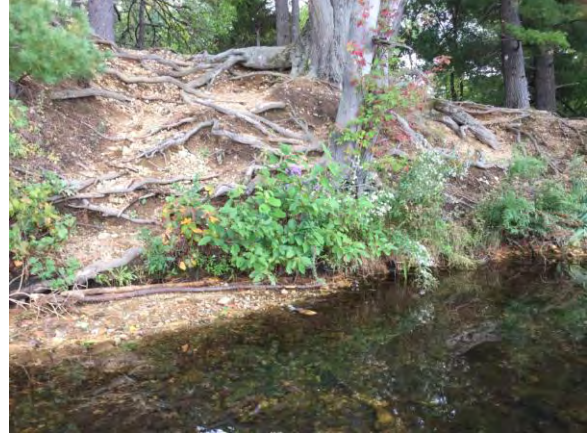
Steep foot access point to pond from walking path on Morses Pond Land. Due to position on public land and proximity to deep water, this location is popular among fishermen. Heavy foot traffic, steep slopes, and erodible soils have created an area of immediate concern for erosion and sedimentation issues. This location is an excellent candidate for several erosion/sediment control methods. This location could also be valuable to educate the public about erosion, its causes, and methods to address it. Establishing this area as a formal pond access with steps, stairs, shoreline stablization features, etc. should be considered as well.

**Cause of Erosion or Deposition:** Heavy foot traffic

**Other Observed Impacts:** Unmanaged access

Steep and eroded pond access location.

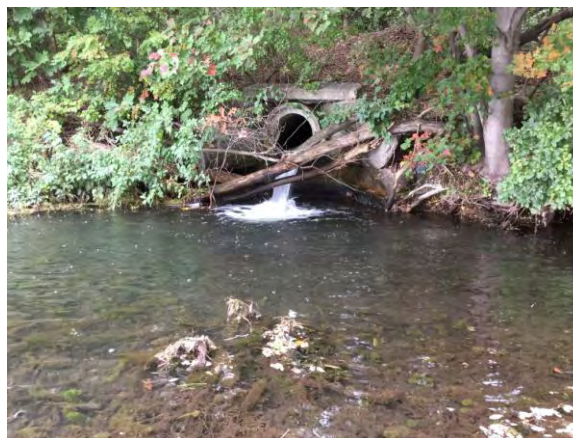
At this location, an 18-inch concrete outfall enters the pond from the north. At the time of observation, flows from the outfall were heavy. Flows have created a scour hole on the pond bottom and undermining under the outfall against the bank. Assessing the stability of the outfall and restoring it with rip rap is a potential restoration scenario.

Outfall near Crosstown Trail.

**Cause of Erosion or Deposition:** Outfall

**Other Observed Impacts:** Scour on pond bottom and bank undermining under the outfall

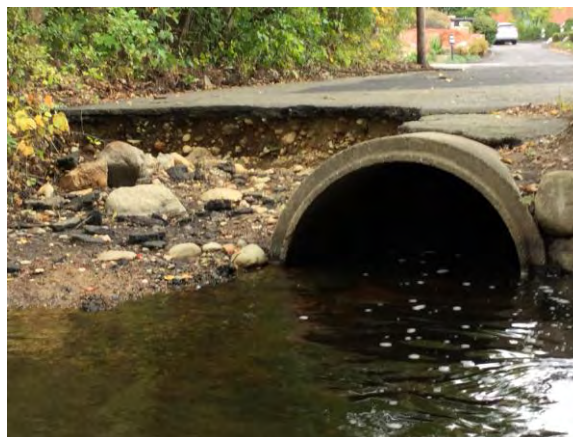
This location is behind 4 Grove Rd in Natick. A 48" diameter culvert conveys flows from Jennings Brook directly upstream of its confluence with Bogle Brook. The parking lot behind 4 Grove Rd extends right up to the edge of the culvert where a large washout has occurred. Outfall stabilization and improved stormwater management practices are appropriate restoration strategies.

48" concrete culvert conveying flows of Jennings Brook. Note erosion next to culvert.

**Cause of Erosion or Deposition:** Gully next to 48" ID culvert
