## SECTION 1. PROJECT APPROACH

Public resources, especially as unique as the Fuller Brook Park, contribute heavily to what makes Wellesley a great place to live. The Fuller Brook Park Preservation Project is now entering into its third phase, the implementation of the design. While all phases of the program are important for various reasons, this is the phase that will directly result in the skilled crafting of the desired improvements into an engineered plan that is fiscally sound and technically accurate. This will ensure that the construction phase is successful and that this valuable resource will be improved and protected for future generations to enjoy.

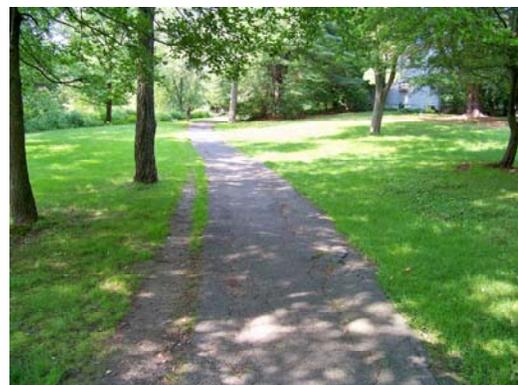
The Preliminary Design Plans shows alignment shifts in the path for various functional reasons. These include providing space for wet meadows, avoiding manhole covers, moving away from fences or other fixed objects which are currently very close to the path, and/or improving the path's approach to roadway crossings. Alignment shifts are also proposed to add interest and enhance visual appearance. This proposed alignment will be reviewed, adjusted and design engineered to facilitate its layout in the field for construction purposes as well as quantity calculations for contractor payment.

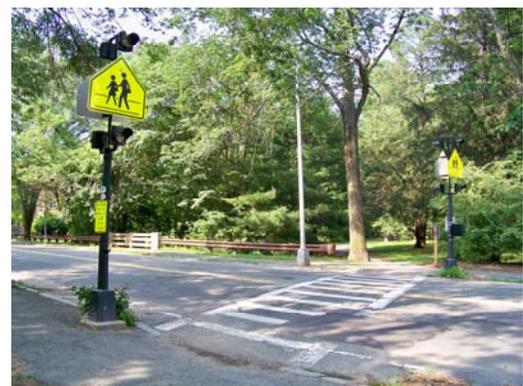
The path intersects 11 roadways. Three of these currently have high visibility pedestrian crossings with signage and warning beacons. While some of the remaining may not need enhanced measures, there are others that should be evaluated for greater pedestrian safety given traffic flow and other parameters. An example is Cottage Street and Abbott Road, where some preliminary studies have been conducted. Our Traffic Engineers will review these locations and make recommendations for the Town's consideration.

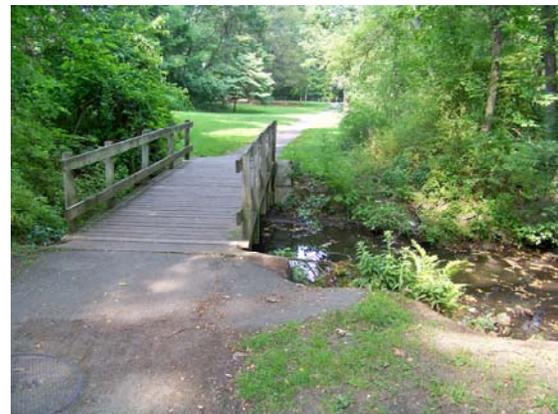
While the intent is to retain the current footbridges, with the possible exception of the one in the boardwalk area in Segment 4, there are related issues to be addressed. Our field walk noted that at most bridges, there is an unprotected area between the path and the brook at the end of the bridge railings. While in many cases, the drop in elevation is not significant between the path and the brook, there are some locations where the drop is significant. An example is the footbridge path near the rear of the Hunnewell School. Our Team will evaluate measures to provide a level of protection that is in keeping with the natural character of the surroundings. The goal will be to minimize potential falls/slips, particularly in locations used by school aged children. Also to be considered in some of these locations there is a need to retard the flow of heavy runoff from the path flowing into the brook to minimize erosion of the bank.

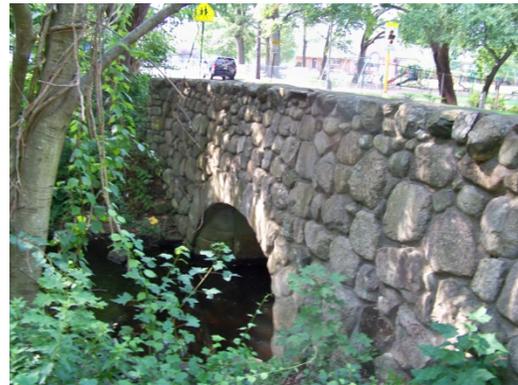
### **Cameron Street**

This structure consists of a 4 ft high x 8 ft wide by approximately 42.5 feet long box culvert with field stone wingwalls and headwalls formed into the shape of an arch. These walls extend up to form parapets along the back edge of the sidewalks. In the northeast corner of the crossing a small section of steel highway guardrail has been installed to protect vehicles from the rather steep embankment sloping down to the river.

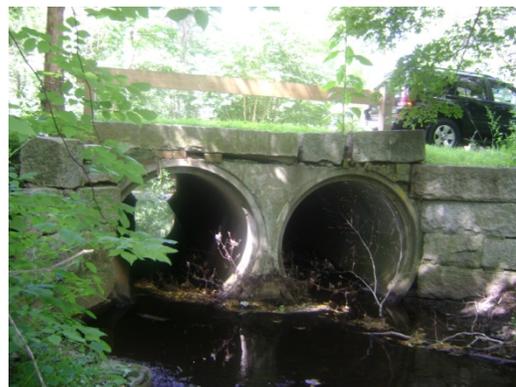
### **Brook Street**

This structure consists of twin 6 foot diameter reinforced concrete pipes with stone wingwalls and brick / stone headwalls. It was noted that there are several gaps between the stone headwalls and the brick and mortar area above and around the pipes. At this location, short sections of wooden guardrail are present just in front of the culvert's headwalls.

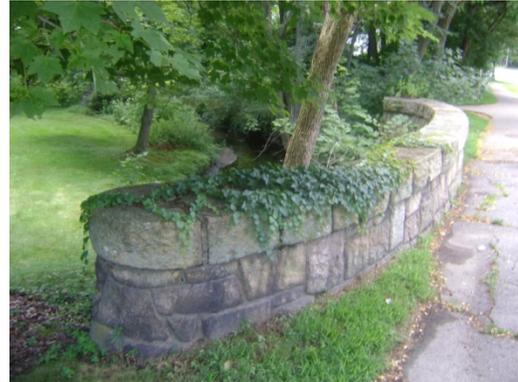
**Wellesley Avenue**

This structure consists of a 6.1 ft high x 7.5 ft wide by approximately 46.5 feet long box culvert with field stone wingwalls and headwalls formed into the shape of an arch. These walls are in very good condition and extend up to form very nice looking curved parapet walls along the back edge of the sidewalks. The ivy plants and curved parapets provide a historic look and feel to this location.

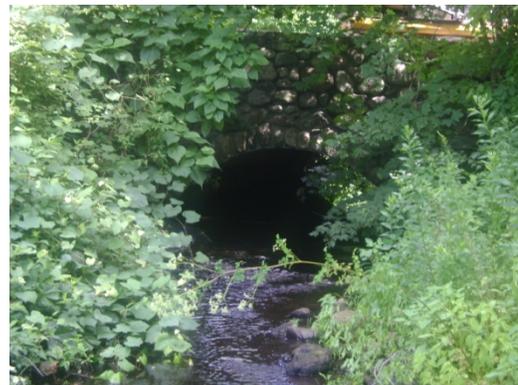
**State Street**

This structure consists of an unknown sized box culvert with field stone wingwalls and headwalls formed into an arch. This structure is heavily overgrown with vegetation and not very visible from the path. Again, at this location, the stone walls extend up to form parapet walls along the back edge of the sidewalks.

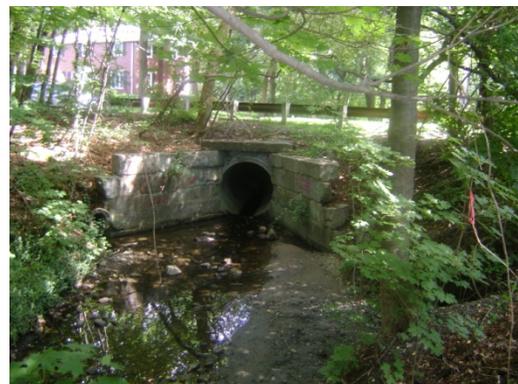
**Forest Street**

At this location, a 60" diameter reinforced concrete pipe carries Fuller Brook under the roadway. Stone block wingwalls and headwalls provide support of the roadway embankment. At this location some minor bank erosion was noted at the ends of the wingwalls. Along the roadway a short section of steel guardrail with wooden posts and an all wooden guardrail are present.

basin is depressed and most likely is a regular source and conduit for sediments reaching the brook and contributing to the required past and planned dredging. Another location is at the Forest Street Bridge where catch basins appear to discharge directly into the brook without the benefit of sumps or other BMP's. **Our Team will evaluate each roadway crossing and develop low investment recommendations to improve direct discharges to the brook.** We will also consult with the DPW on upstream sediment sources and changes that may be being proposed, as part of the Town's Stormwater Management Plan

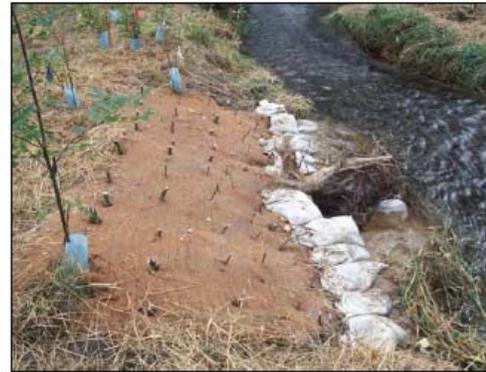
Numerous areas throughout the park are denoted as needing bank stabilization, removal of concrete liners and other materials, and reconstructing of the channel shape. Given the relatively flat topography of the stream and the consistency of the stream in size and channel shape, our Team anticipates that the practices and techniques for bank stabilization and channel reconstruction will be consistent throughout the length of the project. Similarly, the method and design for removing concrete liners will also be consistent across areas where this work is necessary. Therefore, it is anticipated that the design plans will include a plan view showing locations for these practices, and cross-section details that describe how these practices will be implemented for various stretches of the stream. The hydraulic analysis will be used to verify that the design is suitable for the expected stream flow velocities and volumes.
