# MORSES POND BEACH & BATHHOUSE FEASIBILITY STUDY

October 27, 2023

MARYANN THOMPSON ARCHITECTS  
[www.maryannthompson.com](http://www.maryannthompson.com)

Weston & Sampson<sup>SM</sup>  
design studio

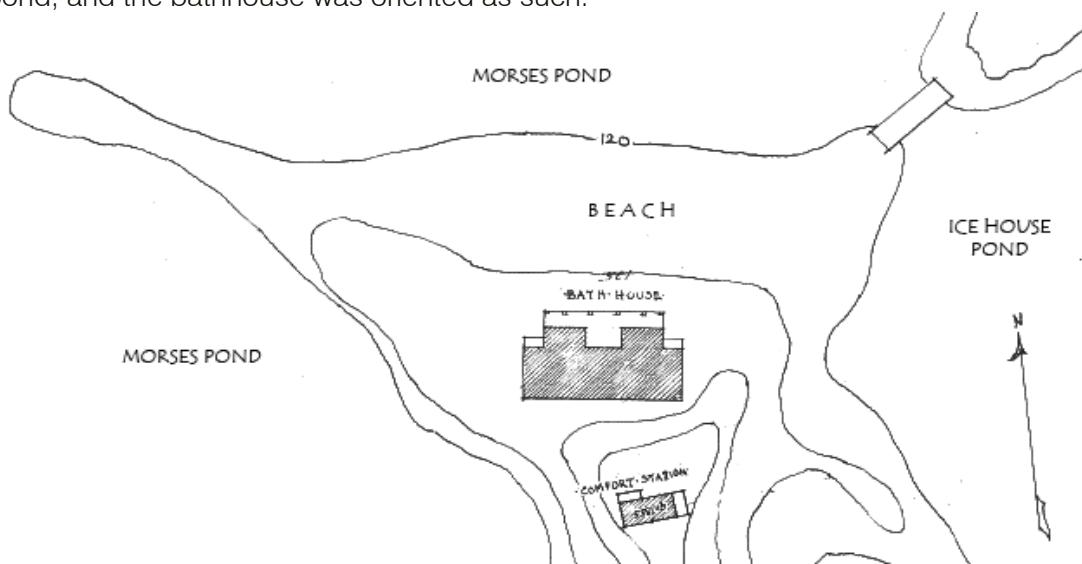
The 'old beach' as it is referred to now was on the north side of the peninsula that extends into the pond, and the bathhouse was oriented as such.

*Plan of the original beach with bathhouse*

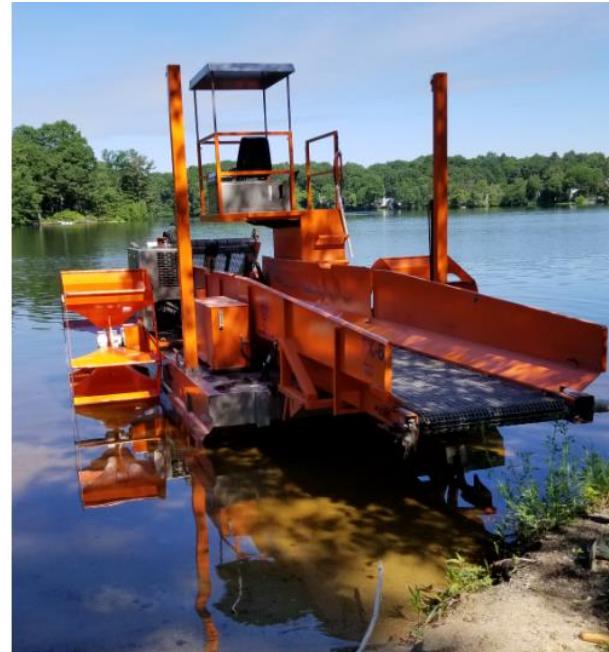
The Town has been managing this issue with the assistance of a weed harvester, which collects the weeds daily during the summer season and hauls the material off site to be composted. The Wellesley Department of Public Works manages and maintains a phosphorus inactivation system to help combat the weed growth in addition to the weed harvesting.

*Weed harvester in the pond*

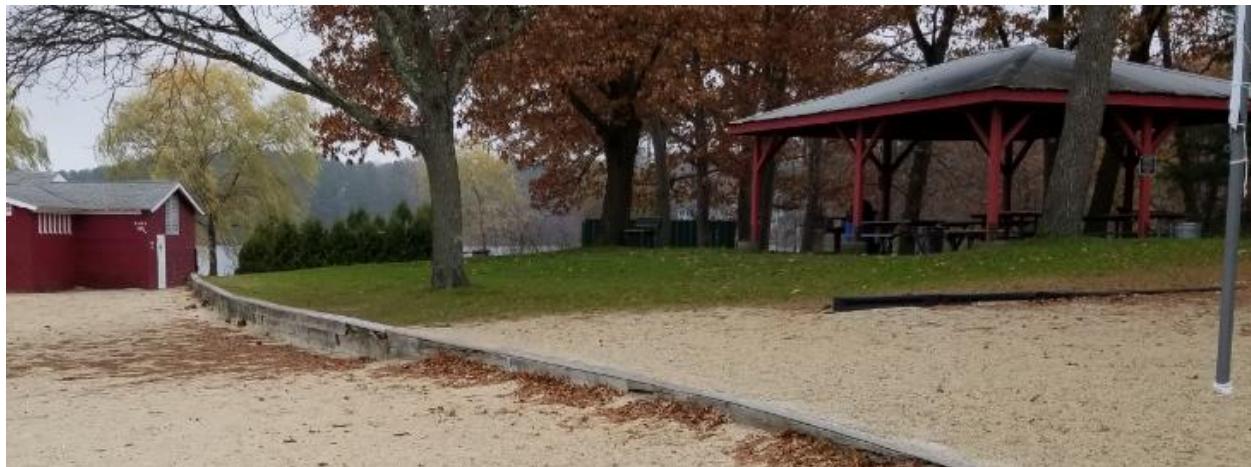
The site is divided between a lawn area and the sandy beach area by a pressure treated timber retaining wall which is starting to fail. Guests enjoy the ability to lay blankets on either the grass or the sand. The height of the wall varies from approximately 18" to 8" in height.

The walls make the transition from the lawn to the beach difficult for some users because of the step down. Small amounts of CCA can also leach into the surrounding areas over time which is not ideal for this natural resource environment utilized by people and wildlife.

*Existing retaining wall looking toward the shelter*

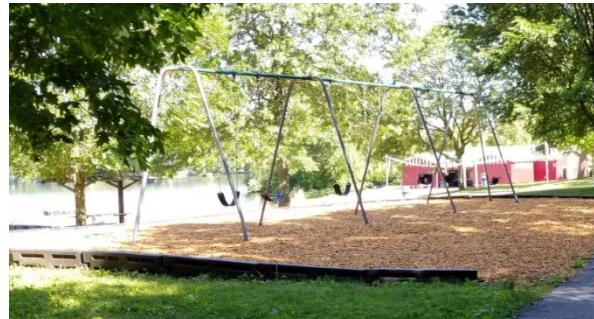
The wood chip surfacing in the playground area is not ideal for walking and it is not ADA accessible. The wood chips are also not the safest surface when dealing with trips and falls.

The playground also does not accommodate play for children with disabilities. The play structure is not accessible, and the swings do not have any seating that can be used by children with mobility difficulties.

Existing swings with wood chip surfacing

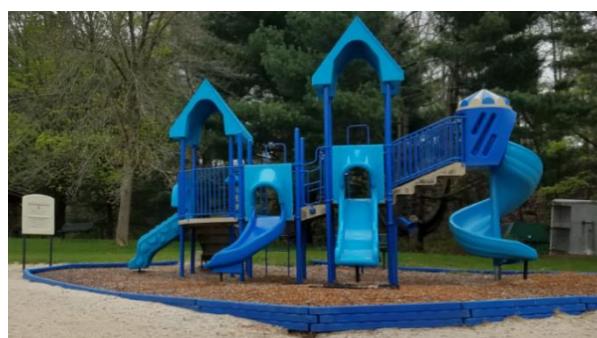
Existing play structure with wood chip surfacing

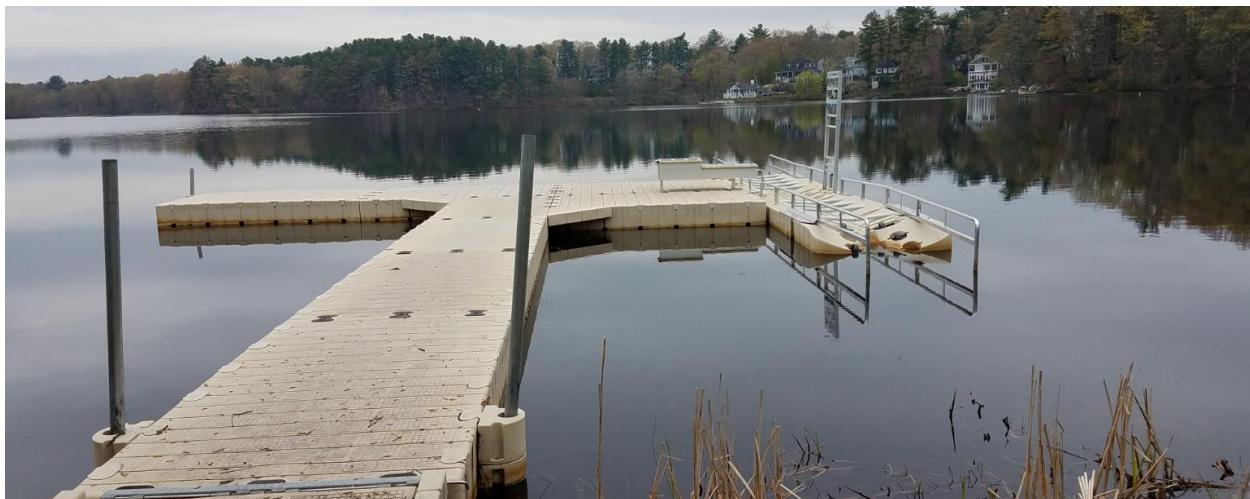
There is an ADA accessible kayak launch located at the north side of the beach which was installed in the summer of 2014 and is recommended to remain. The grassed area to reach this boat launch is not ADA accessible and will be addressed in the recommendations of this feasibility study. Kayaks and equipment are available for rental from the office in the bathhouse. Kayaks are stored in the green storage container and brought out by guards for rental. This is not an ideal operation for this amenity.

*The ADA accessible boat / kayak dock*

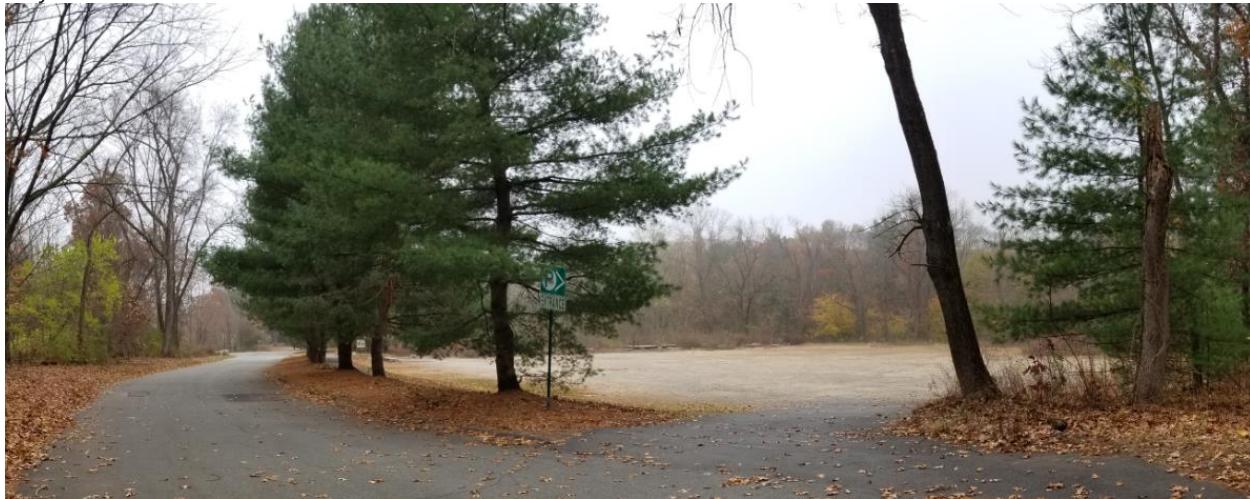
The existing parking area is located on the east side of Ice House Pond and the Water Department Building. The lot is approximately one and a half acres and has a compacted gravel surface. The western edge of the lot is adjacent to the Zone 1 wellhead protection area. There is no striping or

signage to help the organization of the lot, and this leads to inefficient parking congestion on busy days.

*The existing entry drive to the main public parking lot*

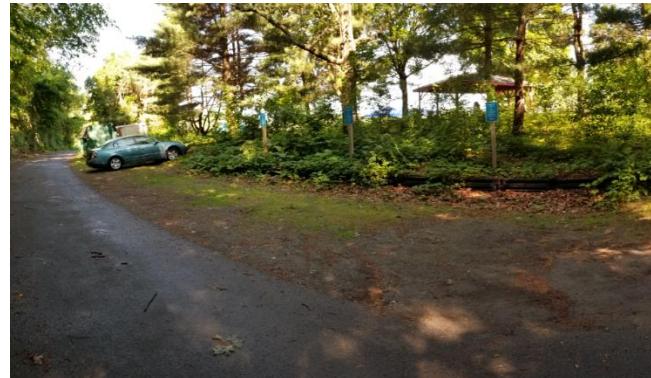
Other than the signage, the existing ADA parking adjacent to the beach areas is essentially non-conforming on multiple fronts.

Both the dirt parking and the slope from parking up to the main walkway, do not conform to the requirements set forth for accessible parking. As with the main public parking lot there are no delineated parking spaces.

*Existing parking located closer to the beach area*

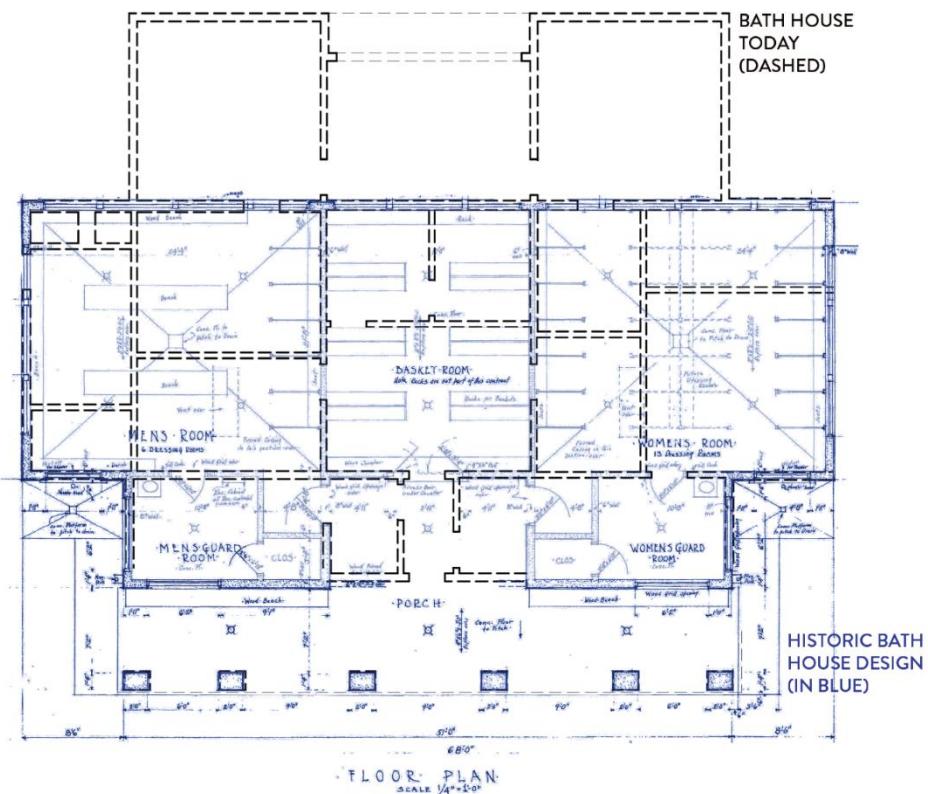
The original bathhouse was a simple structure with a central 'basket room' where guests would leave their change of clothes after having put on bathing suits in either the men's or women's changing rooms. There were also a small room for each male and female lifeguards. The original design drawings for the structure show the building in the Mediterranean Revival architectural style with clay tile roof and a stucco finish, which was popular regionally during the time period that this was built, in the early 1930's.

*Original Bathhouse with Current Floorplan Overlay illustrating additions and changes to the original floorplan*

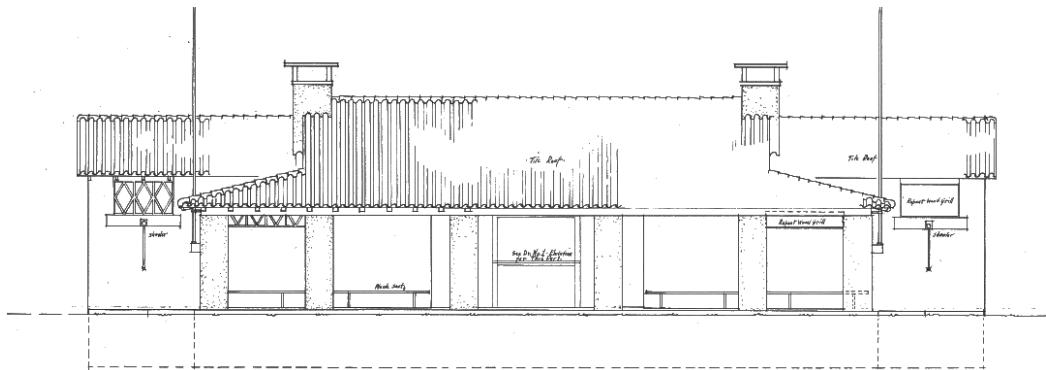
*Original Bathhouse Elevation*

Over the years this original structure underwent a series of renovations and additions which carved up the original spaces as the need for staff space, storage and bathroom facilities grew. The current building finishes also underwent changes as well with the primary materials being painted brick and an asphalt shingle roof. The roof is simple exposed wood framing with some small vents under the eaves which don't allow for adequate ventilation leading to issues with mold and mildew. As it stands now, the current facility configuration is poor and does not meet programmatic needs and code requirements, particularly as regards accessibility and storage.

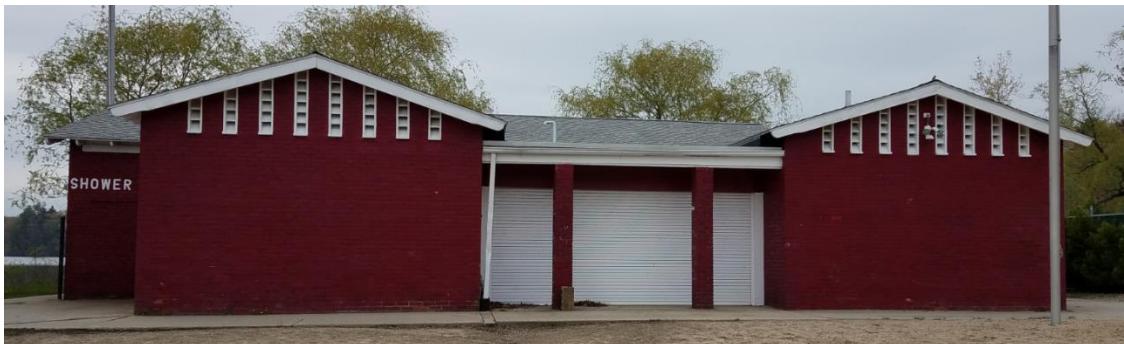
*Current bathhouse elevation*

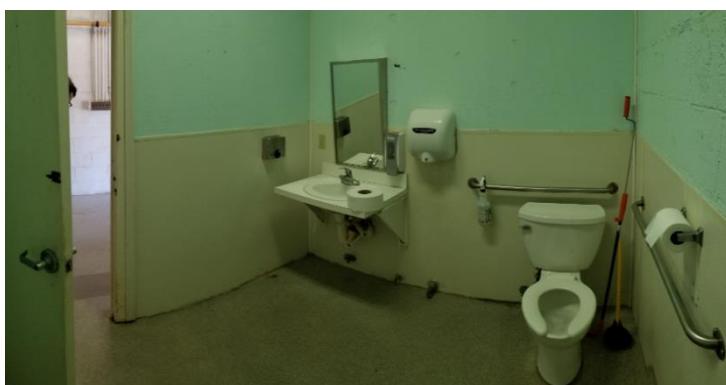
*Single accessible bathroom*

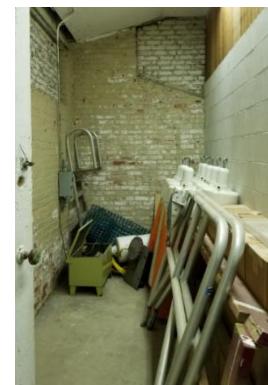
*Small storage area*

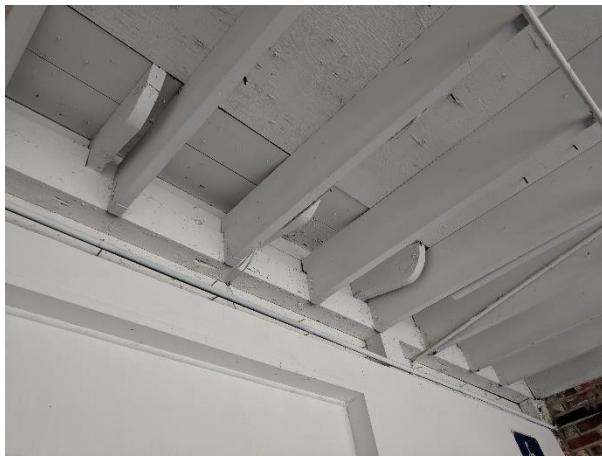
Roof structure

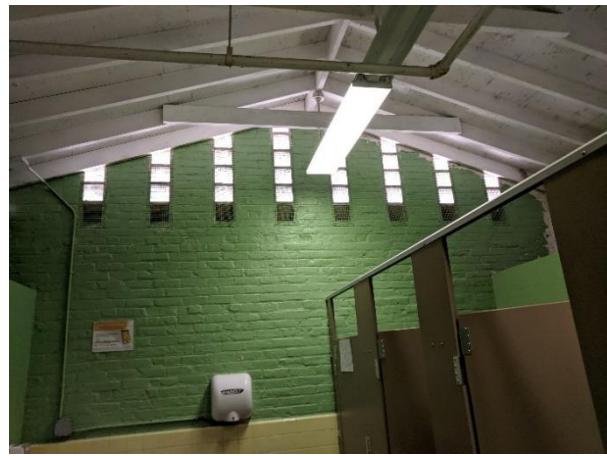
Bathroom ventilation

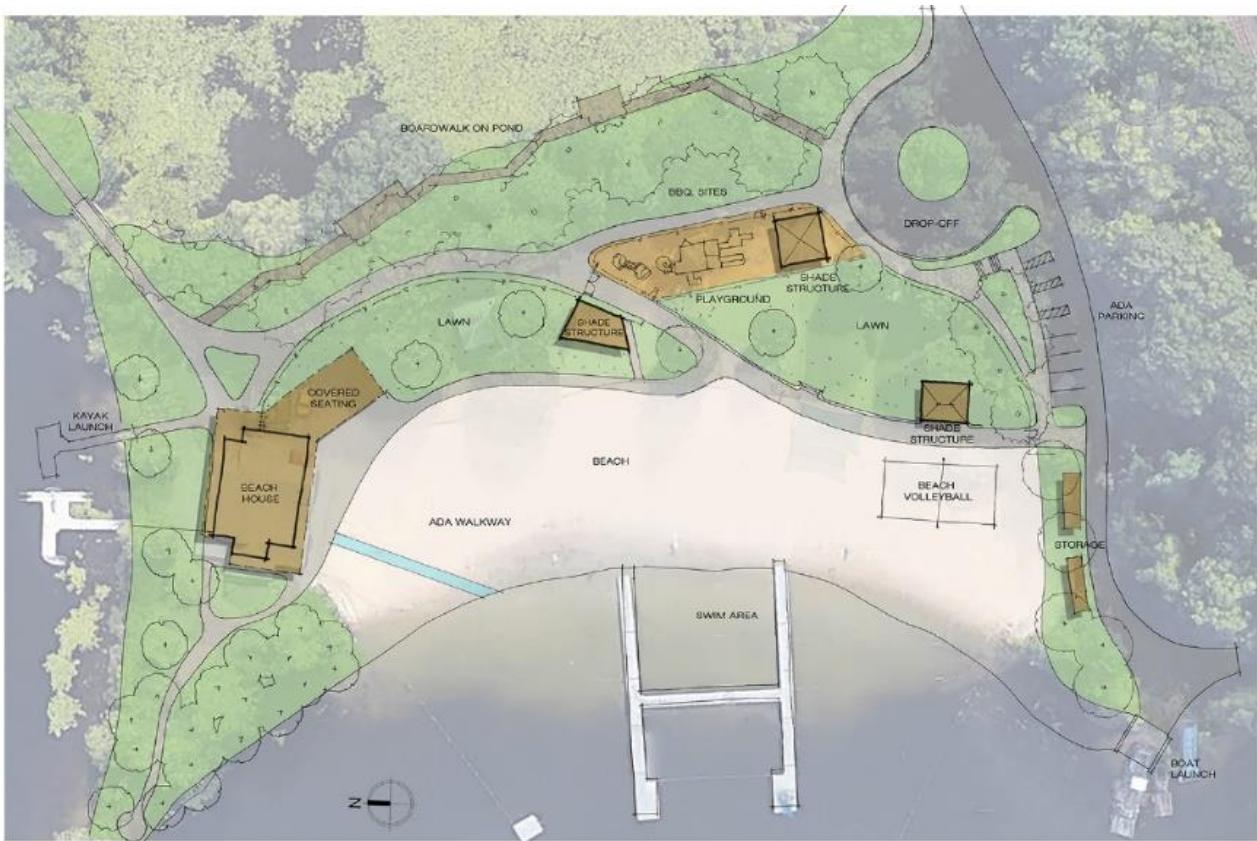
Master plan scheme one first looked at creating a new building in roughly the same location as the existing building. The location of the buildings are not conducive to the new drop-off and parking area. This would require visitors to navigate across the site from the drop-off to pay their entry fee to use the beach facilities.

This scheme was not pursued because the building did not function well with trying to squeeze all of the programming into a single footprint, and its position in the relation to the primary swim area was not advantageous.

Master plan scheme 1

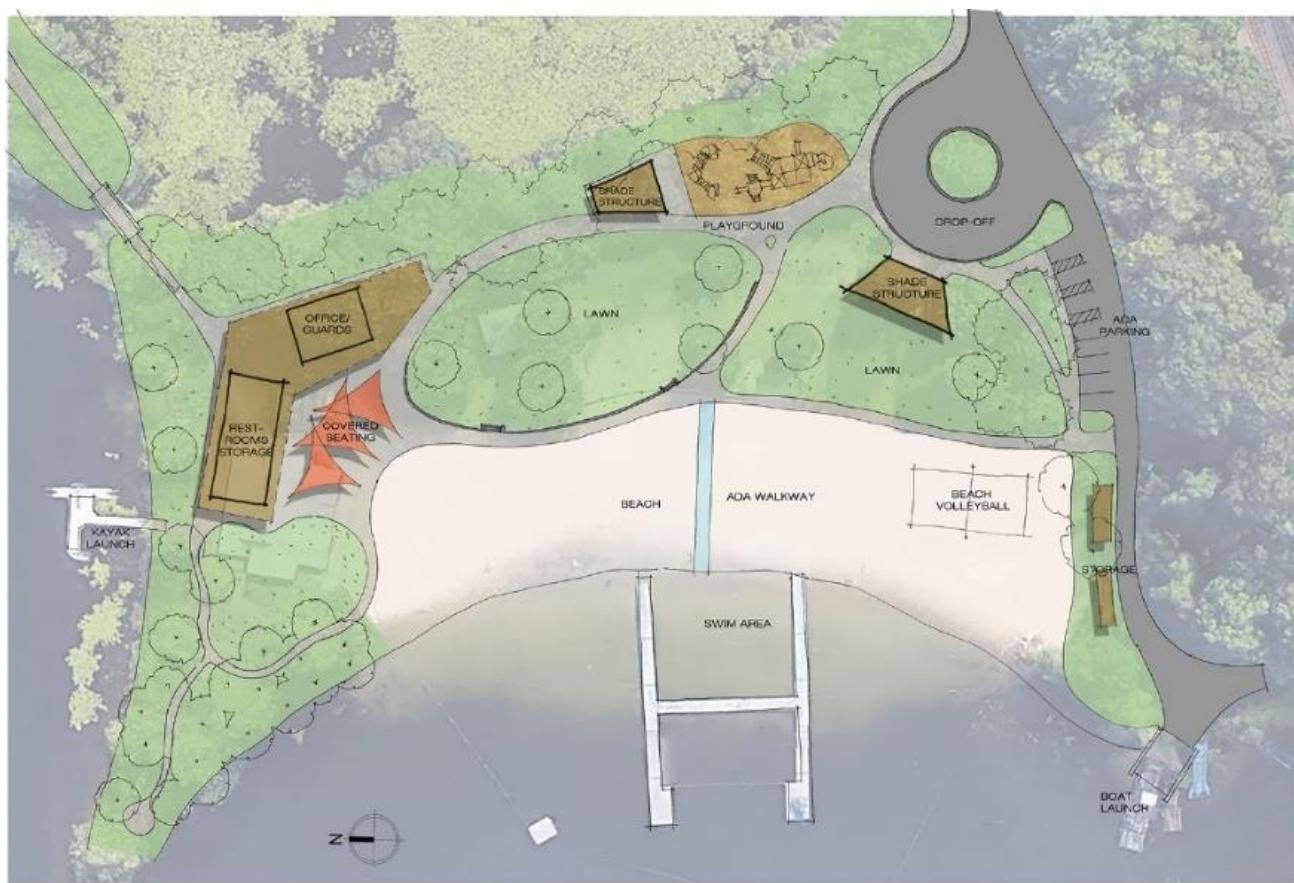
Master plan scheme two created a new pair of buildings closer to the existing bridge on the northern portion of the site. Advantages of this scheme included the creation of a formal and highly visible gateway between the buildings and to create the sense of arrival, while the building locations help to open up more space for guests around the perimeter of the beach.

The location of the playground would require some extensive regrading of the site to accommodate this amenity. The location of the buildings are not conducive to the new drop-off and parking area. This would require visitors to navigate across the site from the drop-off to pay their entry fee to use the beach facilities. For these reasons, this scheme was not selected.

Master plan scheme 2

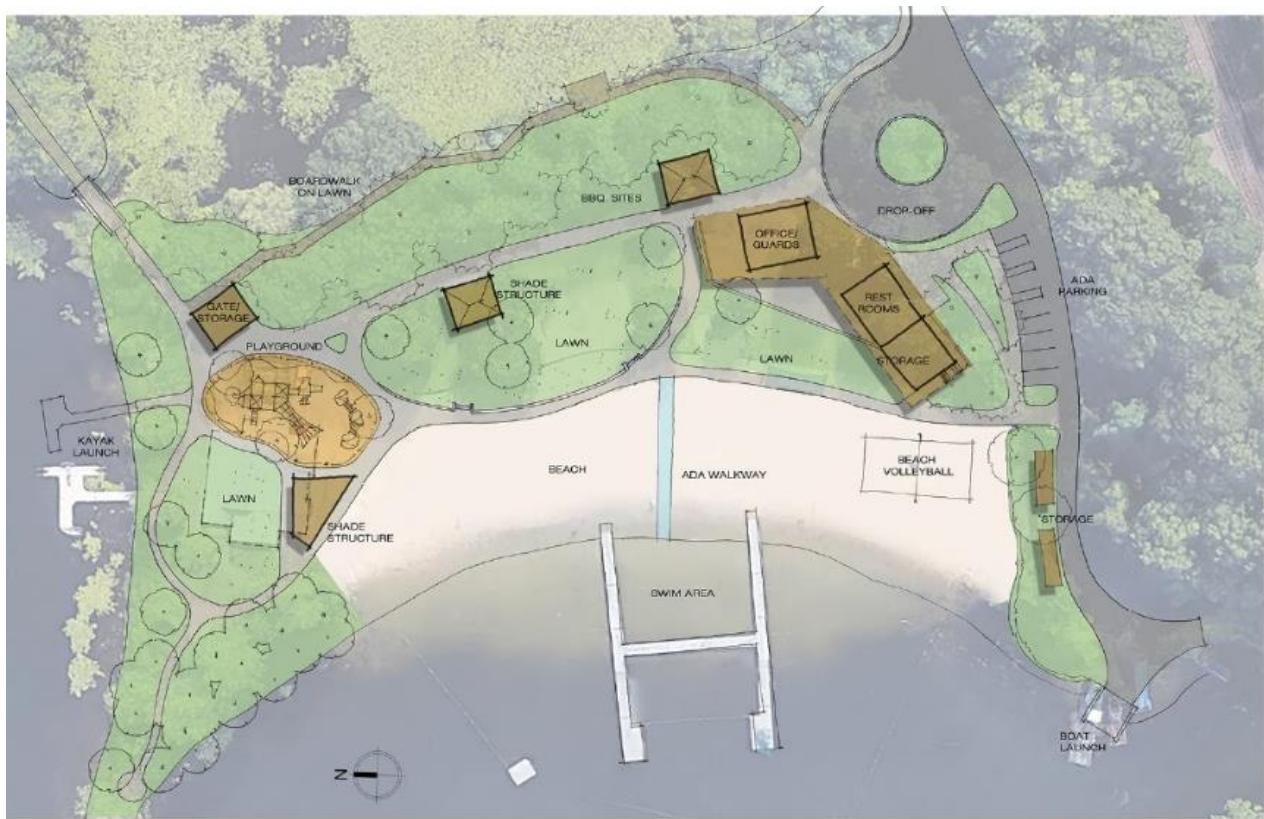
With the buildings being located closer to the proposed drop-off and new parking area, it makes for a much simpler and quicker entry experience to the beach facilities. It also is advantageous for visitors who have mobility issues.

The location of the playground is also in an existing area that is relatively flat so extensive grading would not be required to make this a fully accessible and inclusive space.

Master plan scheme 3

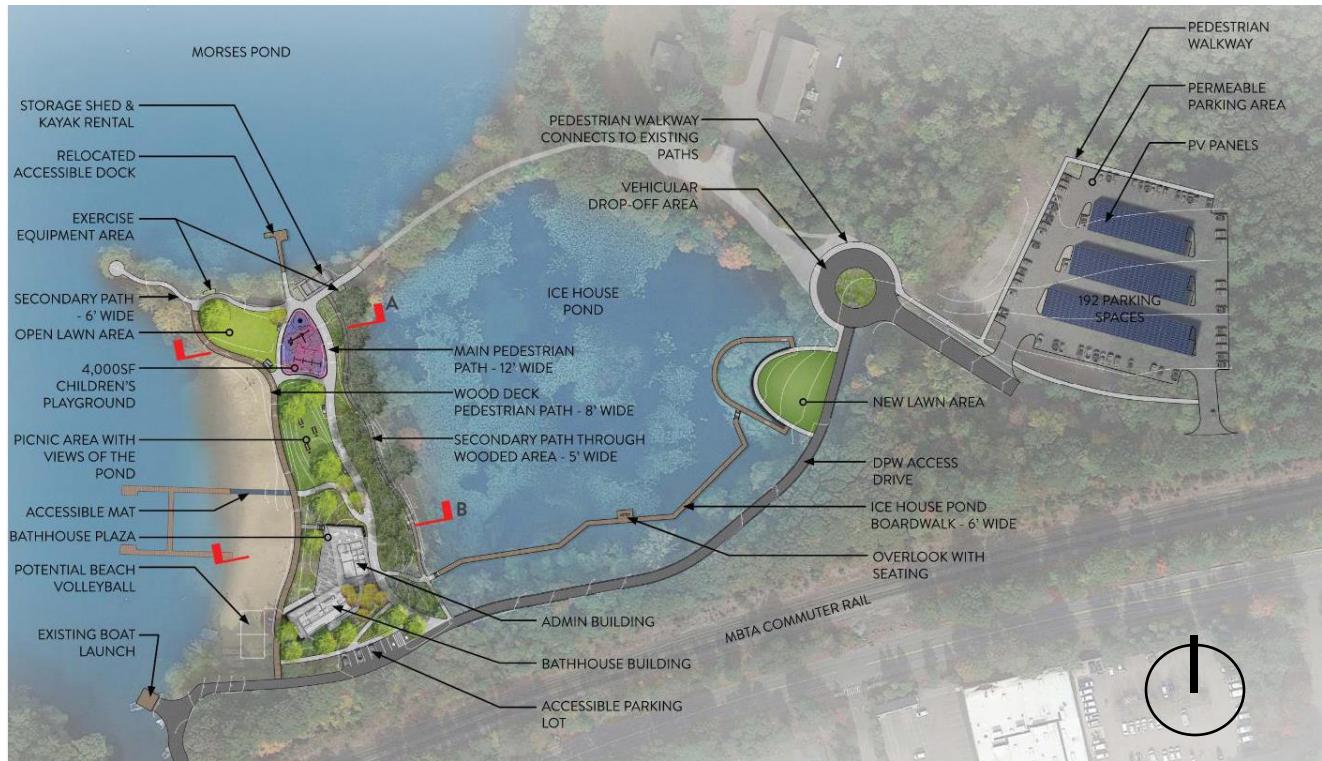
This design reflects the full potential build out option that was derived from stakeholder feedback received after reviewing the first master plan developed in 2019 and 2020. The current proposed project scope within this study has components of this plan that are not included due to budget constraints.

- New bathhouse building's location closer to entrance drive/walkway.
- Bathhouse broken into two buildings, one which can be shut down during off-season.
- ADA parking brought into compliance and moved closer to the new buildings.
- Increased and improved storage areas.

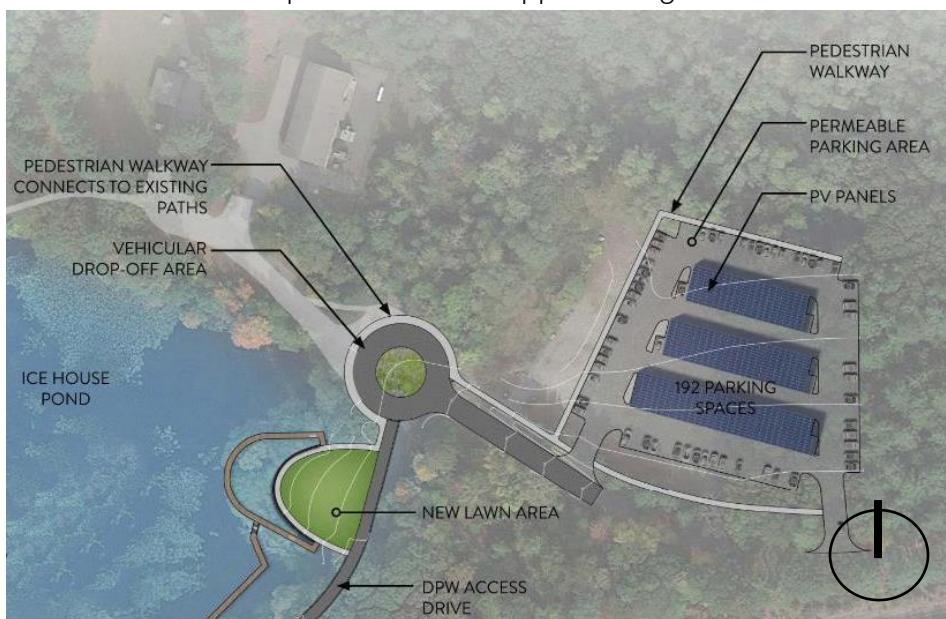
Proposed entry drop-off and parking area

In order to clarify and remedy this issue the intent is to reconfigure the drop-off area, developing signage and visual clues to promote using what is currently the service and handicapped parking drive into the main pedestrian walkway. These changes will also create a more distinct vehicular access drive for the Water Department.

In an effort to help protect the town drinking wells, the parking lot, which currently abuts the Zone 1 wellhead protection area is proposed to be moved approximately 100' to the east in order to give a larger buffer to the wellheads.

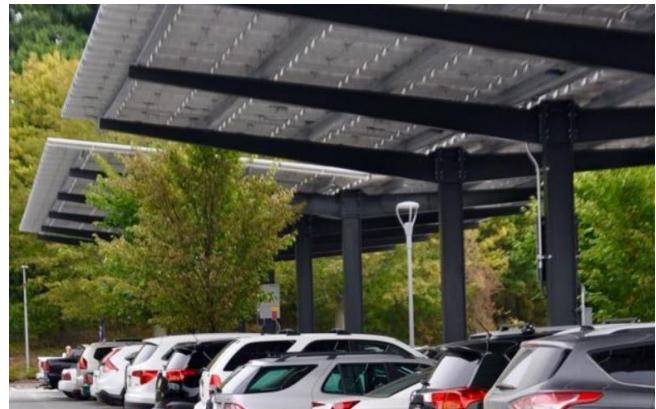
Unless the lack of rebates and credits makes it cost prohibitive, there is the potential of adding solar array panels at the parking area. These solar array panels could possibly be purchased and installed under a separate contract when funds become available.

*Image of canopy supported PV array*

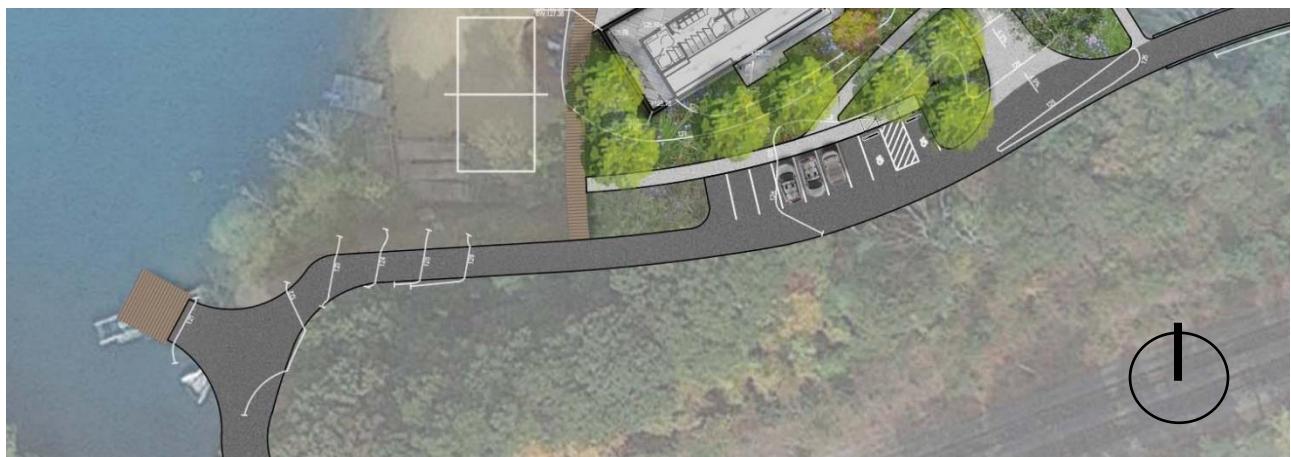
*Reconfigured drive to boat launch and accessible parking stalls*

In addition to expanding the width of the drive to allow for emergency vehicle access, the drive will have designated drive and walkway lanes in the infrequent event that both pedestrians and a vehicle are sharing the road.

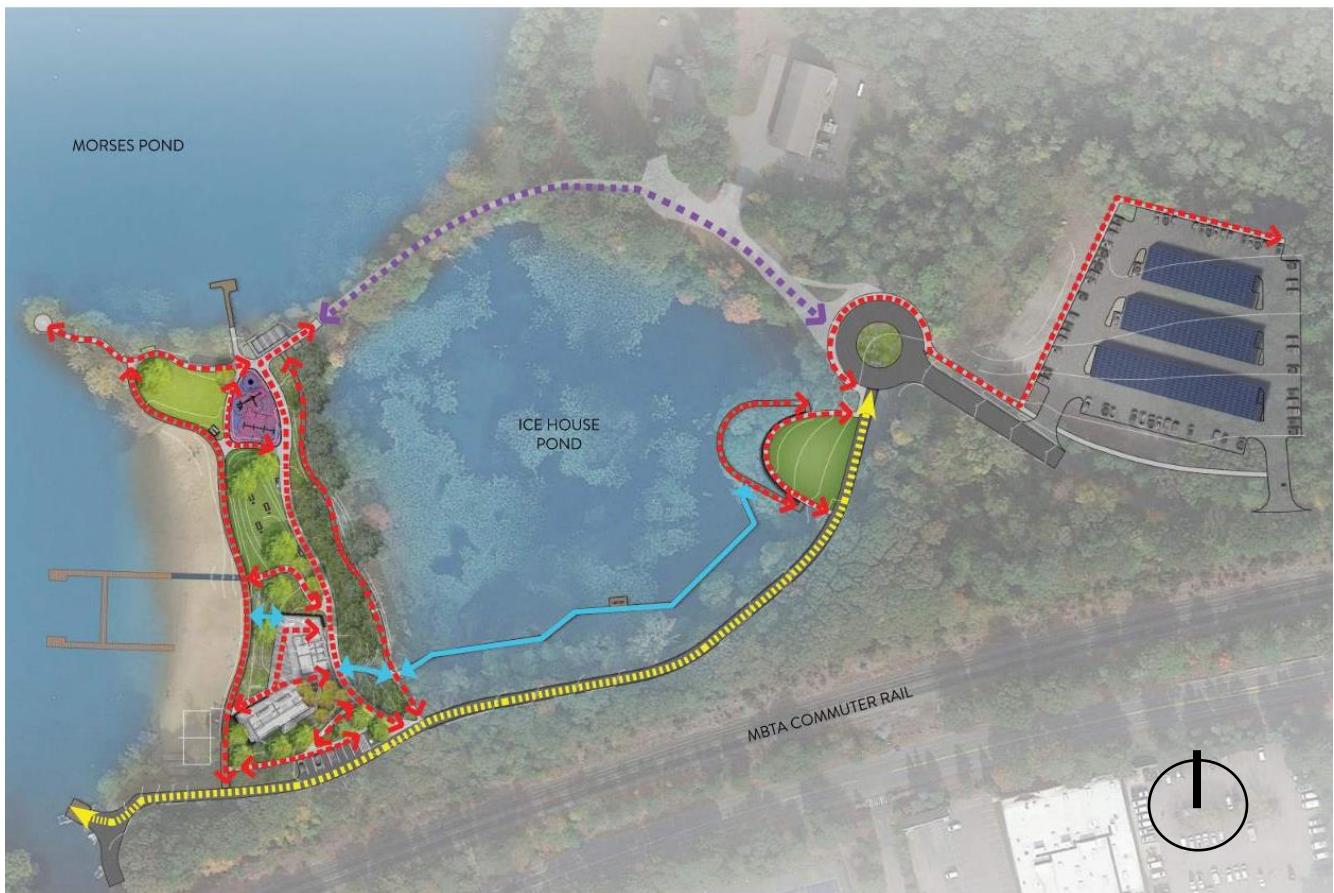
## Site Master Plan Accessibility Diagram

The diagram below indicates the accessible pedestrian routes from the parking lot to the bathhouse and other amenities throughout the site.

↔ NEW PEDESTRIAN  
ACCESSIBLE ROUTE: SLOPE  
AT 5% OR LESS

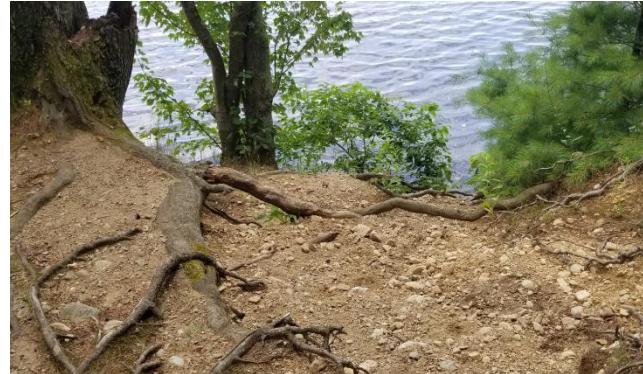
One location in particular need of attention is the woodland path on the north side of the 'Old Beach' near the Water Department property.

*Erosion at Old Beach*

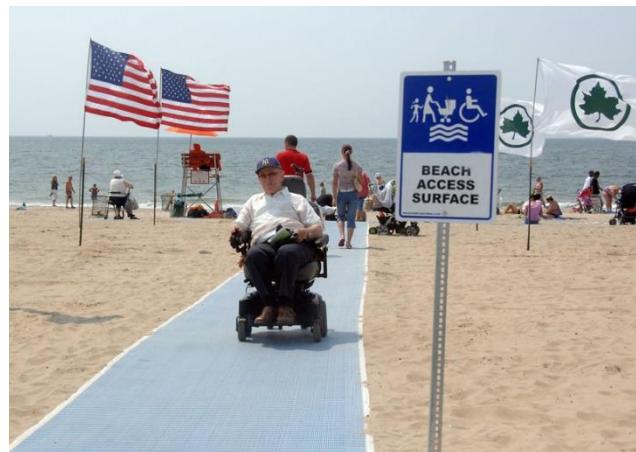
Additionally, an accessible mat system is proposed to allow guests with disabilities to get across the sand to the docks and water. These mats are easily to install and can be removed during the months when the beach area is closed to the public.

*An accessible beach mat for wheelchair users*

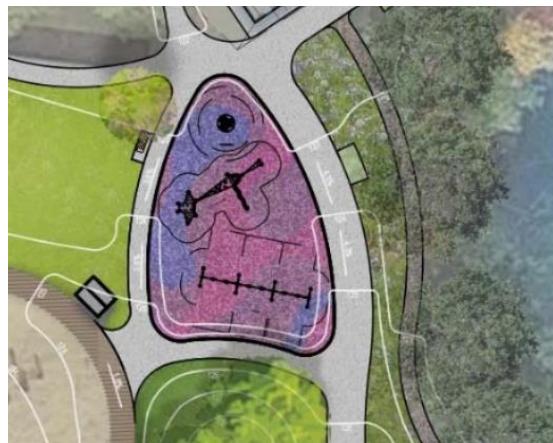
The playground has been graded to meet current ADA guidelines with cross slopes of less than 2%. Rubberized safety surfacing to help prevent serious injuries from trips and falls is proposed. A new main play equipment structure, swing set, and educational/sensory pieces are included in the design.

A fence surrounds the perimeter of the playground to help coral children in a safe environment while they play.

*The proposed playground*

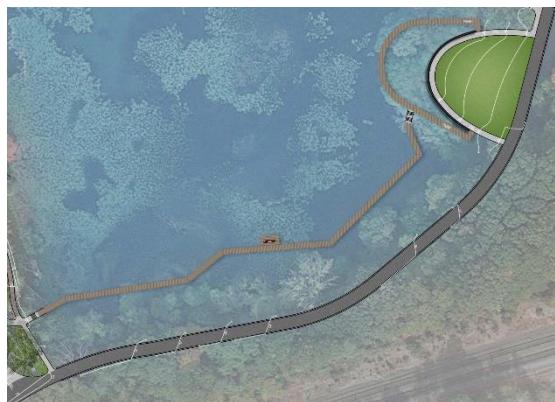
An overlook area with seating would provide an area of respite for visitors using this connection, or a perfect place to fish.

*Plan of the Ice House Pond boardwalk*

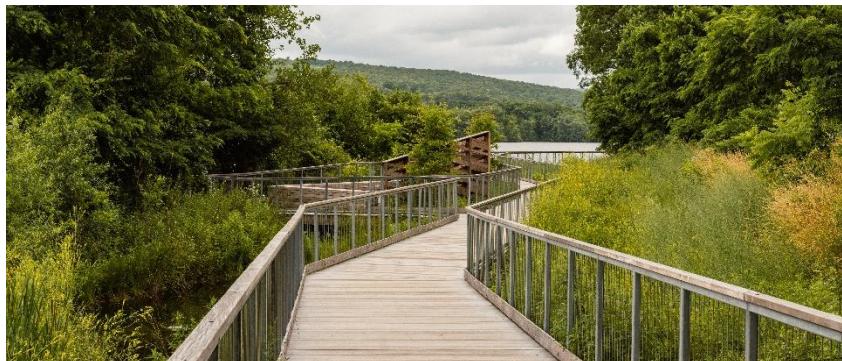
The material recommended for the decking and guardrails would either be Trex or a tropical hardwood. Trex is a sustainable product constructed of recyclable materials that requires no maintenance. Ipe or similar tropical hardwoods also require no maintenance and come from sustainable sources. Using these materials would prolong the lifespan of this amenity within Ice House Pond.

*Tropical hardwood decking and steel guardrails*

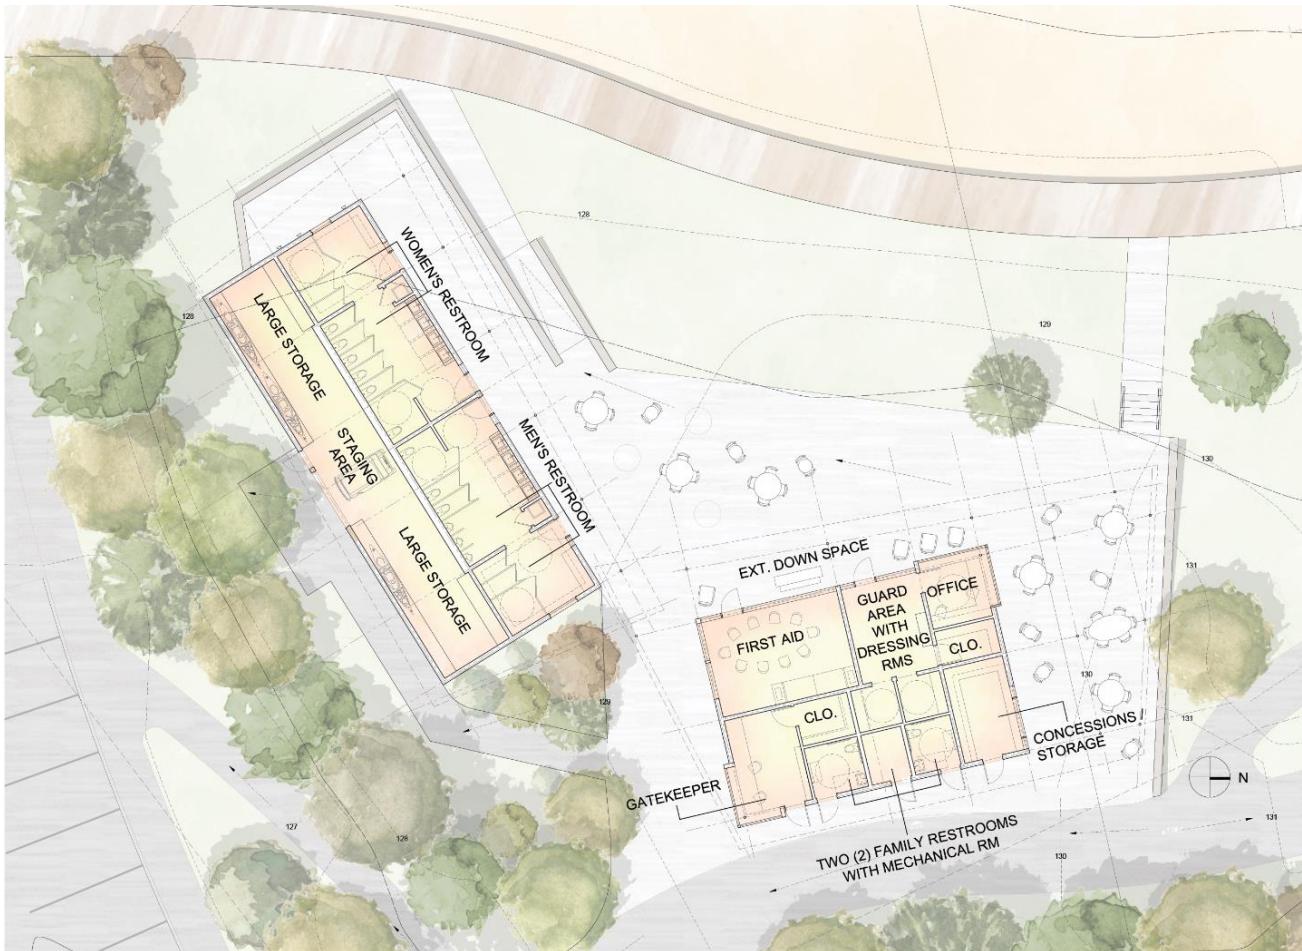
The following images highlight the proposed plans and elevations for the new bathhouse and administration building. These plans and elevations include the feedback received from multiple sources during the public engagement and stakeholder's meetings.

*Floor plans of Bathhouse and Administration Building*

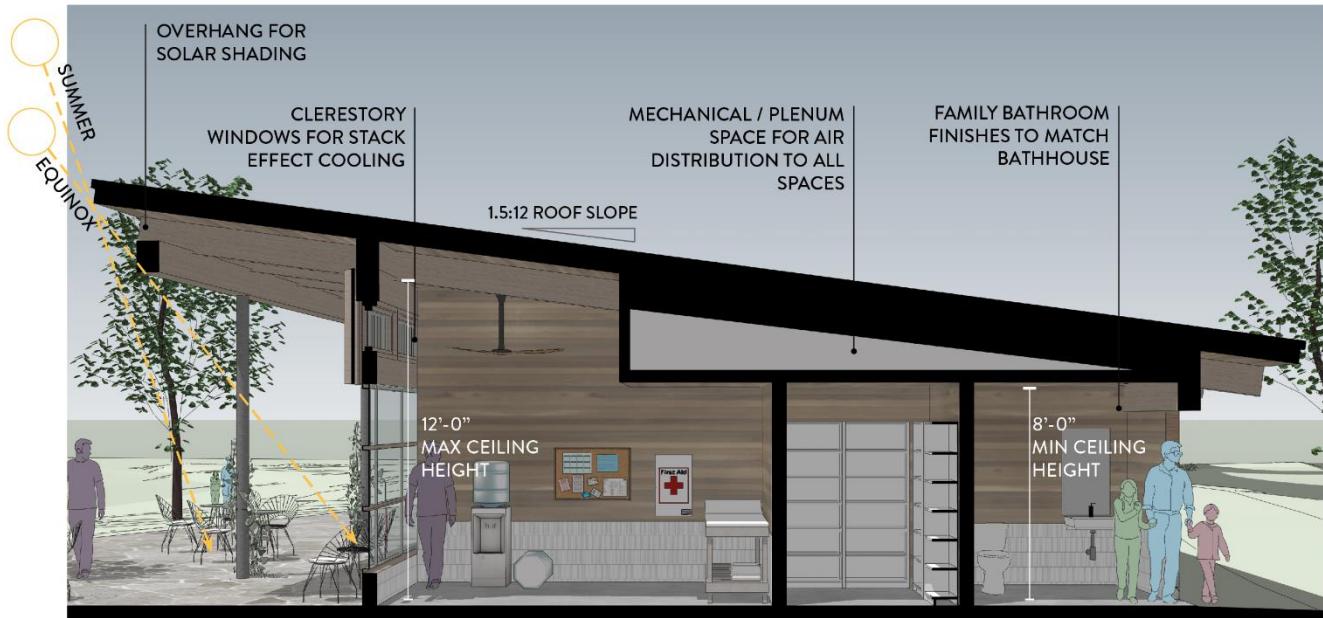
Section through the Administration Building

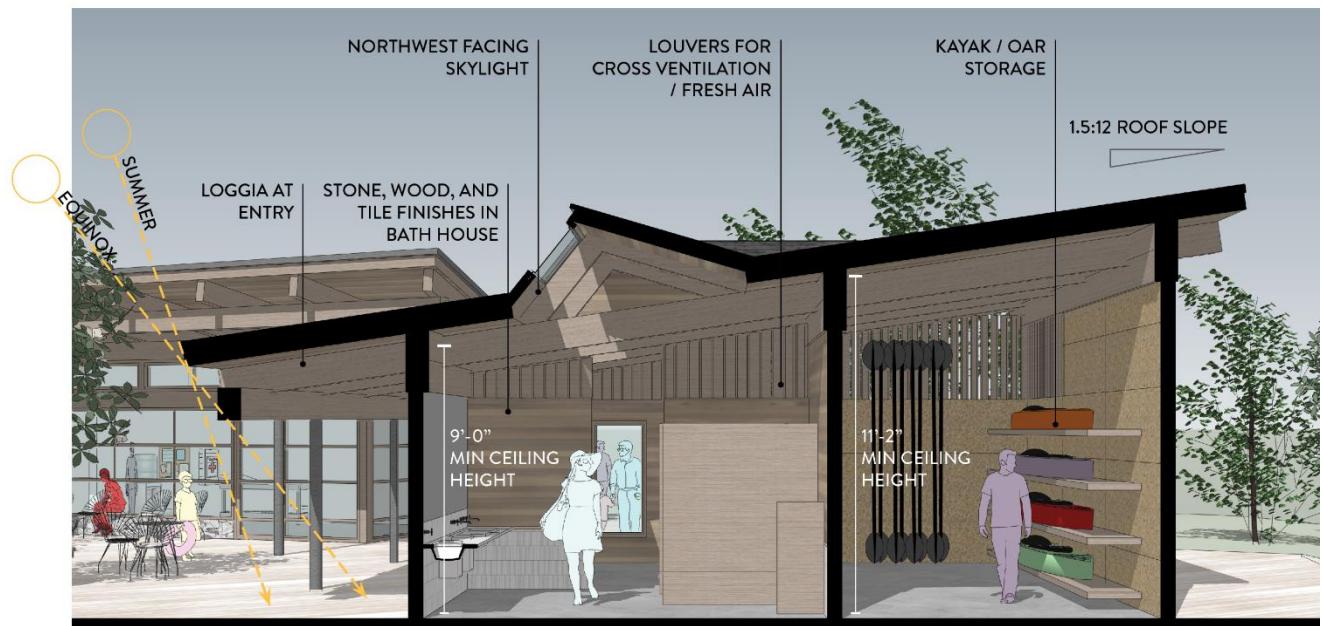
Section through the Bathhouse Building

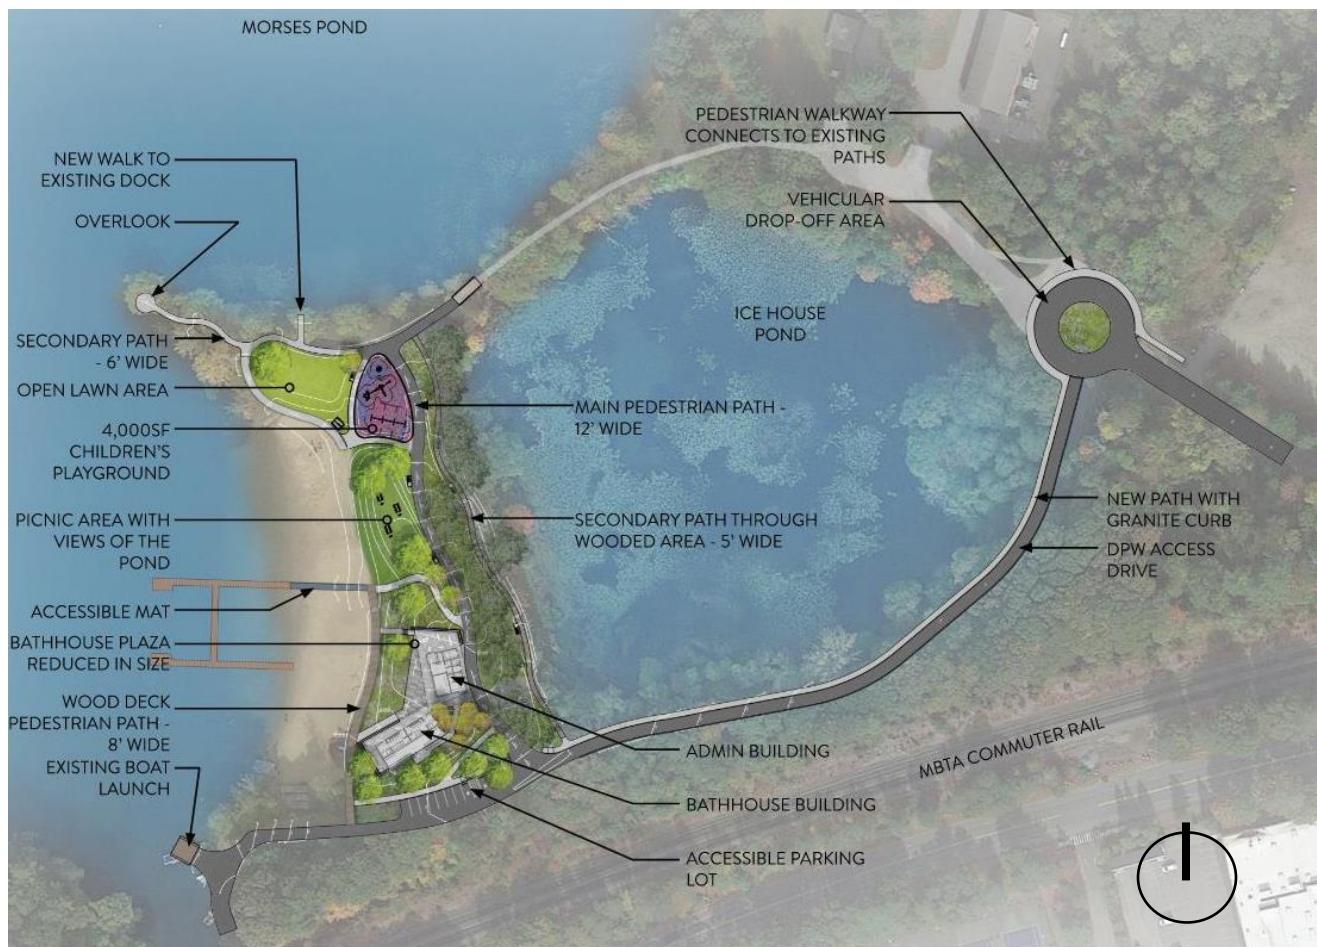
## Value Engineered Concept Site Master Plan

The beauty of this master plan design is that the scope items removed during the value engineering exercise can easily be designed, and built under separate contracts, even after the construction of this master plan has been completed. This value engineered master plan still delivers major improvements to Morses Pond for Wellesley residents to enjoy.
