# MORSES POND BEACH & BATHHOUSE FEASIBILITY STUDY

October 27, 2023

MARYANN THOMPSON ARCHITECTS  
[www.maryannthompson.com](http://www.maryannthompson.com)

Weston & Sampson<sup>SM</sup>  
design studio

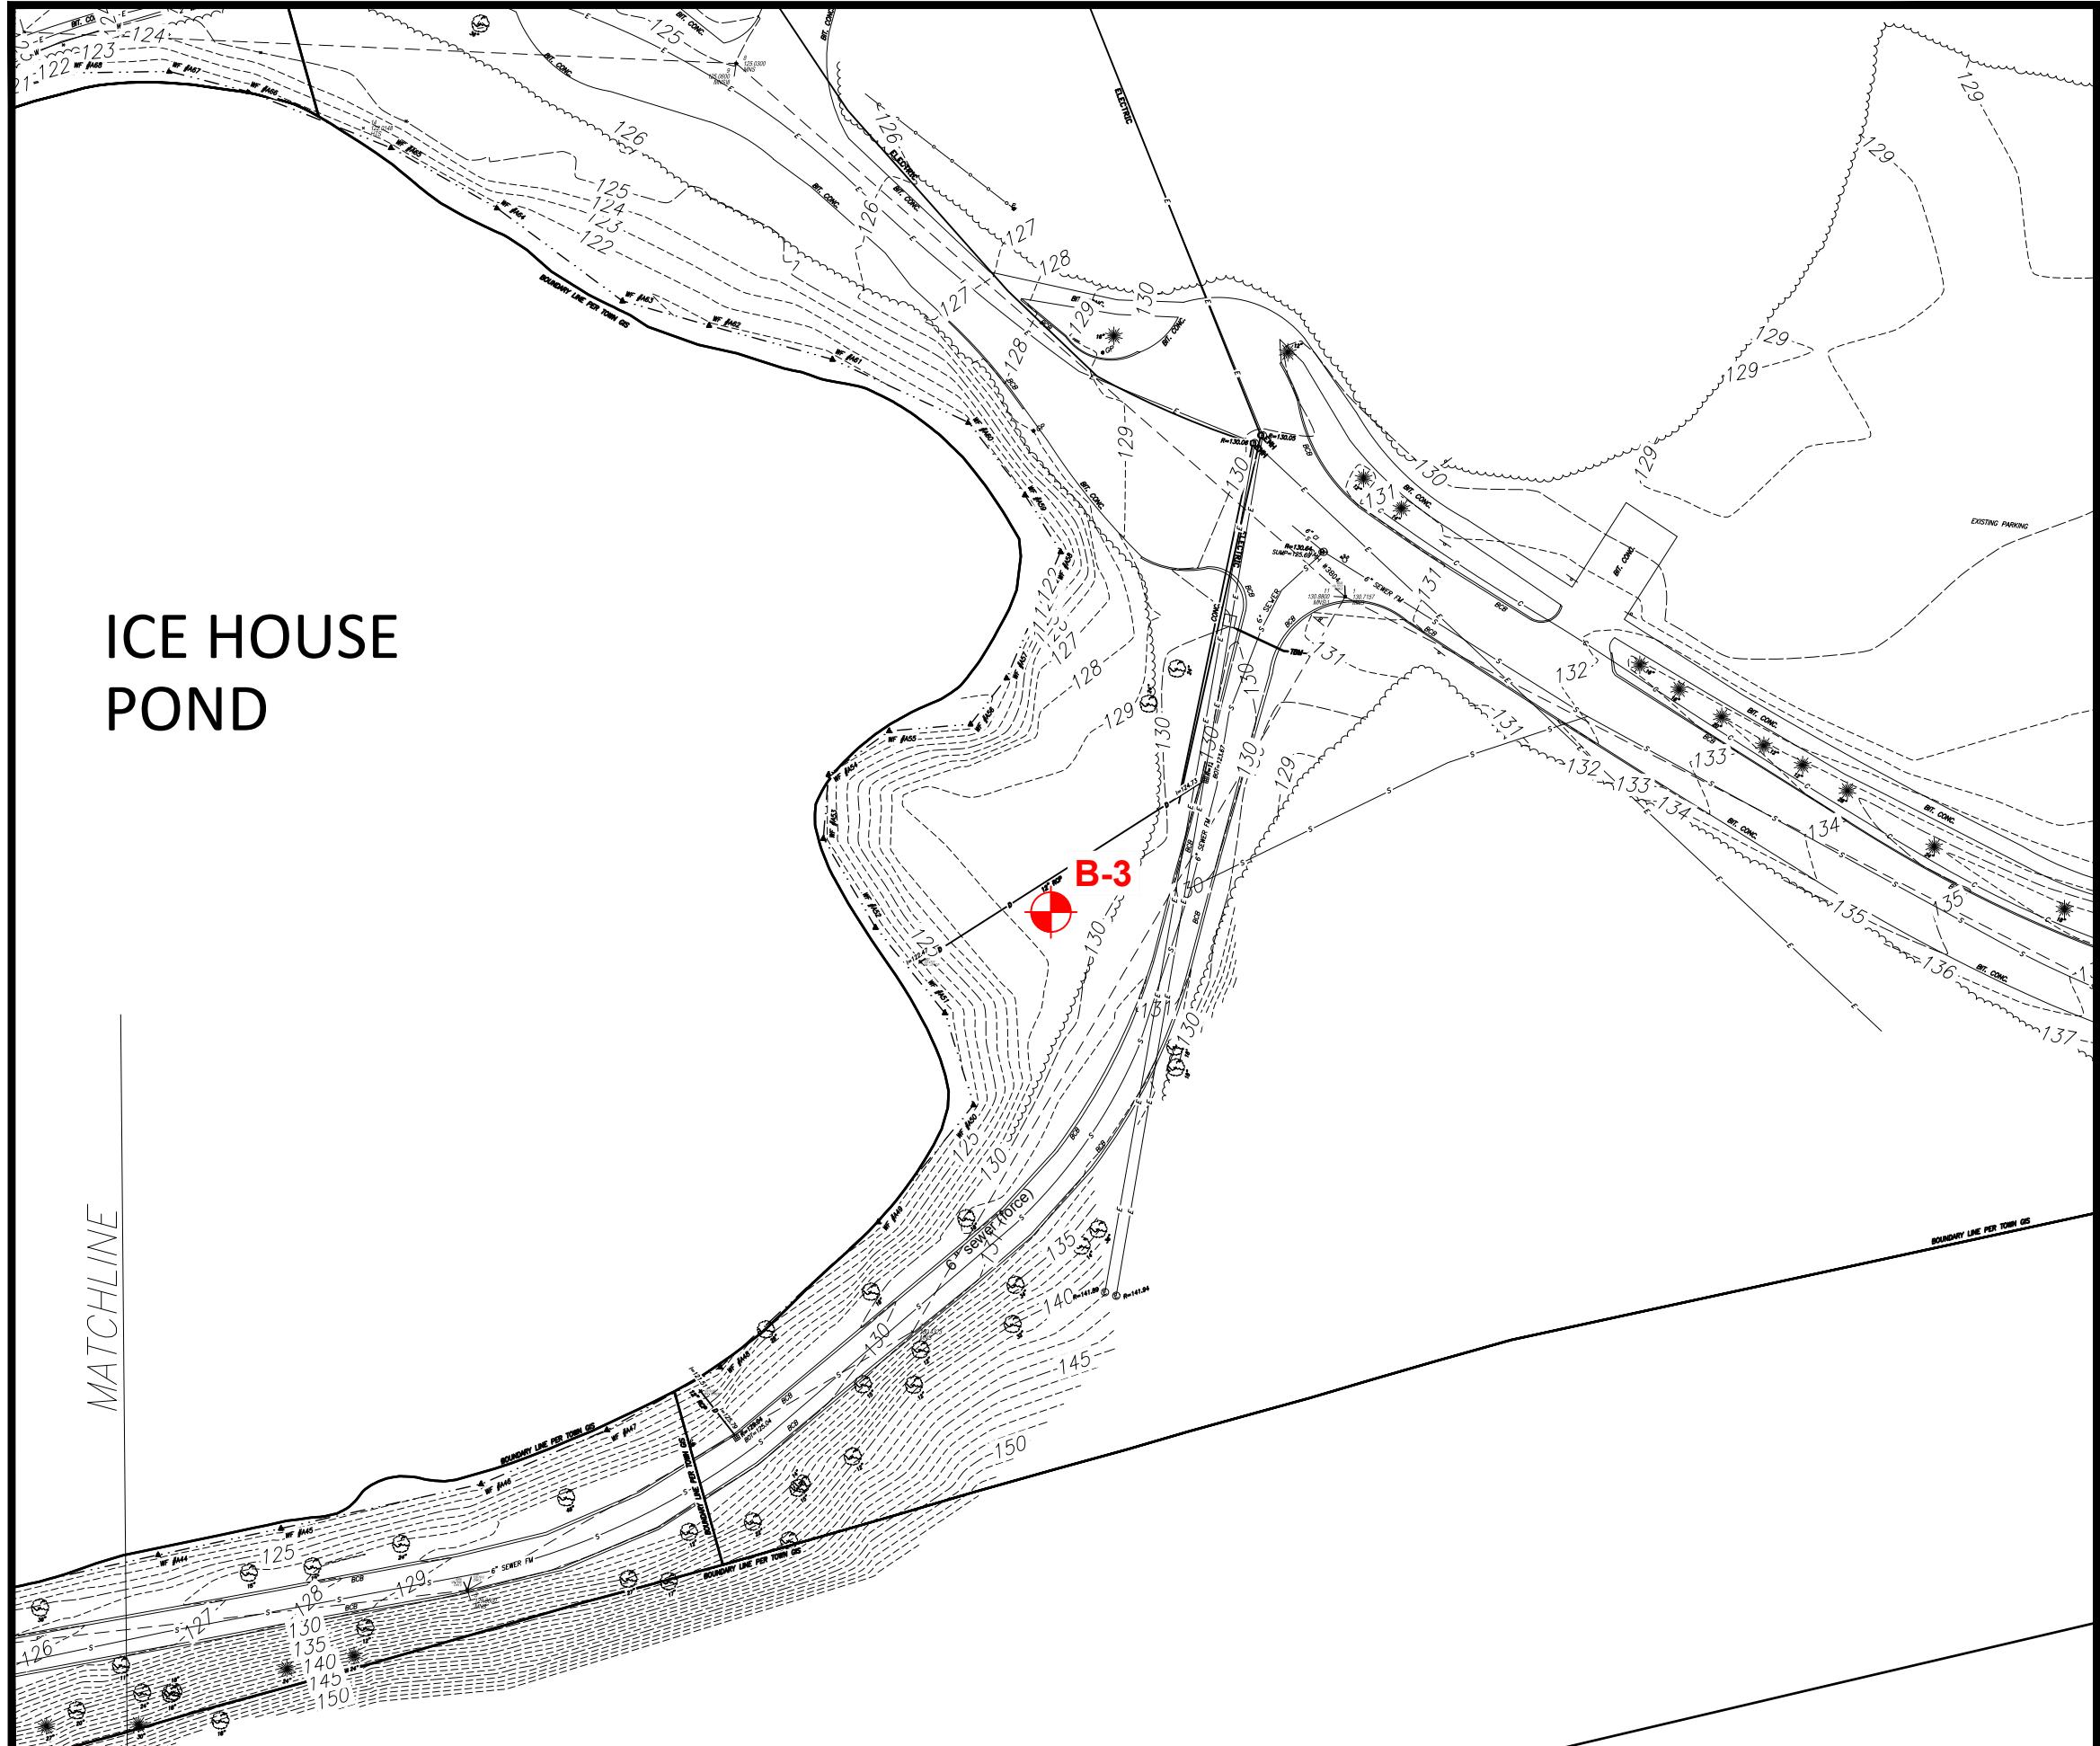
**FIGURE 2B**

ORIENTATION	TITLE
	<b>SITE PLAN - EAST</b>
	PROJECT
	<b>MORSES POND BEACH AND BATH HOUSE</b>
	WELLESLEY, MA 02482
DATE	11/2021
DRWN BY	AJC
CHKD BY	MZ
PRJ. NO.	ENG21-0701
REV. NO.	-

The new administration and bathhouse buildings are proposed at the apparent high point of the site based on the existing site grades depicted in *Figures 2A and 2B*.

Subsurface conditions at the site were explored on September 1, 2021, by advancing five borings (B-1 through B-5) to depths ranging from 6 to 21 ft. Approximate boring locations are shown in *Figure 2*. Weston & Sampson geotechnical engineering staff monitored explorations in the field and prepared logs for each exploration.

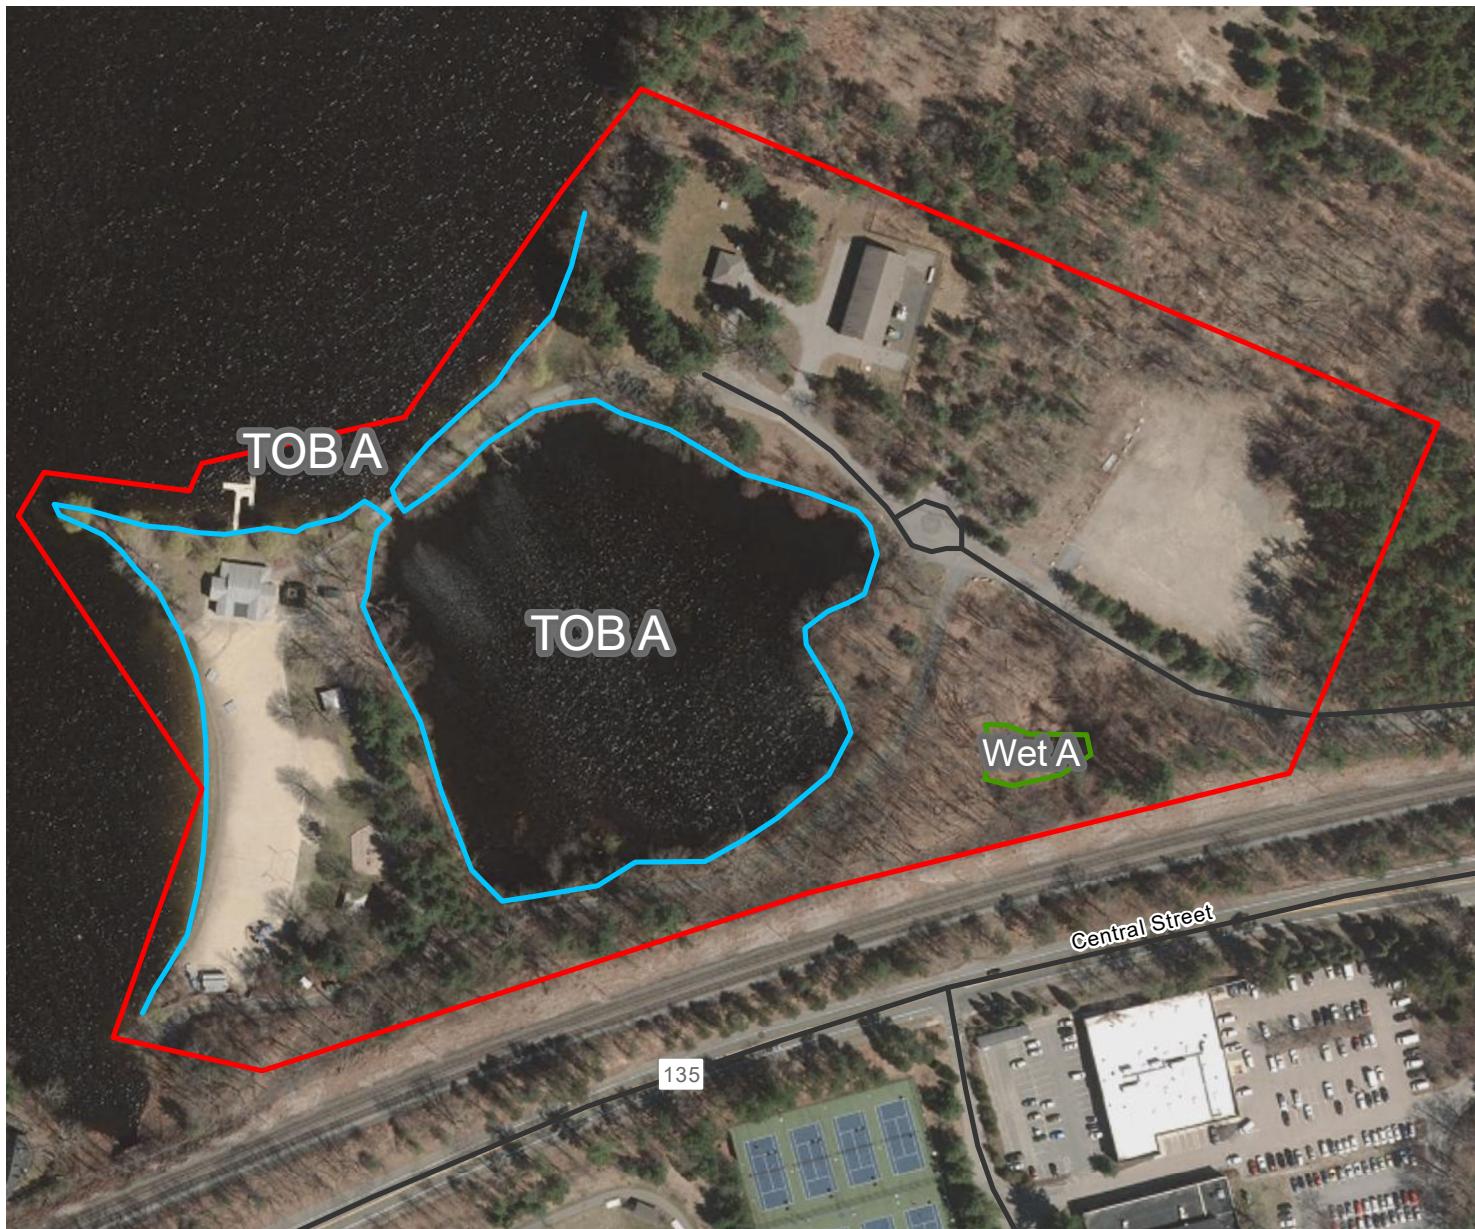
**FIGURE 1**

Morses Pond Beach  
Wellesley, MA  
Wetland Field Map

On August 27<sup>th</sup>, 2021, the presence of wetland resources was investigated near Morses Pond in Wellesley, MA. This investigation area is located off Morses Pond Access Road with undeveloped woodlands and recreational walking paths. Please see Figure 1 (Wetlands Field Map) and Figure 2 (USGS Topographic Map) of this report for the investigation area.

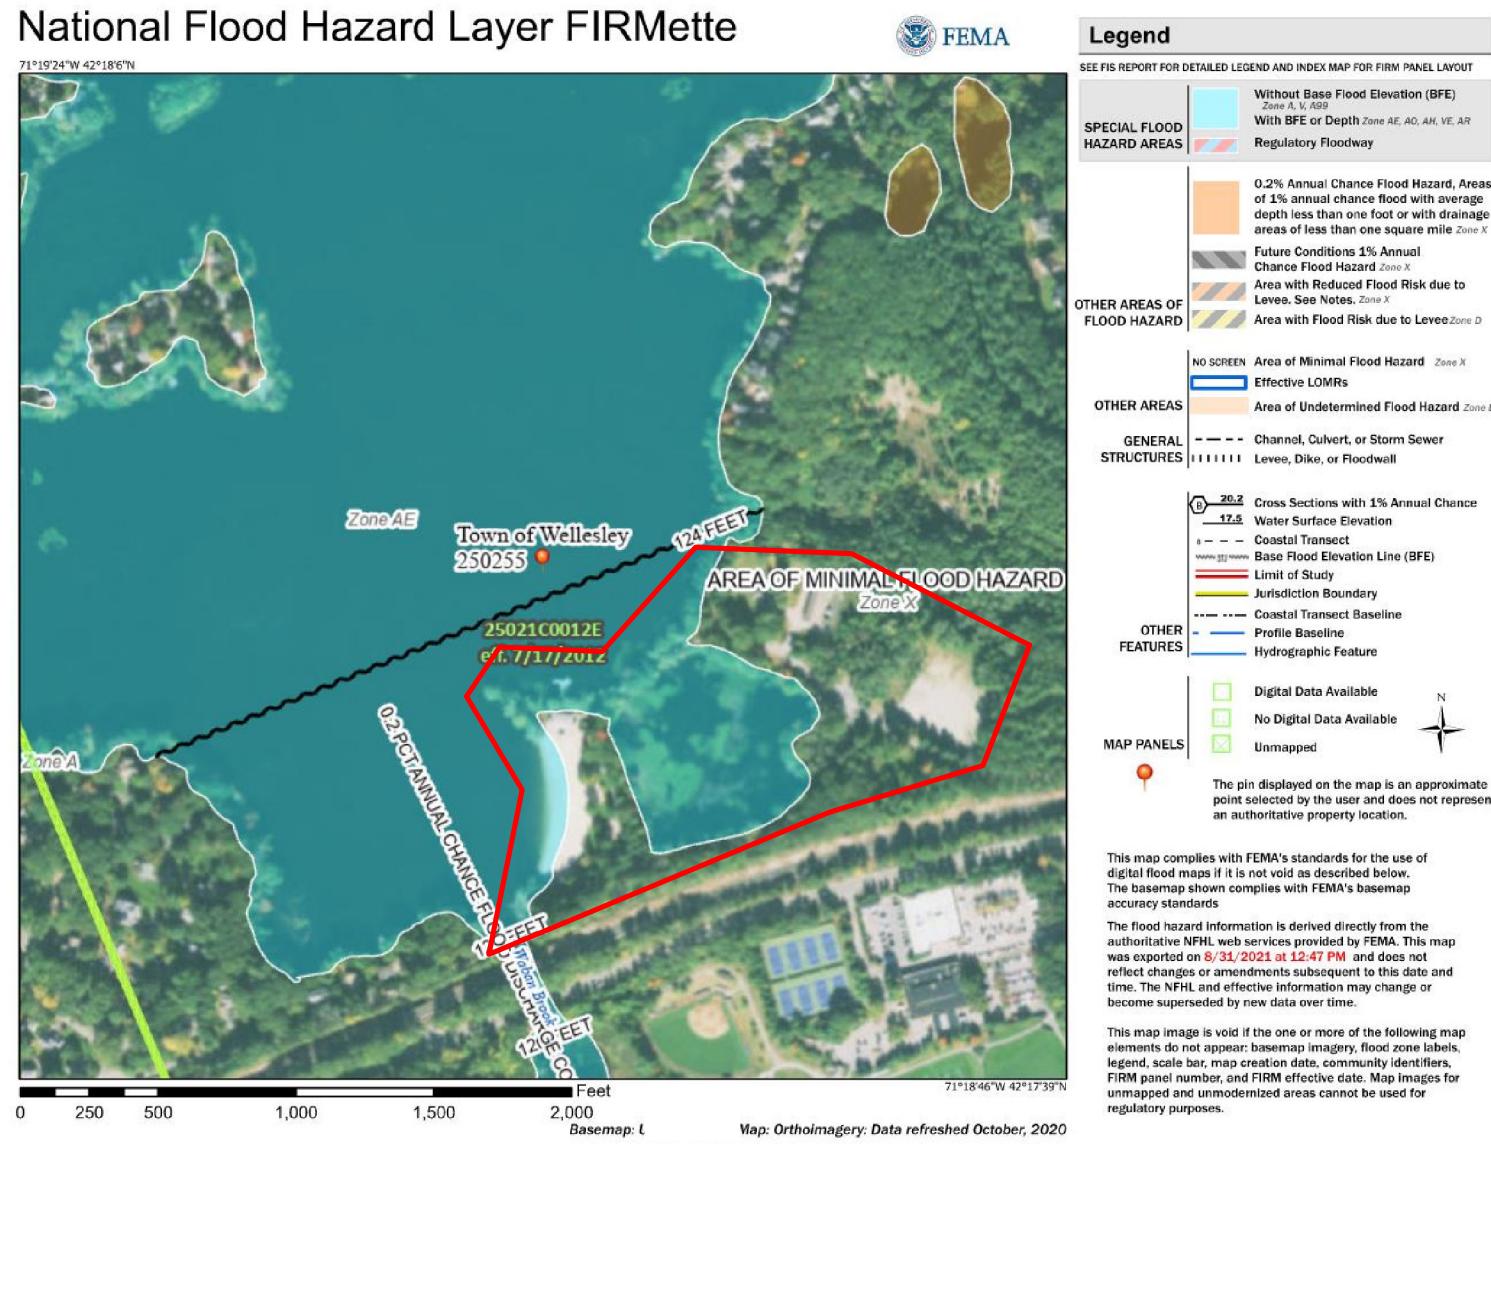
### FIGURE 3

## FEMA Map

FEMA Flood Insurance Rate Maps (FIRM) were created online from the FEMA website to determine if there is a 100-year flood zone at the site. See Figure 3 for FIRM map. Based on the information provided

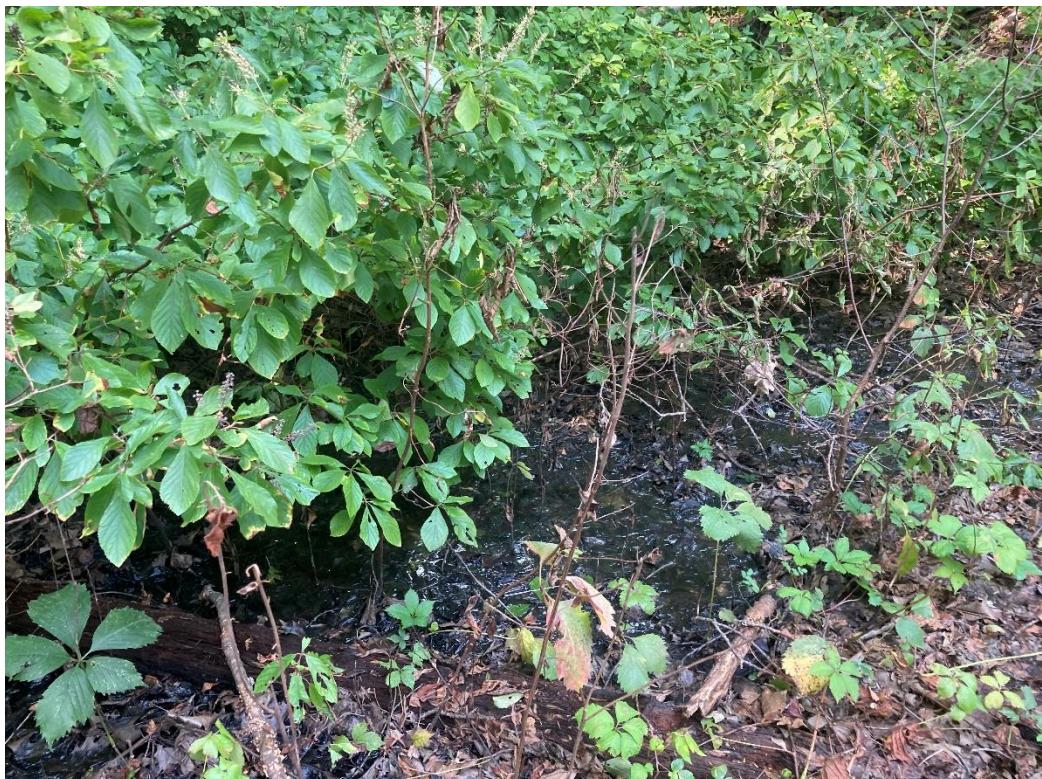
Photo 4: Isolated Wetland
