**George J. Saraceno, Senior Civil Engineer**

**TO:** Don McCauley, Planning Director  
**RE:** Review of Adequacy (ROA)  
11 Caroline Street  
**DATE:** December 18, 2020

The Department of Public Works (DPW), Engineering Division received a copy of plans and design documents for a new project located at 11 Caroline Street. The Civil plans were prepared by Metro West Engineering, Inc. of Framingham, MA. We received a copy of the project submittal from the Planning Department with a transmittal sheet dated December 18, 2020. The hearing for the project is scheduled with the Planning Board on January 19, 2021. A project summary was provided in the Hydrologic Assessment Report. The property area is 17,506 square feet, which is in a Zoning SR10, Single Family Residential 10,000 square foot Zoning District and is not within the Town's Water Supply Protection District. The project site is located outside the 100-foot wetlands buffer zone.

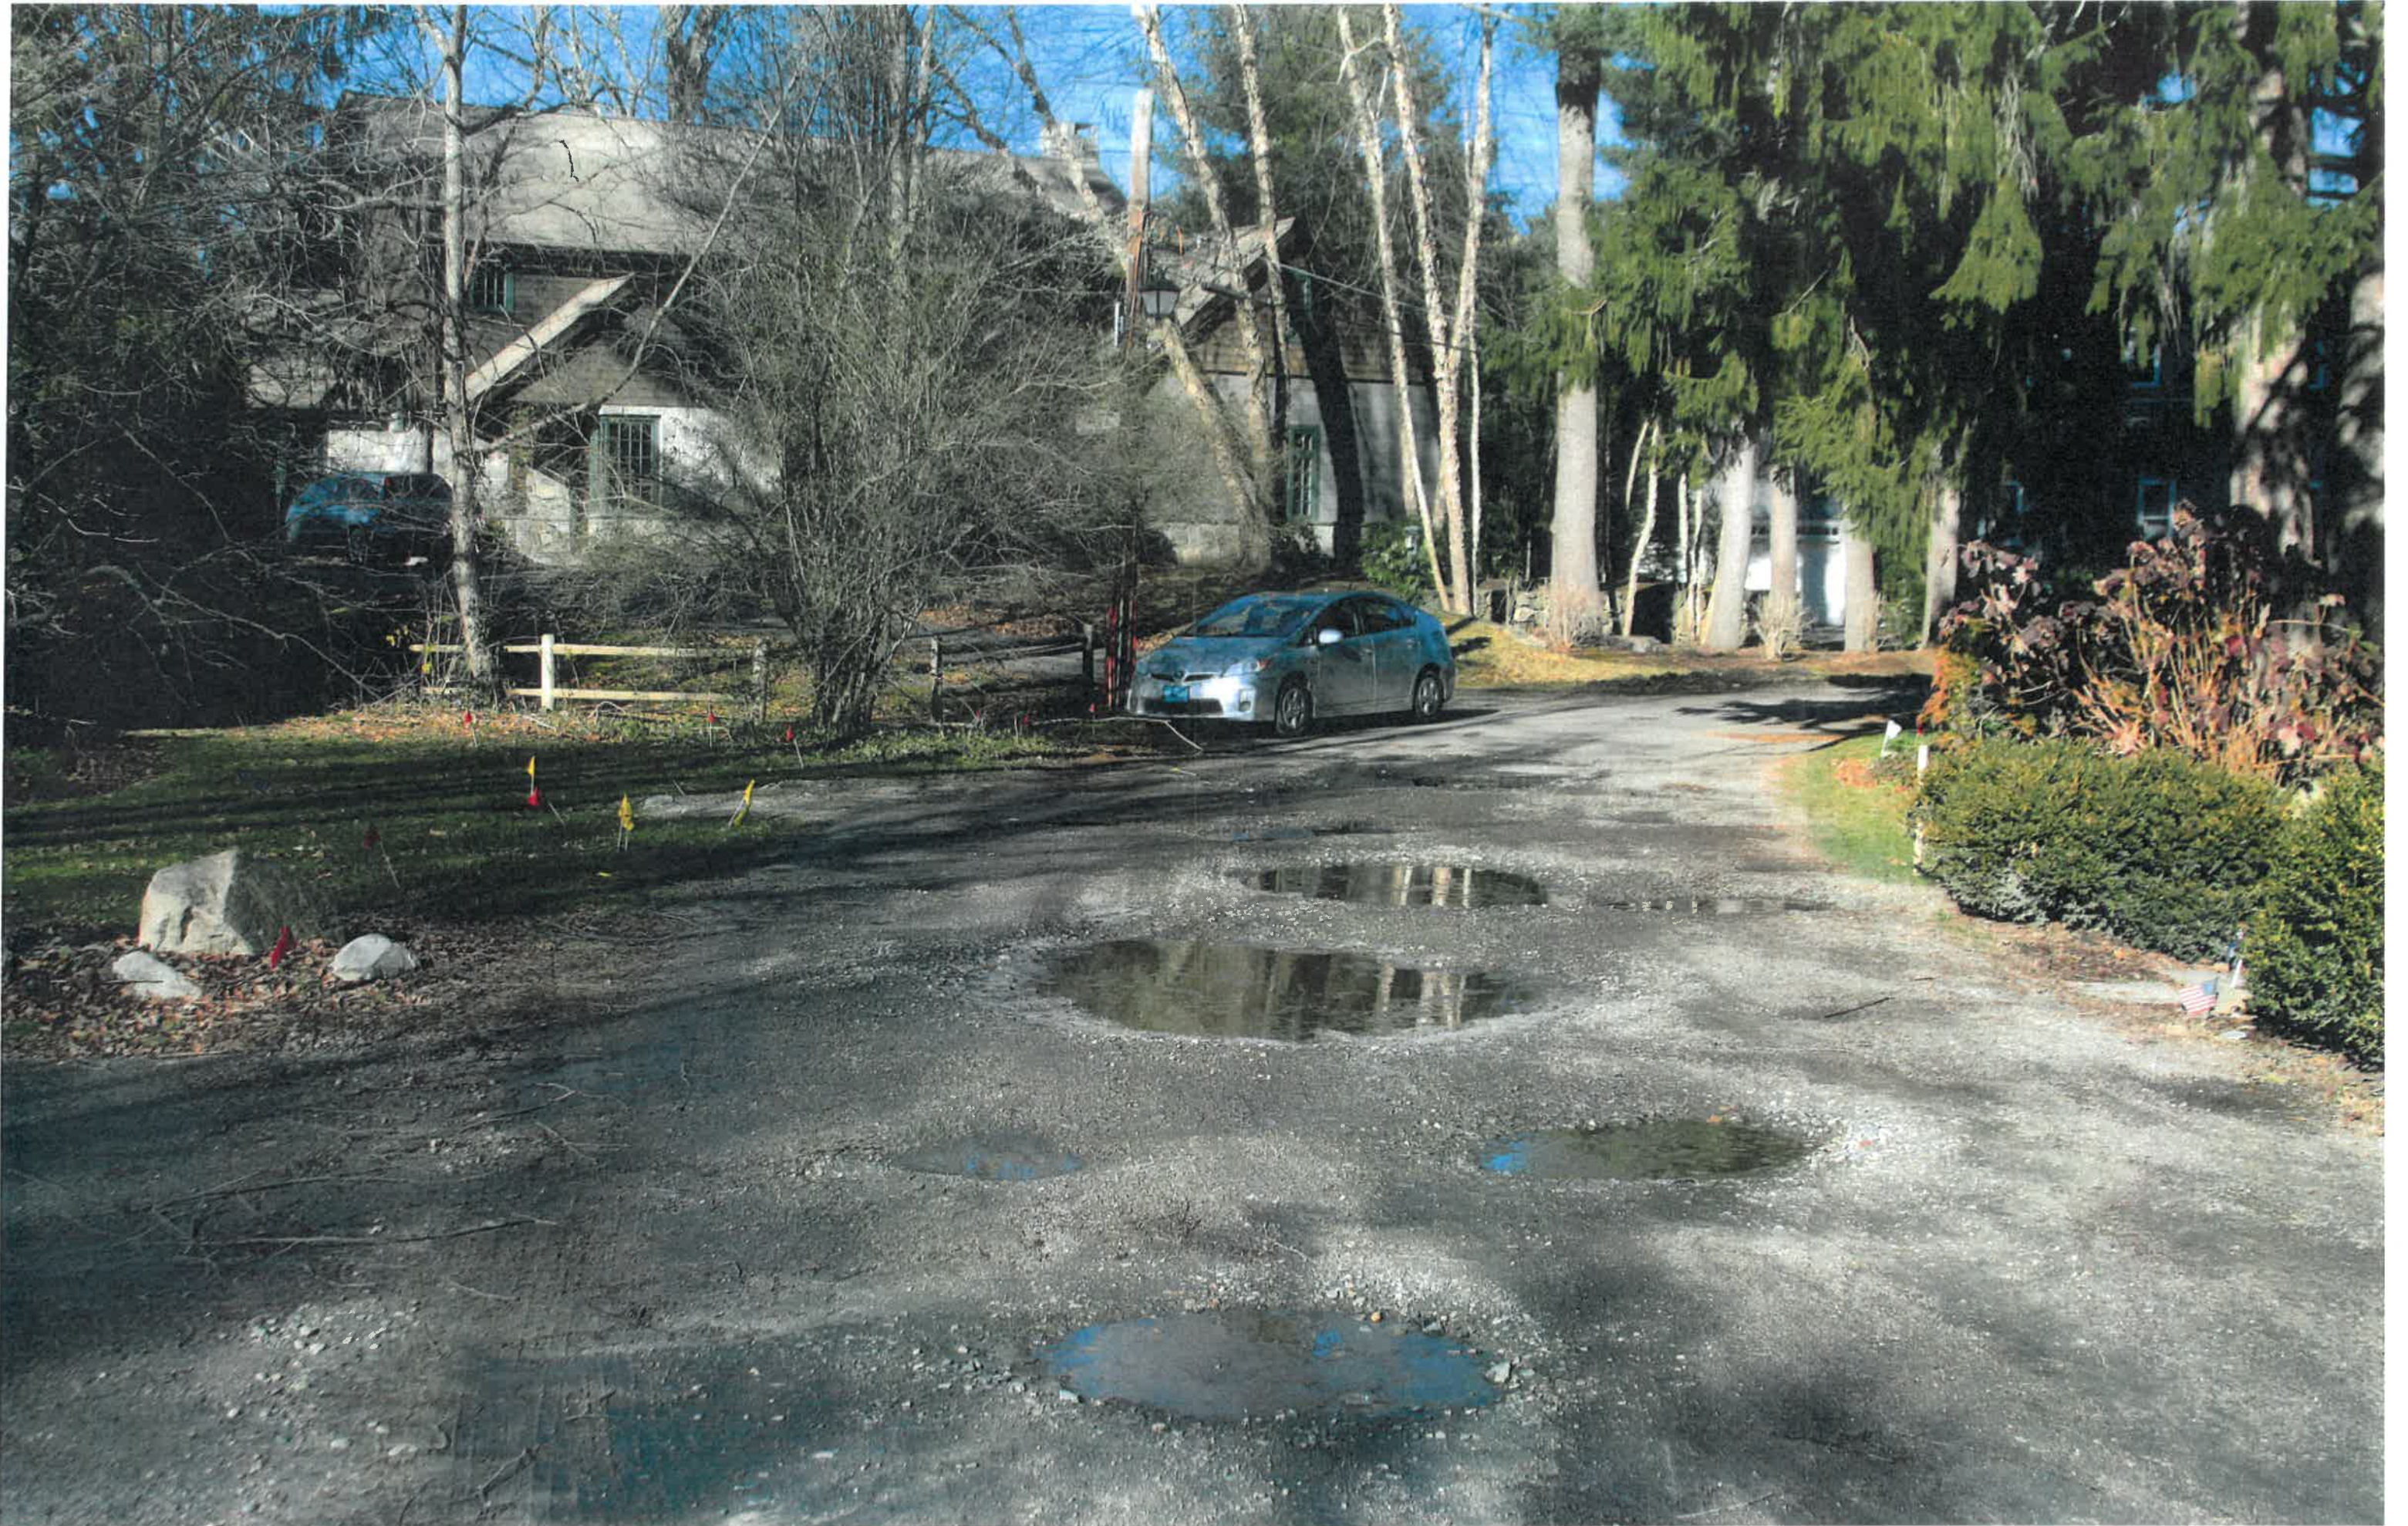
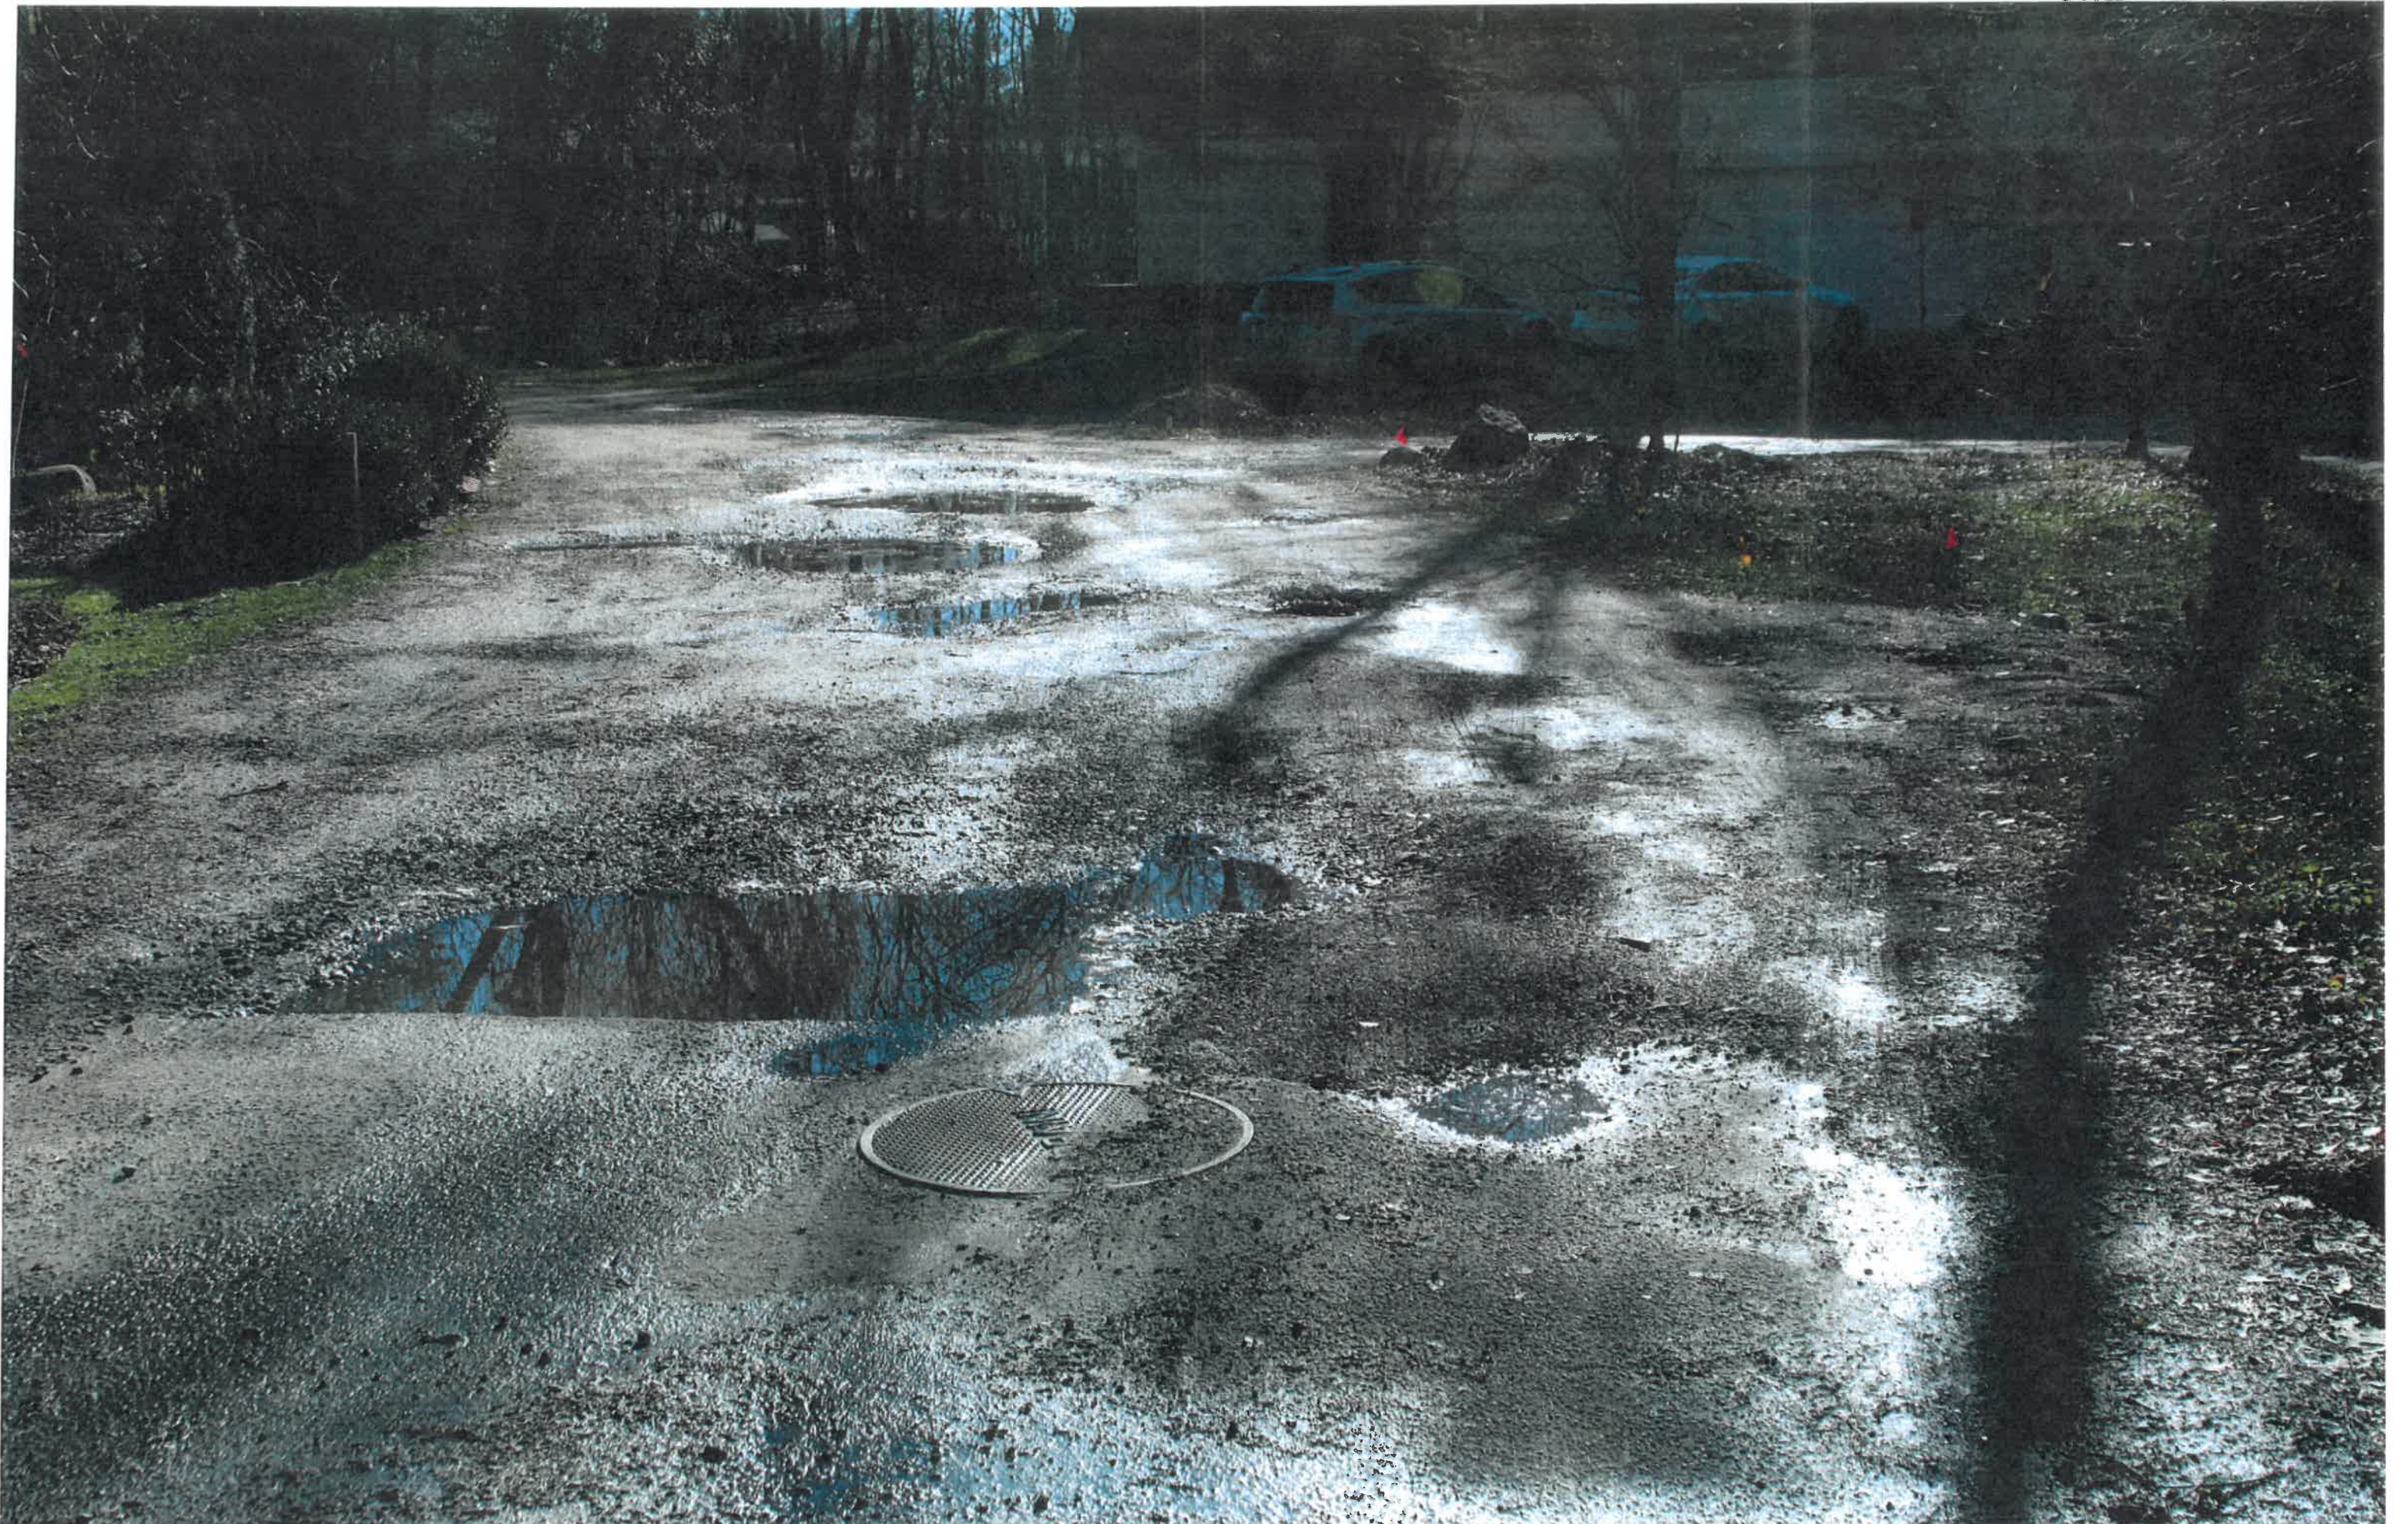
Enc. (1): Photographs  
Enc. (2): Cost Estimate

- We recommend that any fill brought to the site be inspected by an engineer prior to unloading onto the site.
- Provide the cut and fill calculations for the project. How many trucks will be required to deliver fill to the site?
- The private way, Caroline Street, is in poor condition in front of this property with large potholes throughout. Photographs are provided, see enclosure 1. We recommend paving the road along the entire frontage of the lot, edge of road to edge of road. Any paving work would require new sub-base material and paving the binder and top course with a centerline and cross slope grade at 2% on either side.
- Provide a note on the Erosion and Sediment Control Plan, sheet 2 of 6, that silt sacks should be provided for the two catch basins in front of the site on Caroline Street. Provide a detail of the silt sacks on the Erosion and Sediment Control Plan.

The existing gravel road in front of the property is in poor condition with an uneven surface and deep potholes throughout. We recommend paving the roadway to a roadway width of 18' along the entire frontage of the lot. The approximate cost for a full depth reconstruction of the 94' long section with an average of 18' wide travel way is \$19,242, see enclosure 2. We recommend that the designer consider biological treatment of the on-site stormwater runoff in addition to the infiltration systems. We recommend that the project be conditioned to fill-in the remaining potholes on Caroline Street, post construction, due to heavy equipment from the construction site traveling through Caroline Street.
